REVIEW OF LANDSLIDES IN 2006

GEO REPORT No. 237

**GEOTECHNICAL ENGINEERING OFFICE
CIVIL ENGINEERING AND DEVELOPMENT DEPARTMENT
THE GOVERNMENT OF THE HONG KONG
SPECIAL ADMINISTRATIVE REGION**

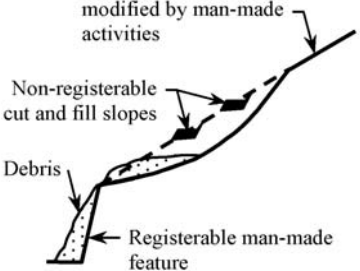
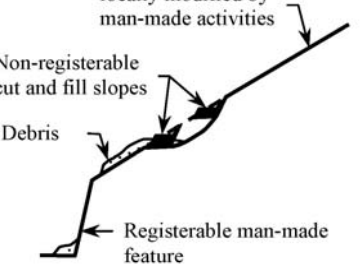
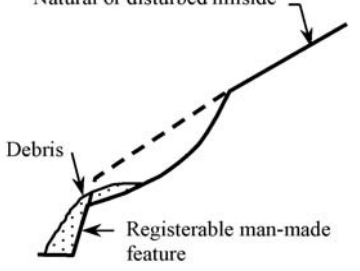
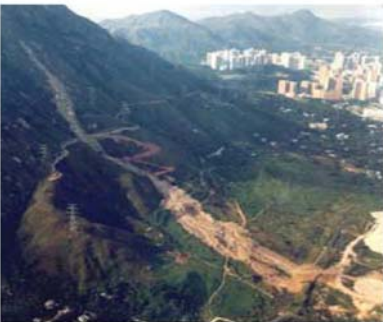
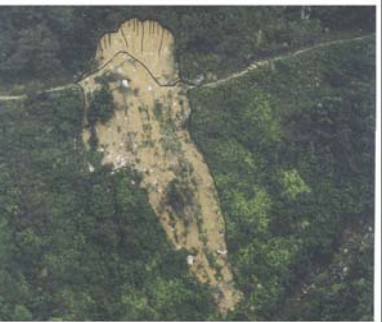
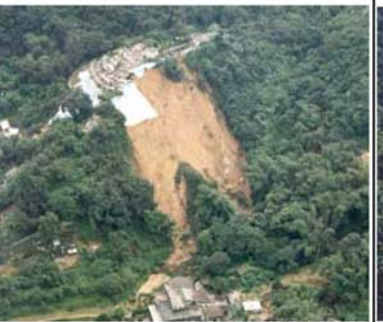
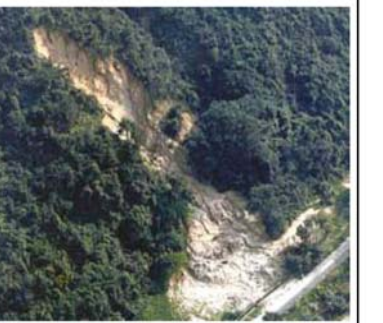
Figure 2 - General Classification of Hillside Failures

Classification	Natural hillside failure	Disturbed-hillside failure		Hillside failure involving registerable man-made features
		Type A	Type B	
	<p>Natural hillside not modified by man-made activities</p>

<p>Debris</p> <p>Registerable man-made feature</p>	<p>Disturbed hillside locally modified by man-made activities</p>

<p>Non-registerable cut and fill slopes</p> <p>Debris</p> <p>Registerable man-made feature</p>	<p>Disturbed hillside locally modified by man-made activities</p>

<p>Non-registerable cut and fill slopes</p> <p>Debris</p> <p>Registerable man-made feature</p>	<p>Natural or disturbed hillside</p>

<p>Debris</p> <p>Registerable man-made feature</p>
Example

<p>1990 Tsing Shan debris flow (SPR6/96)</p> <p>1997 Wonderland Villas (#88)</p> <p>1998 Pak Sha Wan (#108)</p> <p>1998 Outward Bound School (#108)</p> <p>1999 Sham Tseng San Tsuen (#169)</p>	<p>1993 Lantau Trail (#61)</p> <p>1997 Lido Beach (#89)</p> <p>1997 Ka Tin Court (#91)</p>	<p>1997 To Fung Shan Cemetery (#89)</p> <p>1997 Shatin Heights Road (#88)</p>	<p>1995 Shum Wan Road (#178)</p> <p>1997 Ma On Shan (#90)</p> <p>1997 Kau Wah Keng (#76)</p>

The nature of the 41 incidents has been assessed based on the available information (see the classification shown in Figure 2). Thirty-four are classified as natural hillside failures (i.e. the failures affected hillsides that have not been modified by human activities, such as cutting, filling, etc.). The other seven (which included four registered DT features) involved hillsides that have been locally modified or disturbed by human activities but the man-made elements did not play a significant contributory role in the failures.
