GEO Technical Guidance Note No. 10 (TGN 10) Enhancement of Rock Slope Engineering Practice Based on Findings of Landslide Studies

Issue No.: 4	Revision: -	Date: 19.10.2020	Page: 1 of 7

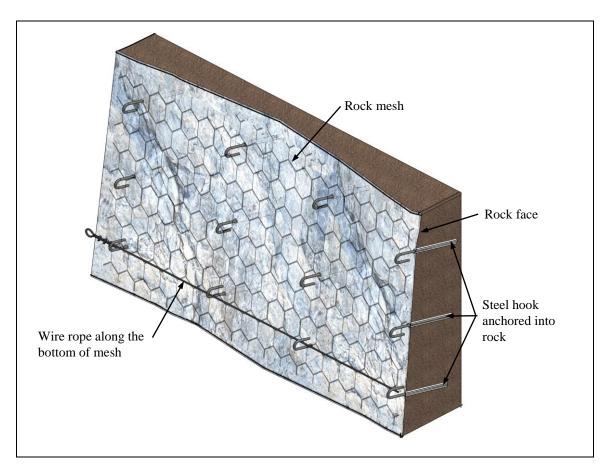
Figure 1 An example of fixing of rock mesh to the bottom of rock face

- 4.2.5 Specific unstable blocks and seepage locations should be dealt with by means of appropriate local support and drainage measures. However, in the case of a heavily jointed or intensely fractured rock mass, patterned rock dowelling in conjunction with prescriptive subsurface drainage measures and rock mesh netting could be an appropriate solution (MGSL, 2002). Adequate number of fixing pins should be provided to ensure that rock mesh netting closely follows the rock slope profile as far as practical, particularly along the edge of the rock mesh netting on rugged rock surface to prevent any potential loose blocks from falling out from the opening between the netting and the rock surface (Lee et al, 2014). The fixing details of any existing rock mesh netting especially for those installed in early years without the provision of a bottom wire rope with adequate fixing at the toe should be enhanced where opportunities arise to the latest standard, e.g. provision of a bottom wire rope and fixing pins to secure the rock mesh to the slope toe (see Figure 1), for improved robustness. Where potentially unstable blocks exceed the maximum size that rock mesh netting could retain, other appropriate methods (e.g. stabilisation, removal, etc.) should be considered (Hui, 2006).
