# **Review of Landslides in 2010**

**GEO Report No. 305**

**A.C.O. Li, J.C.W. Leung & H.W.K. Lam**

**Geotechnical Engineering Office  
Civil Engineering and Development Department  
The Government of the Hong Kong  
Special Administrative Region**

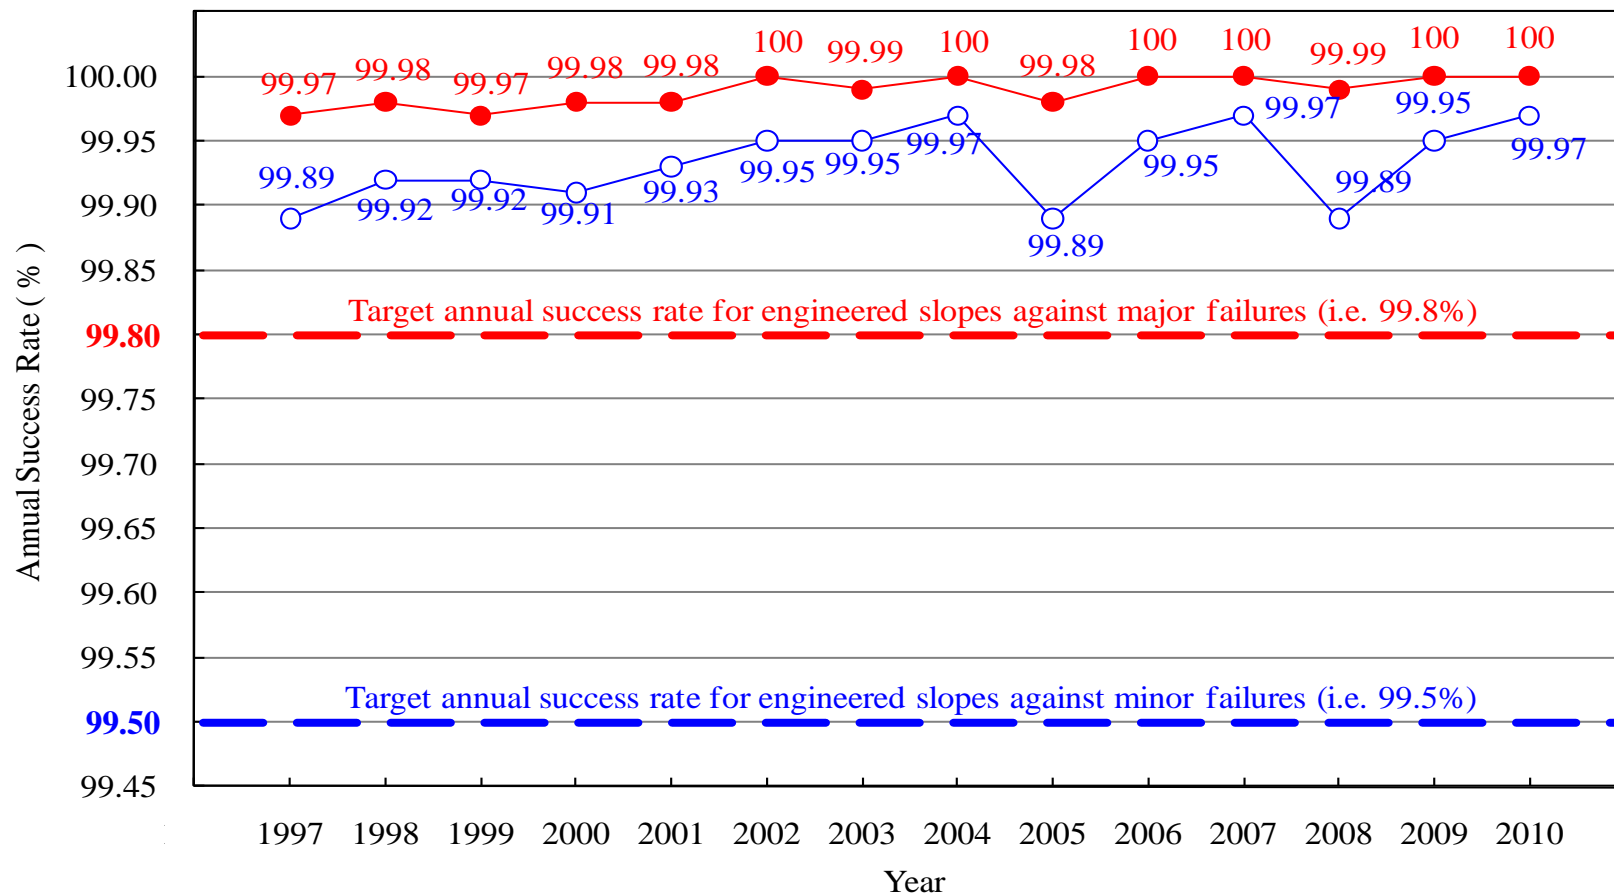
- Legend:
- Annual success rate for engineered slopes against major failures
  - Annual success rate for engineered slopes against minor failures
  - Target annual success rate for engineered slopes against major failures (i.e. 99.8%)
  - Target annual success rate for engineered slopes against minor failures (i.e. 99.5%)

**Figure 4.2 Annual Success Rates of Engineered Slopes from 1997 to 2010**

GEO's target annual success rates (where success rate = 1 – failure rate) for engineered slopes are 99.8% and 99.5% against major and minor failures respectively, on the basis of the number of landslides per total number of slopes. In 2010, the corresponding annual success rates were 100% and 99.97% respectively. Hence, the targets were satisfactorily achieved. The trend of the annual success rates of engineered slopes against major and minor failures respectively for the period from 1997 to 2010 is shown in Table 4.5 and Figure 4.2.

Note: See Figure 4.2 for a plot of annual success rates of engineered slopes against the target annual success rates from 1997 and 2010.
