# **Review of Landslides in 2013**

**GEO Report No. 326**

**R.W.H. Lee & D.O.K. Lo**

**Geotechnical Engineering Office  
Civil Engineering and Development Department  
The Government of the Hong Kong  
Special Administrative Region**

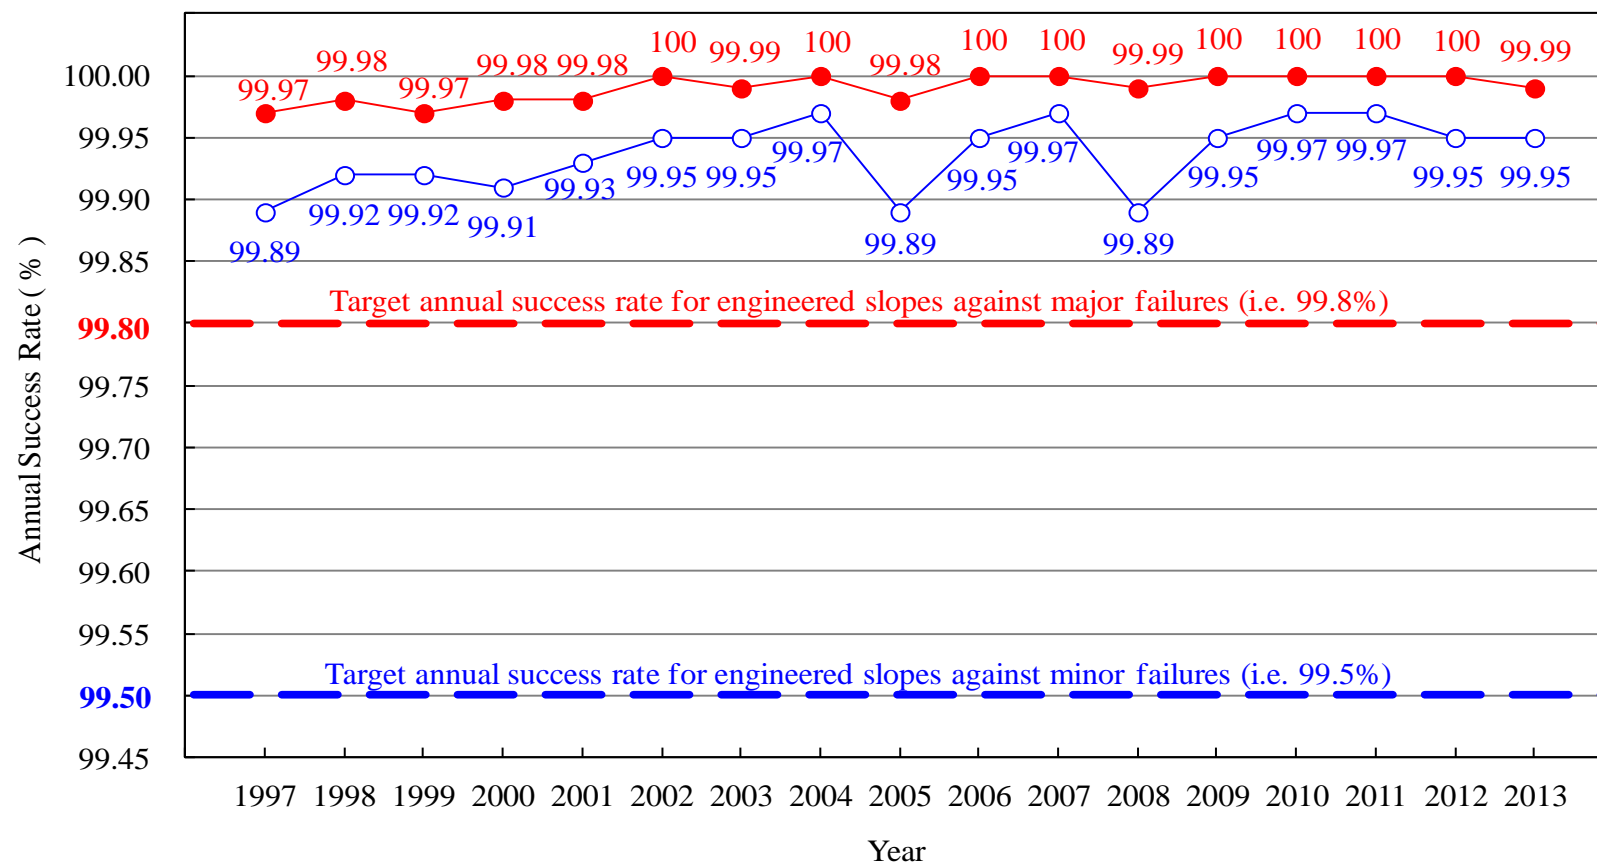
**Figure 4.2 Annual Success Rates of Engineered Slopes from 1997 to 2013**

GEO's target annual success rates (where success rate = 1 – failure rate) for engineered slopes are 99.8% and 99.5% against major and minor failures respectively, on the basis of the number of landslides per total number of slopes. In 2013, the corresponding annual success rates were 99.99% and 99.95% respectively. Hence, the targets were satisfactorily achieved. The trend of the annual success rates of engineered slopes against major and minor failures for the period from 1997 to 2013 is shown in Table 4.6 and Figure 4.2.

Note: See Figure 4.2 for a plot of annual success rates of engineered slopes against the target annual success rates from 1997 to 2013.
