Review of Landslides in 2015

GEO Report No. 335

**Geotechnical Engineering Office
Civil Engineering and Development Department
The Government of the Hong Kong
Special Administrative Region**

This report presents the findings of a detailed diagnosis of landslides in 2015 that were reported to the Government. It serves to review the performance of the Government's slope safety system and identify areas for improvement, as well as further enhancing the slope engineering practice in Hong Kong.

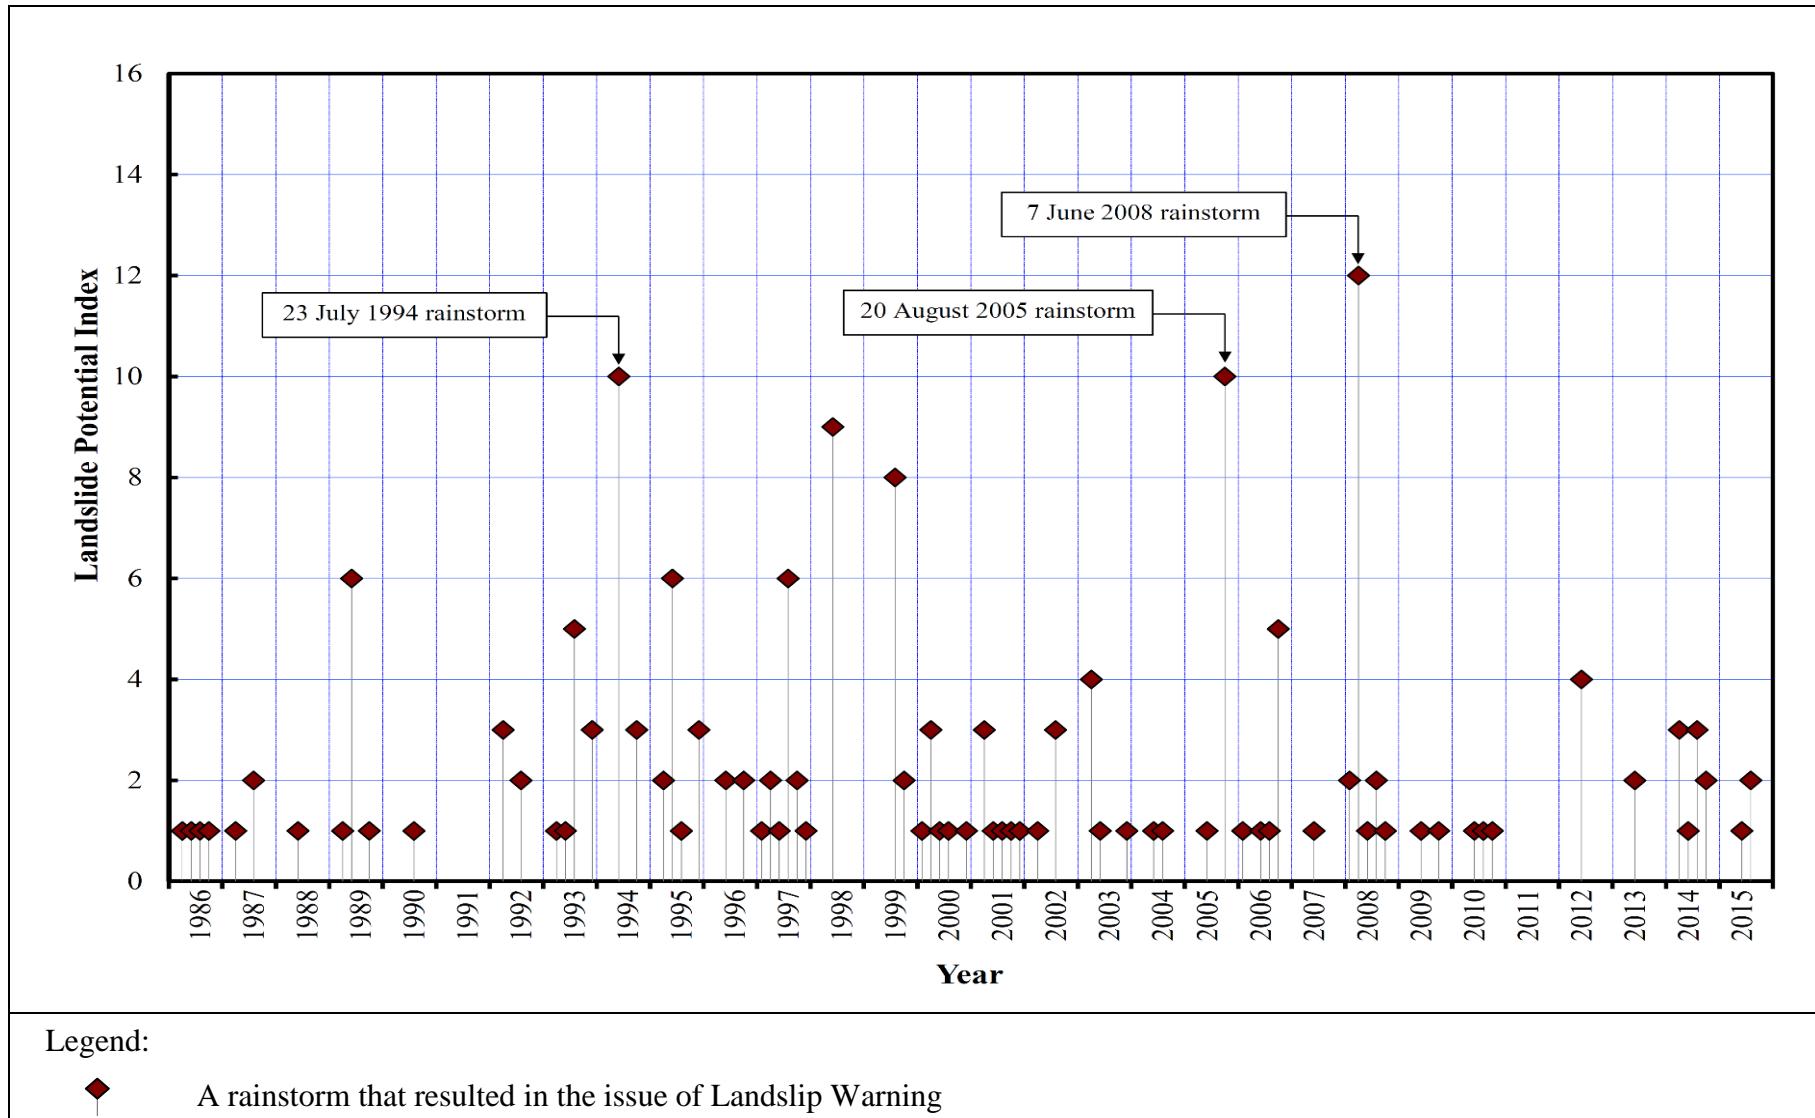
Figure 3.1 Landslide Potential Index for Rainstorms that Resulted in the Issue of Landslip Warnings from 1984 to 2015

Experience has shown that the annual rainfall alone is not a good measure of the severity of the individual rainstorms in terms of their potential to trigger landslides. A more direct measure of the severity of the individual rainstorms in the context of landslides is given by the Landslide Potential Index (LPI) (GEO, 2014a). The LPI is calculated for rainstorms that resulted in the issue of Landslip Warning and is used to depict the relative severity of the rainstorm with respect to its potential to cause landslides. The LPI, which is not a predictive index, is based on the 24-hour rainfall of a rainstorm. The LPI for rainstorms that resulted in the issue of Landslip Warnings from 1984 to 2015 is presented in Figure 3.1.

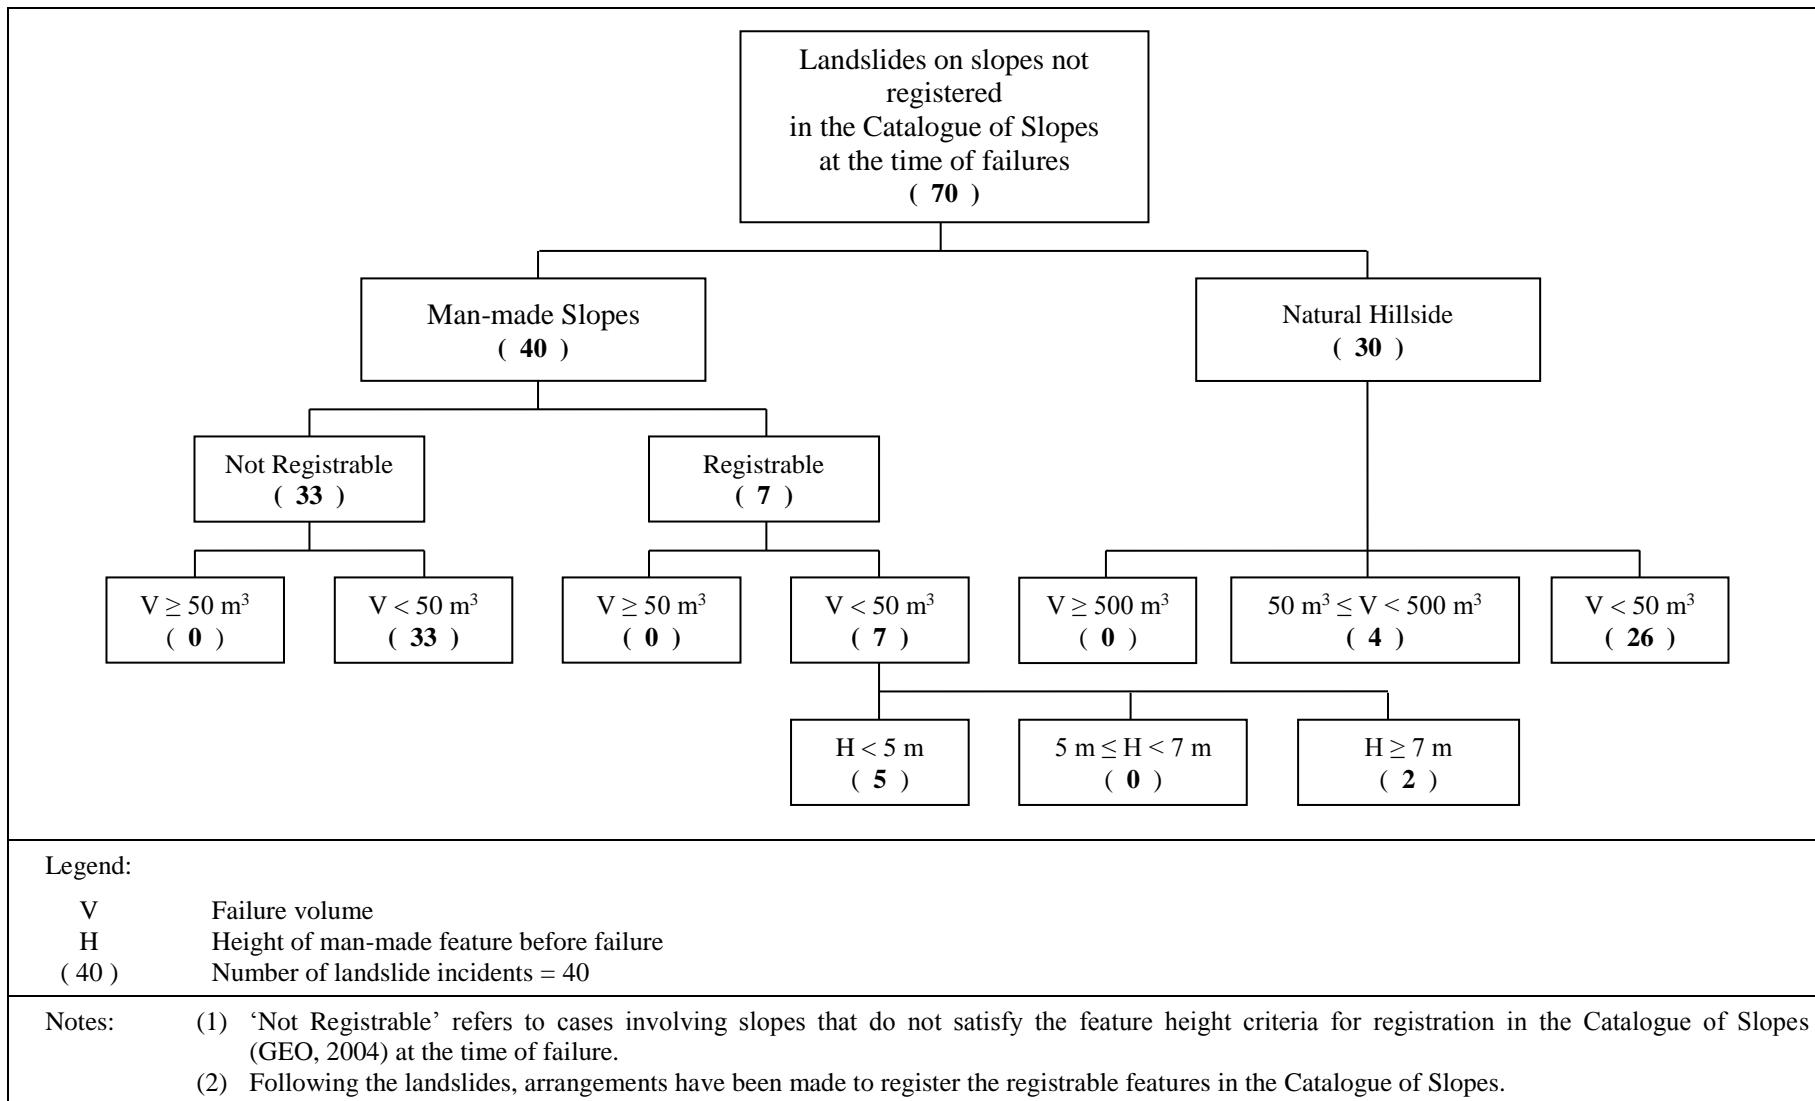
Figure 4.1 Breakdown of Landslides on Unregistered Slopes in 2015

Among the above 70 landslides, 30 occurred on natural hillside, 33 occurred on small man-made slope features that do not meet the slope registration criteria (GEO, 2004). The remaining seven landslides, corresponding to 4.3% of the total number of genuine landslides in 2015, involved slope features that satisfy the slope registration criteria but were not registered in the Catalogue of Slopes at the time of failures. A breakdown of these 70 landslides is given in Figure 4.1.

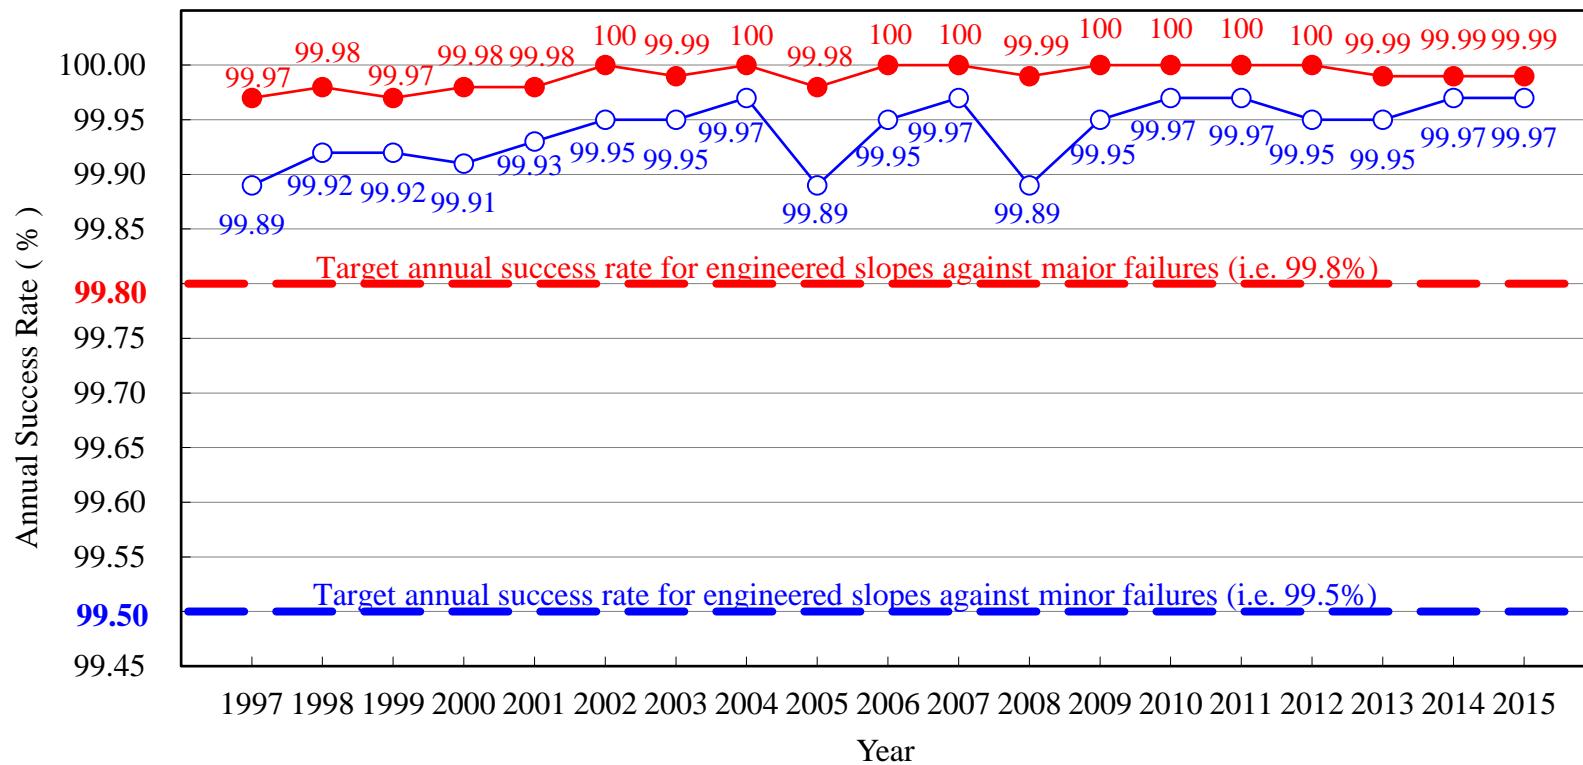
- Annual success rate for engineered slopes against major failures
- Annual success rate for engineered slopes against minor failures
- Target annual success rate for engineered slopes against major failures (i.e. 99.8%)
- Target annual success rate for engineered slopes against minor failures (i.e. 99.5%)

Figure 4.2 Annual Success Rates of Engineered Slopes from 1997 to 2015

GEO's target annual success rates (where success rate = 1 – failure rate) for engineered slopes are 99.8% and 99.5% against major and minor failures respectively, on the basis of the number of landslides per total number of slopes. In 2015, the corresponding annual success rates were 99.99% and 99.97% respectively. Hence, the targets were satisfactorily achieved. The trend of the annual success rates of engineered slopes against major and minor failures for the period from 1997 to 2015 is shown in Table 4.6 and Figure 4.2.

Note: See Figure 4.2 for a plot of annual success rates of engineered slopes against the target annual success rates from 1997 to 2015.
