Review of Landslides in 2017

GEO Report No. 346

R.C.T. Wai, R.W.H. Lee & R.H.C. Law

**Geotechnical Engineering Office
Civil Engineering and Development Department
The Government of the Hong Kong
Special Administrative Region**

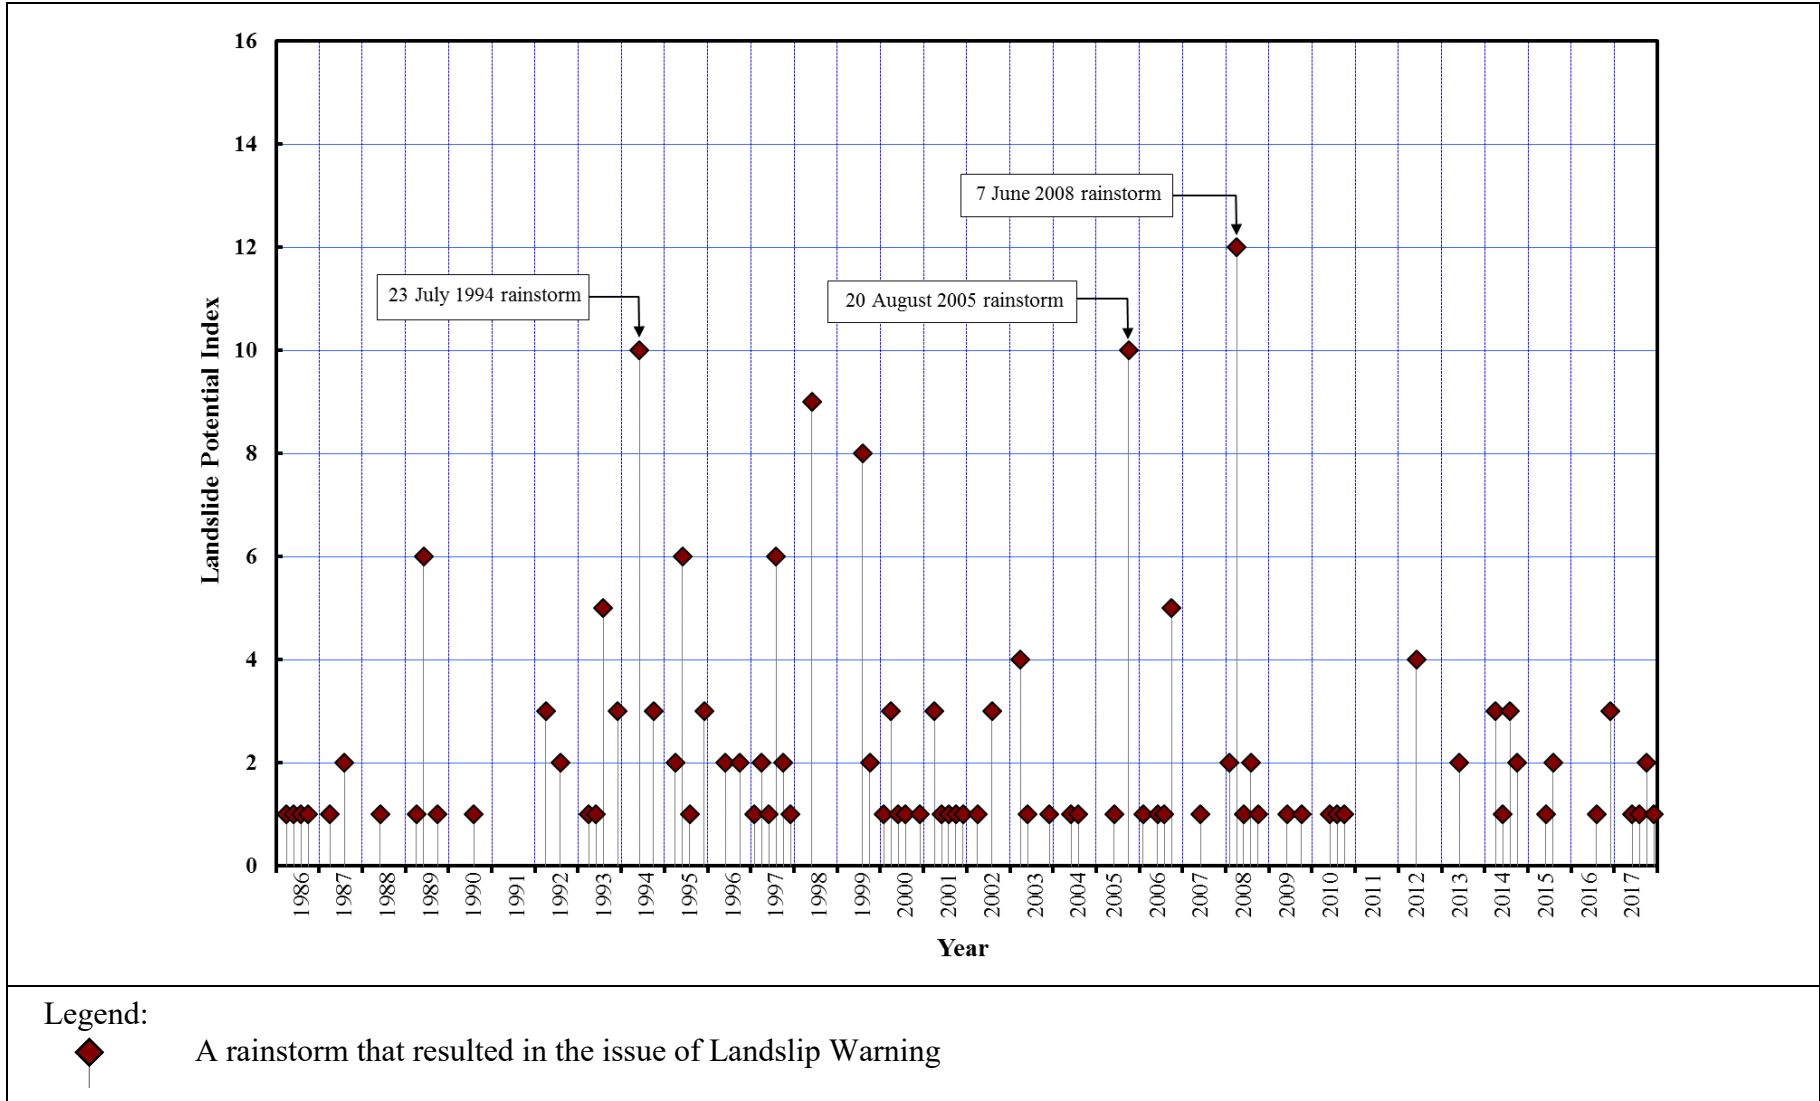
Figure 3.1 Landslide Potential Index for Rainstorms that Resulted in the Issue of Landslip Warnings from 1986 to 2017

Experience has shown that the annual rainfall alone is not a good measure of the severity of the individual rainstorms in terms of their potential to trigger landslides. A more direct measure of the severity of the individual rainstorms in the context of landslides is given by the Landslide Potential Index (LPI) (GEO, 2014a). The LPI is calculated for rainstorms that resulted in the issue of Landslip Warning and is used to depict the relative severity of the rainstorm with respect to its potential to cause landslides. The LPI, which is not a predictive index, is based on the 24-hour rainfall of a rainstorm. The LPI for rainstorms that resulted in the issue of Landslip Warnings from 1986 to 2017 is presented in Figure 3.1.

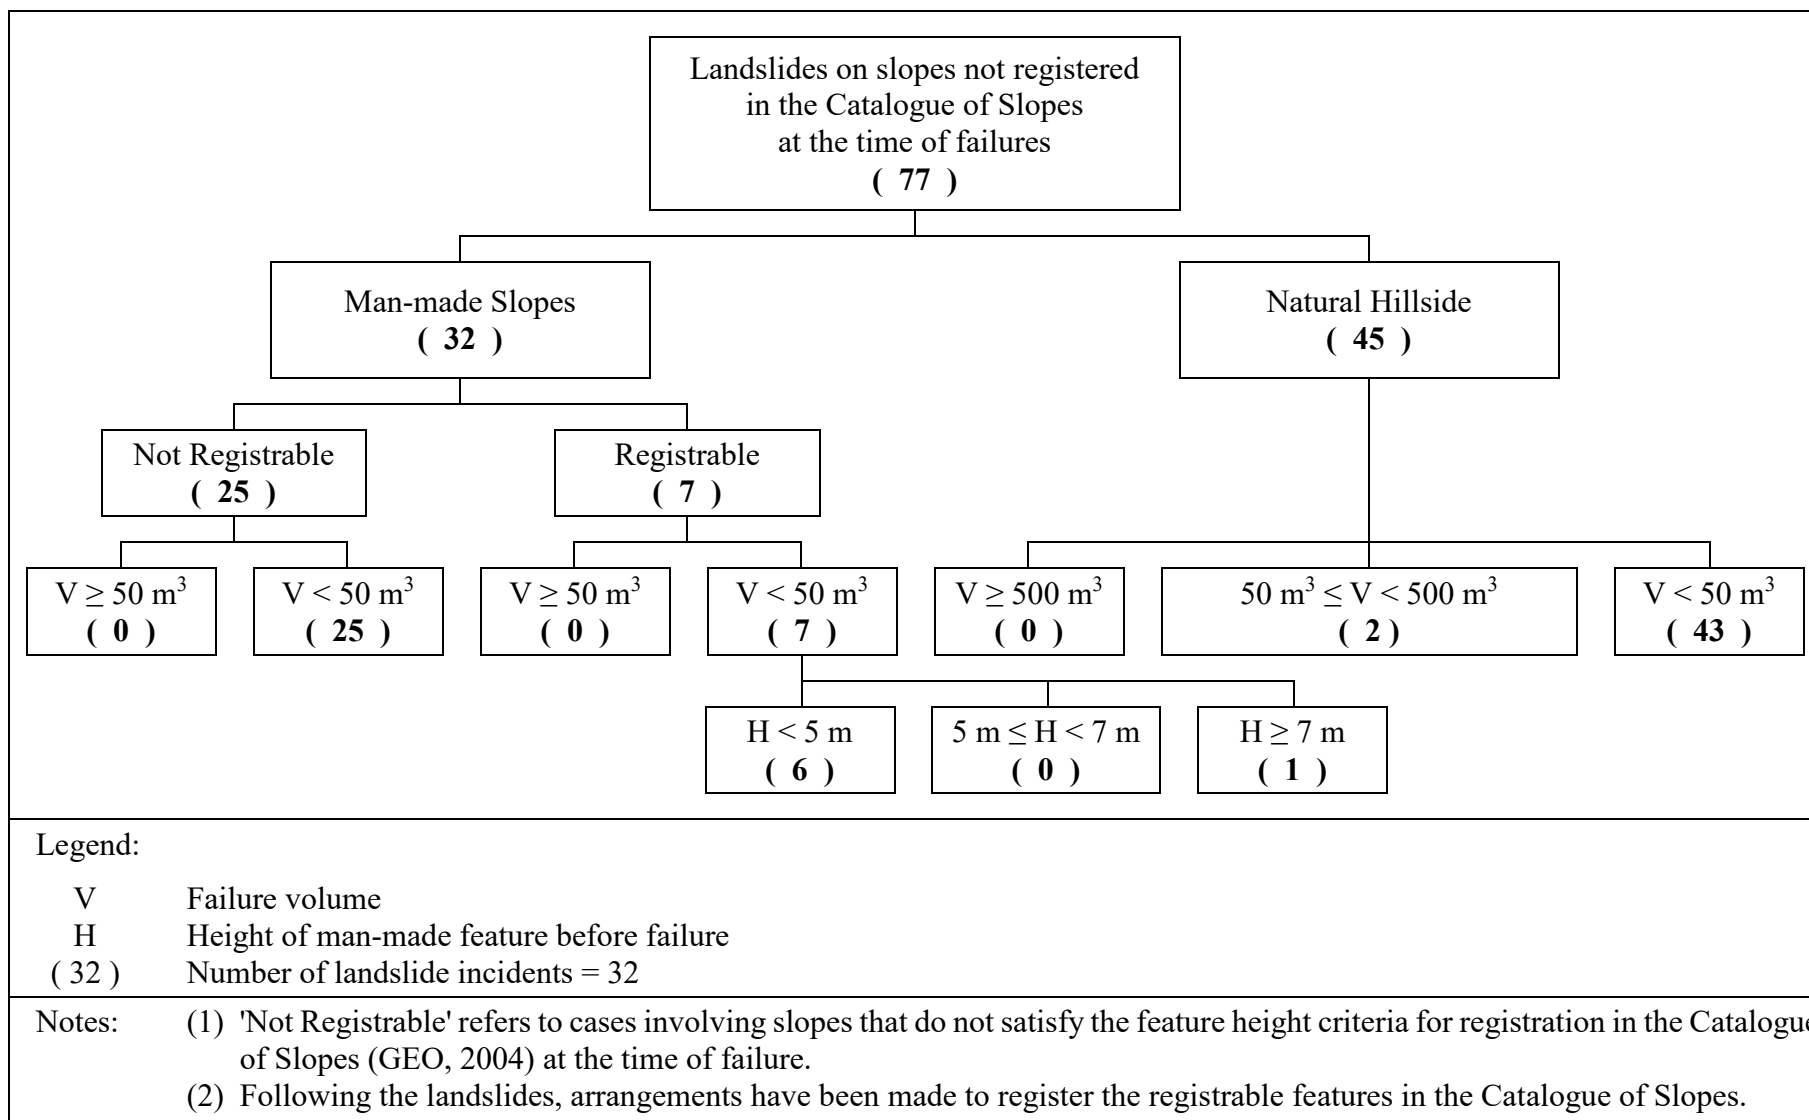
Figure 4.1 Breakdown of Landslides on Unregistered Slopes in 2017

Among the above 77 landslides, 45 occurred on natural hillside, 25 occurred on small man-made slope features that do not meet the slope registration criteria (GEO, 2004). The remaining seven landslides, corresponding to 4.6% of the total number of genuine landslides in 2017, involved slope features that satisfy the slope registration criteria but were not registered in the Catalogue of Slopes at the time of failures. A breakdown of these 77 landslides is given in Figure 4.1.
