# **Review of Landslides in 2018**

**GEO Report No. 348**

**Geotechnical Engineering Office  
Civil Engineering and Development Department  
The Government of the Hong Kong  
Special Administrative Region**

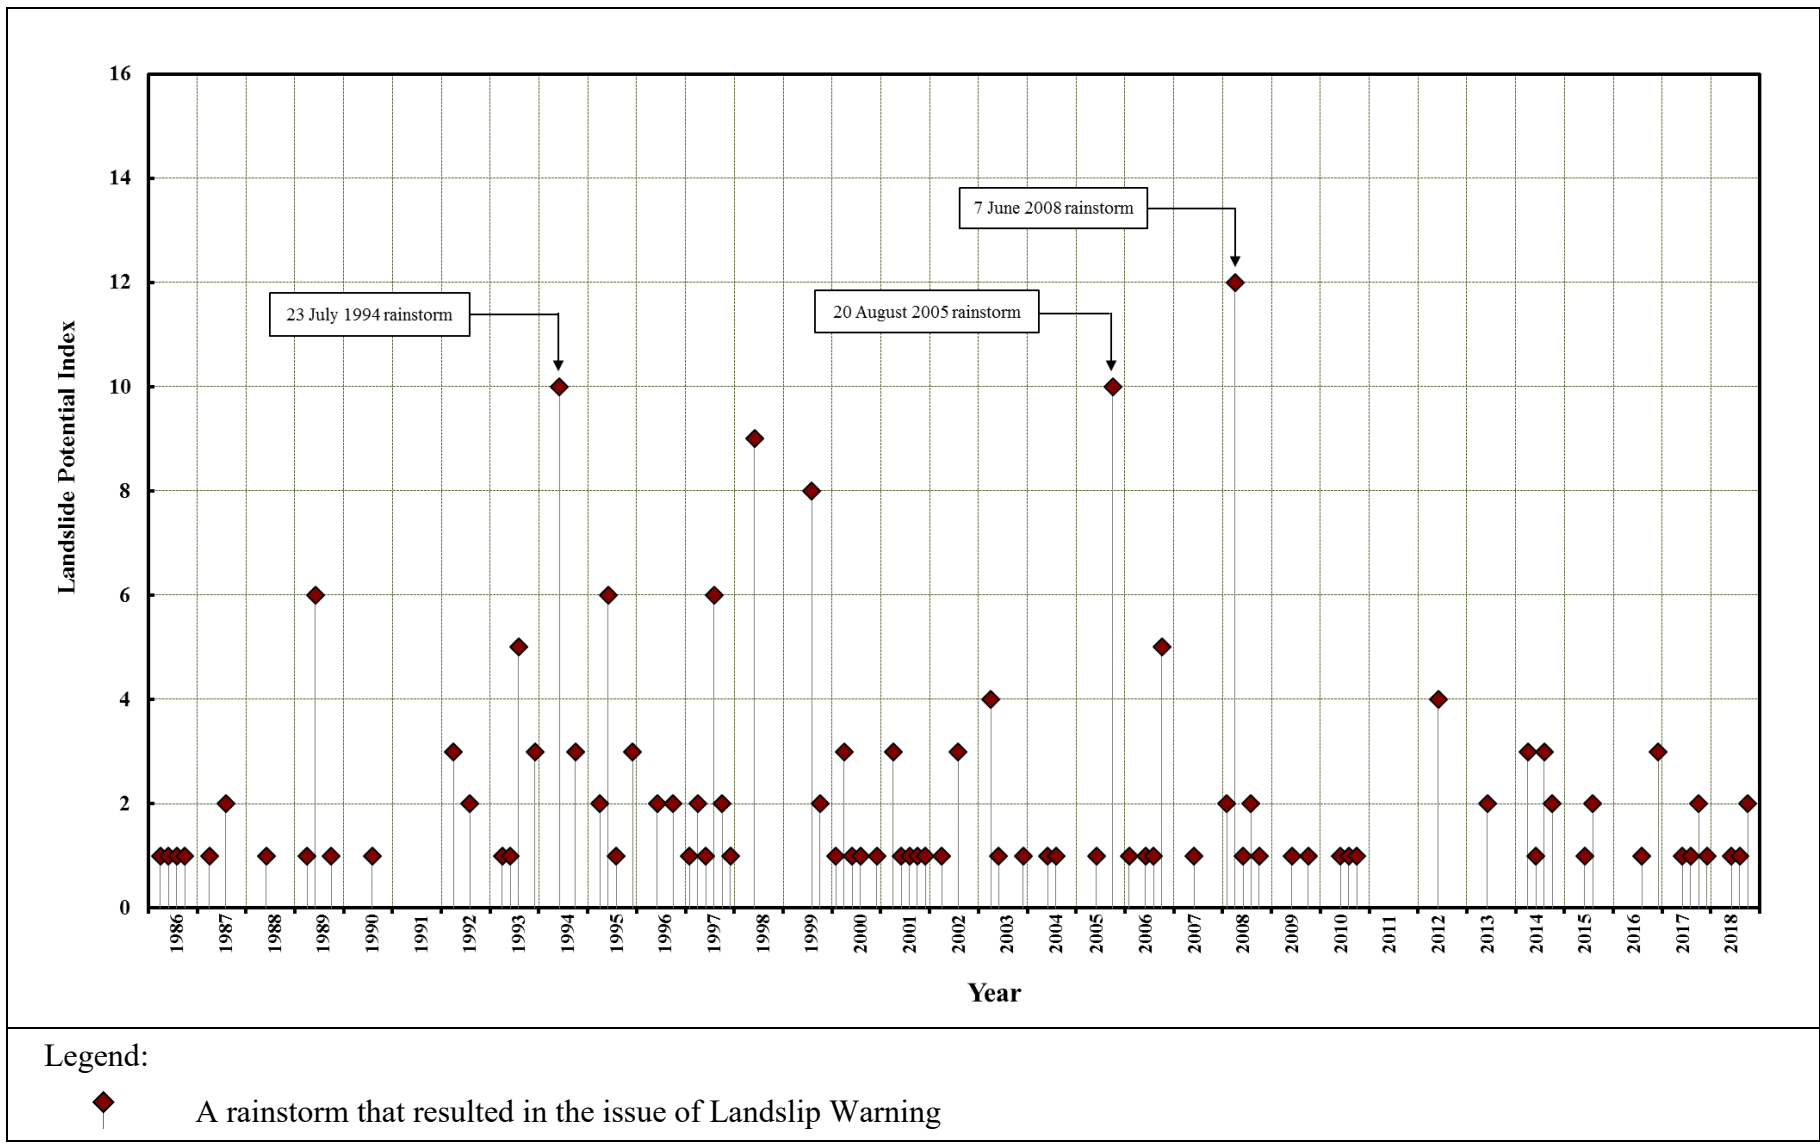
Figure 3.1 Landslide Potential Index for Rainstorms that Resulted in the Issue of Landslip Warnings from 1986 to 2018

Experience has shown that the annual rainfall alone is not a good measure of the severity of the individual rainstorms in terms of their potential to trigger landslides. A more direct measure of the severity of the individual rainstorms in the context of landslides is given by the Landslide Potential Index (LPI) (GEO, 2014a). The LPI is calculated for rainstorms that resulted in the issue of Landslip Warning and is used to depict the relative severity of the rainstorm with respect to its potential to cause landslides. The LPI, which is not a predictive index, is based on the 24-hour rainfall of a rainstorm. The LPI for rainstorms that resulted in the issue of Landslip Warnings from 1986 to 2018 is presented in Figure 3.1.

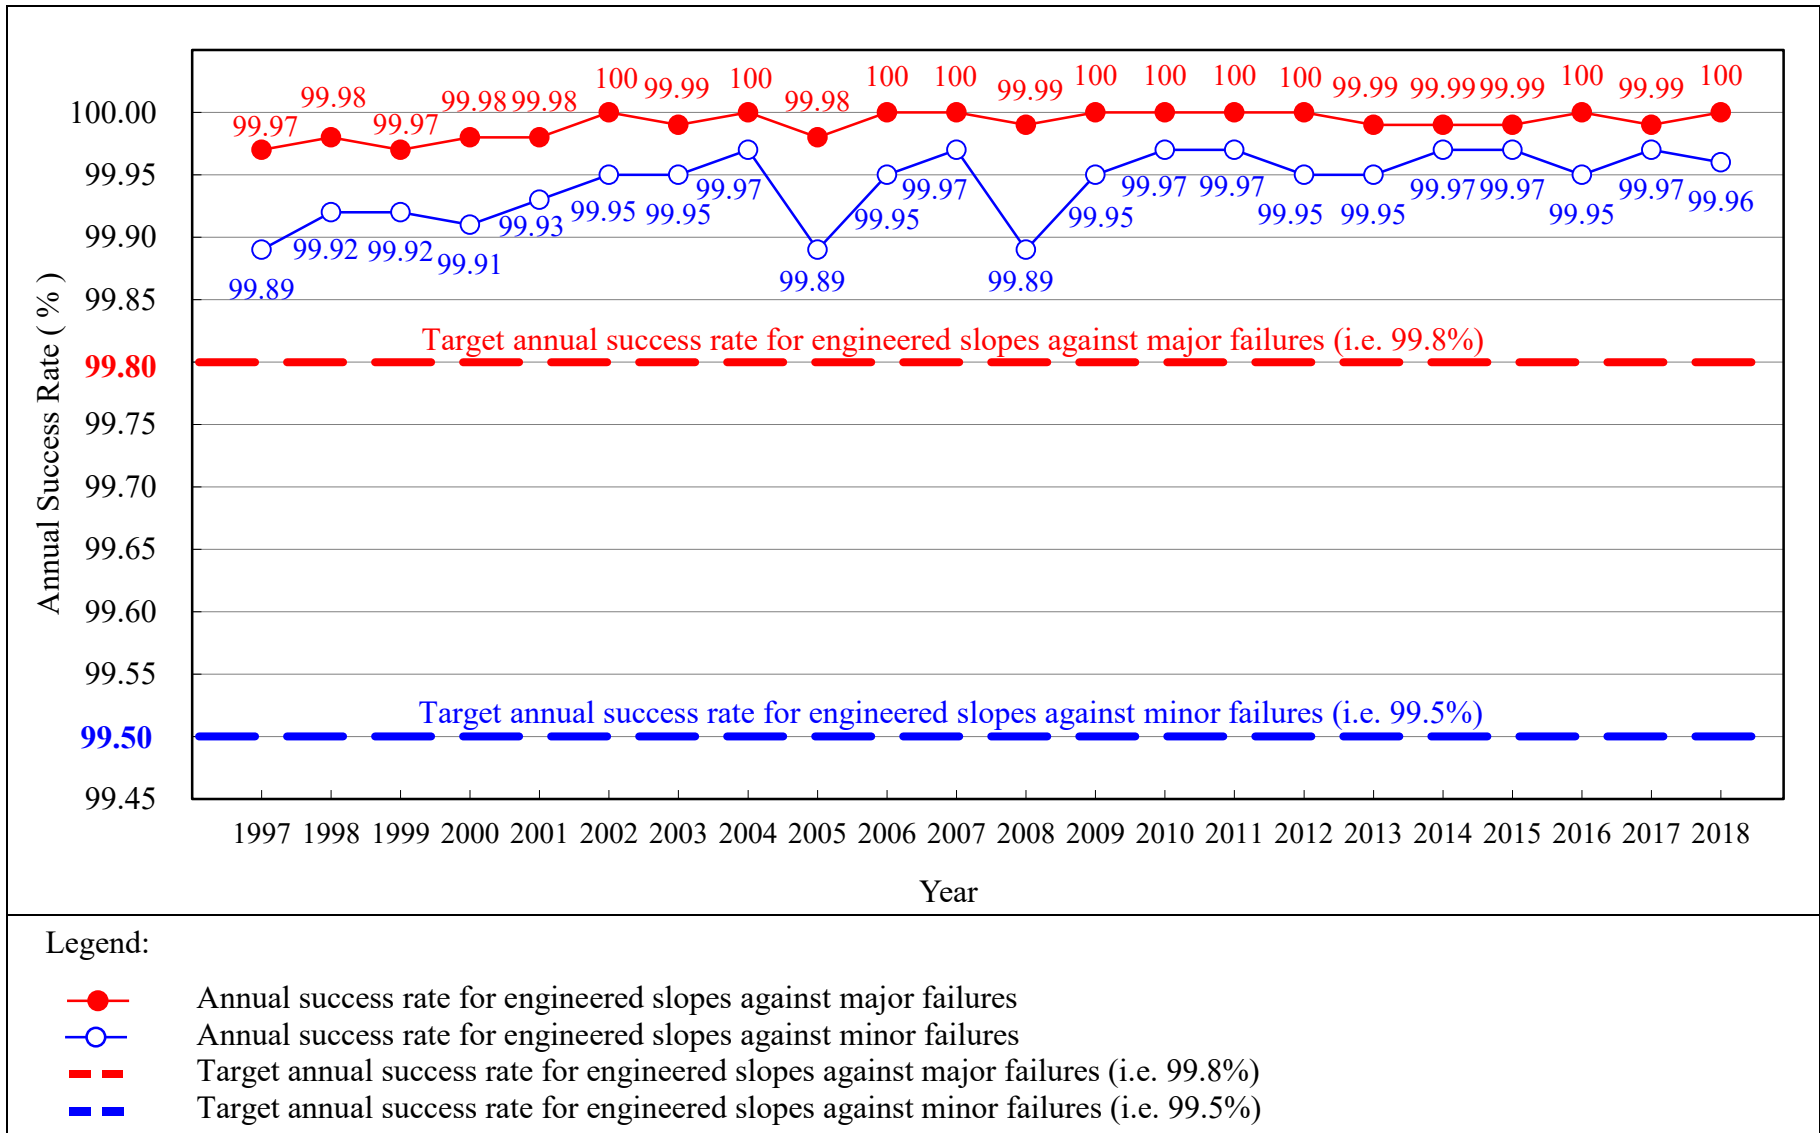
Figure 4.2 Annual Success Rates of Engineered Slopes from 1997 to 2018

GEO's target annual success rates (where success rate = 1 – failure rate) for engineered slopes are 99.8% and 99.5% against major and minor failures respectively, on the basis of the number of landslides per total number of slopes. In 2018, the corresponding annual success rates were 100% and 99.96% respectively. Hence, the targets were satisfactorily achieved. The trend of the annual success rates of engineered slopes against major and minor failures for the period from 1997 to 2018 is shown in Table 4.6 and Figure 4.2.

Note: See Figure 4.2 for a plot of annual success rates of engineered slopes against the target annual success rates from 1997 to 2018.
