project
ASSESSMENT OF GEOLOGICAL FEATURES RELATED TO RECENT LANDSLIDES IN VOLCANIC ROCKS OF HONG KONG
PHASE 2A: CHAI WAN

drawing title
MAP No. 3
LANDSLIDE INCIDENTS

office
 PLANNING DIVISION
 GEOTECHNICAL ENGINEERING OFFICE

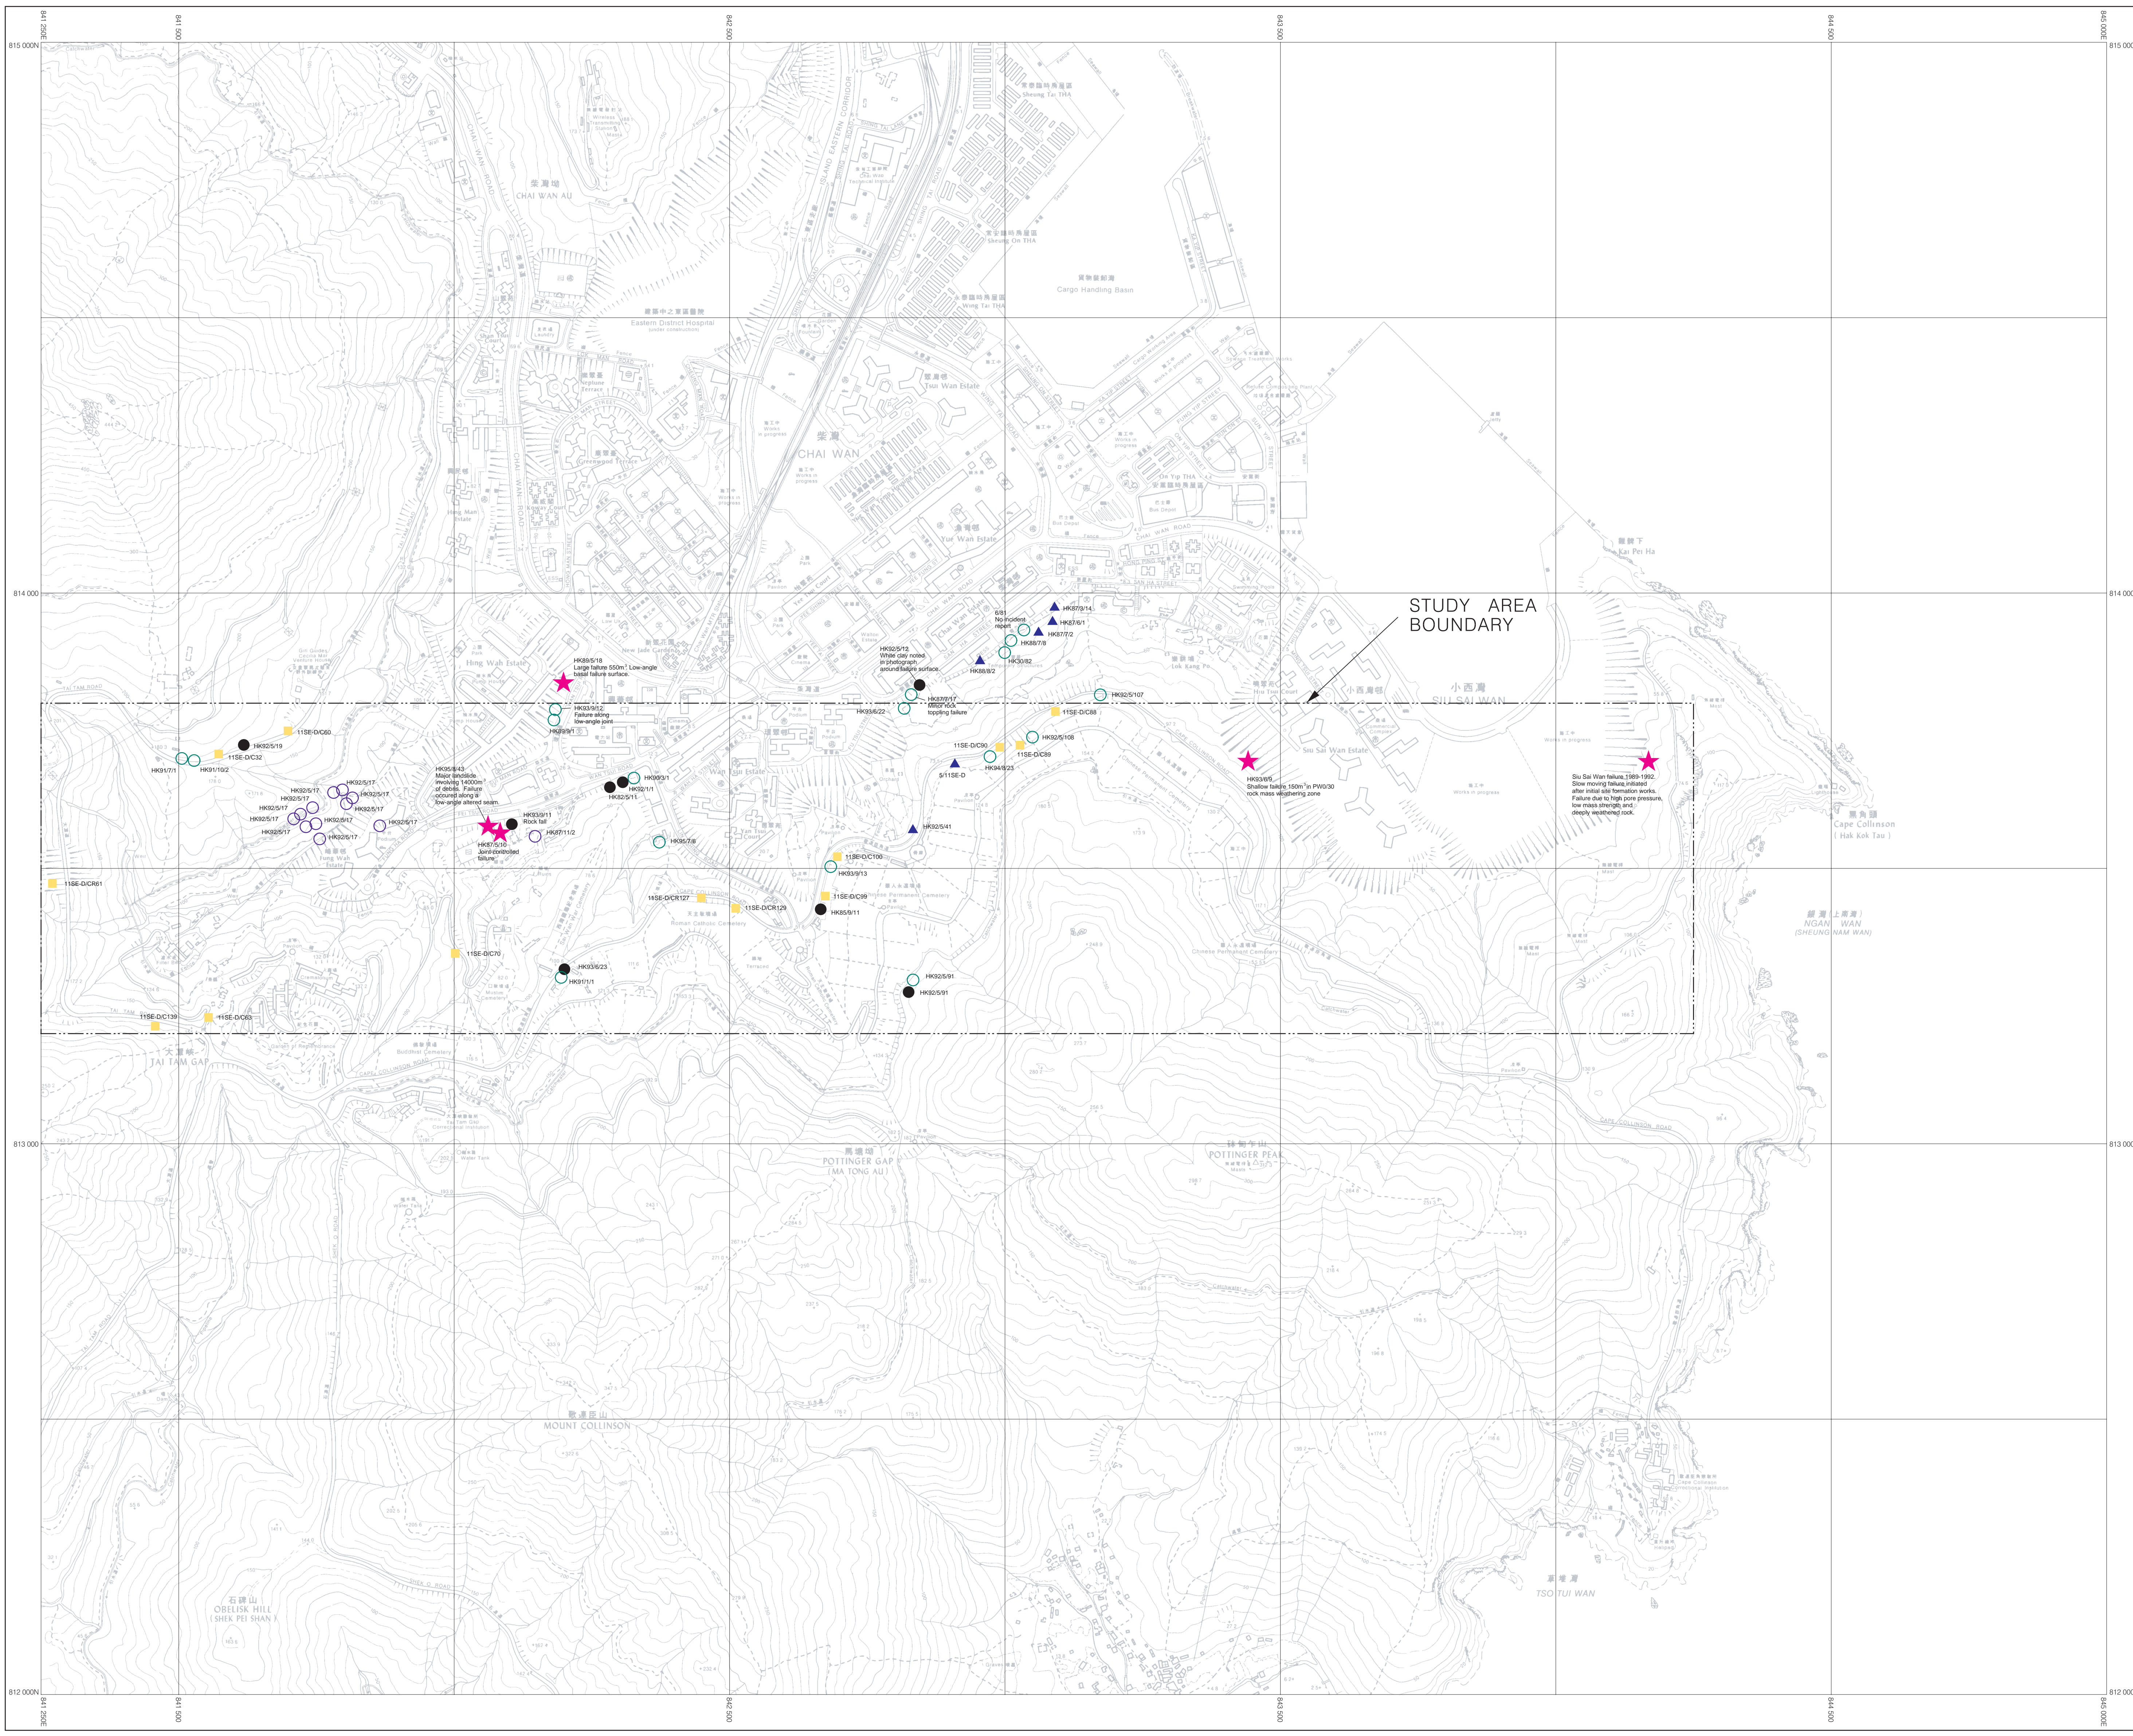
drawing no.	scale
GS-SP/11-SE-D/759	1:5 000

- LEGEND**
- ★ Landslide incident >50m³
 - Landslide incident >5m³ ~50m³ in weathered rock or colluvium
 - ▲ Retaining wall failure
 - Minor incident <5m³
 - Surface erosion
 - Landslide scar noted in Binnie and Partners 1977-1978 slope catalogue (approximate location).
- HK025/17 Landslide Incident number
11SE-DC03 Binnie and Partners slope reference number
