Soil Bioengineering Measures for Natural Terrain Landslide Scars

Key Messages: Soil bioengineering measures offer a potentially effective, low-cost, sustainable, and environmentally acceptable means to repair natural terrain landslide scars.

Geotechnical Engineering Office
Civil Engineering and Development Department
June 2025

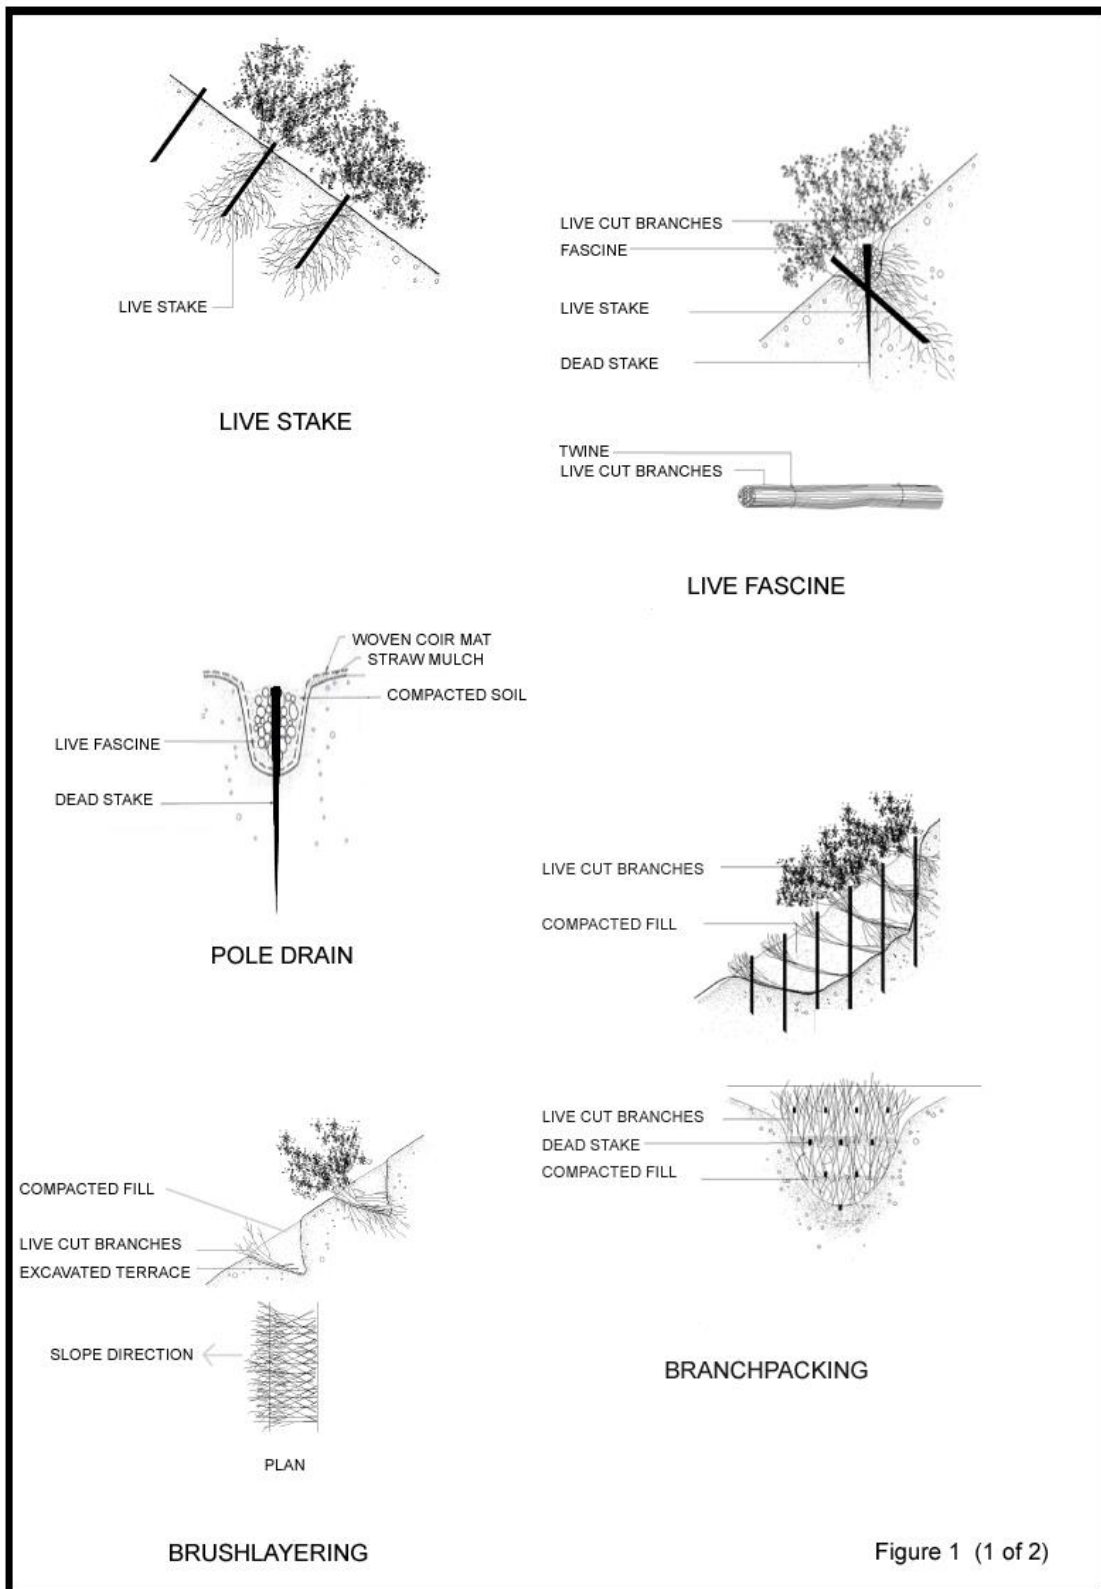
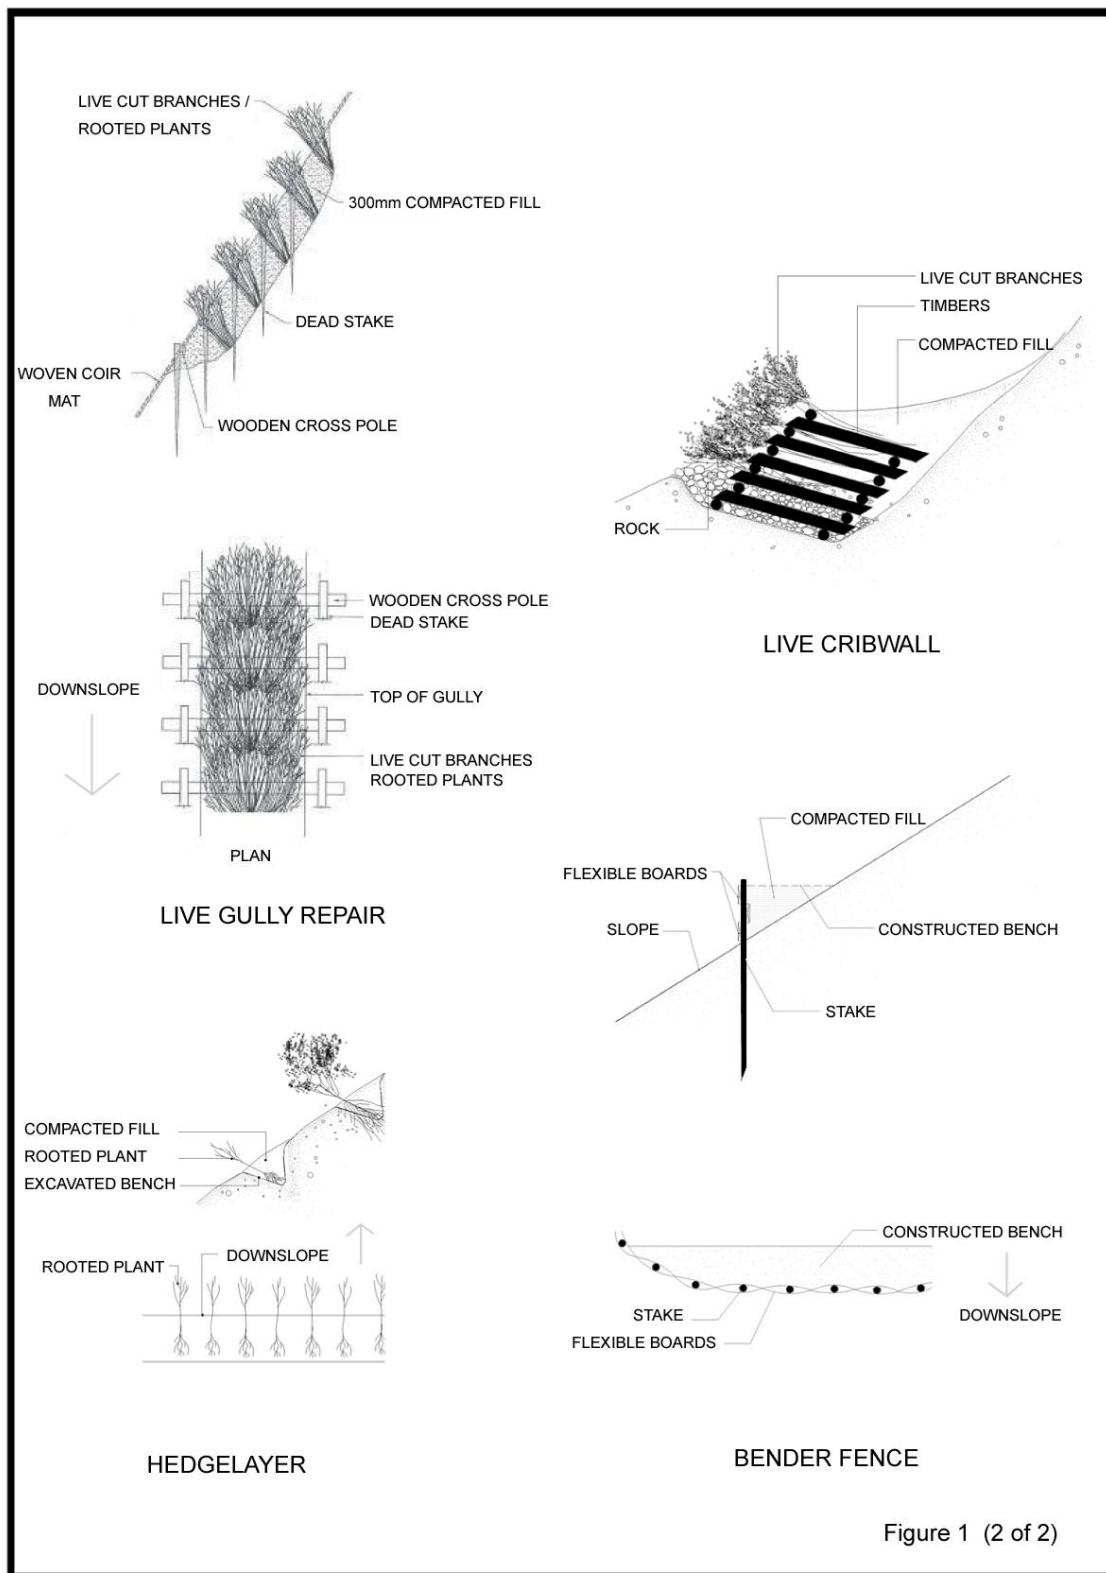
Direct measures include two distinct components, namely, 'living' (i.e. the planting of living plants) and 'structural' or 'non-living' (e.g. timber cribwalls and bender fences). In practice, the two components are commonly combined (e.g. live cribwalls), see Table 1 and Figure 1. Following installation of live plants such as stems and branches, the active growth of roots and stems form the major structural components of the soil bioengineering system. Subsequent invasion by surrounding plants reinforces the system. With rooting depths typically ranging from 200mm to 1200mm for most natural hillside applications, these direct measures can be expected to reinforce the soil to depths of up to about one metre, in contrast to the shallow soil binding depths offered by the more commonly used greening methods such as hydroseeding or conventional planting.
