APPENDIX A

REPORT ON THE STUDY OF OLD MASONRY RETAINING WALLS  
BY GCO (1980)

APPENDIX D

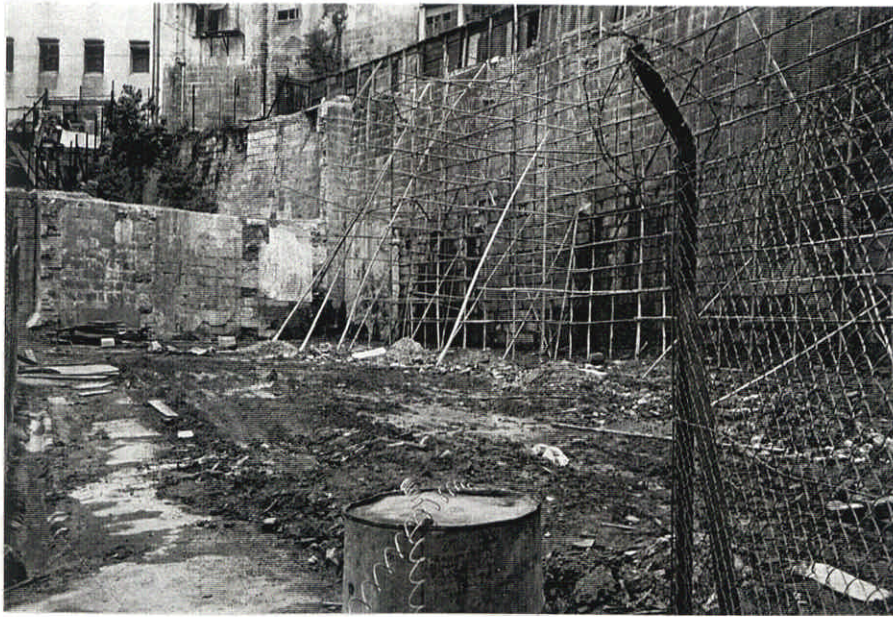
Plate D6.3 - Retaining Wall at Circular Pathway - Elevation of the Western Portion of the Retaining Wall

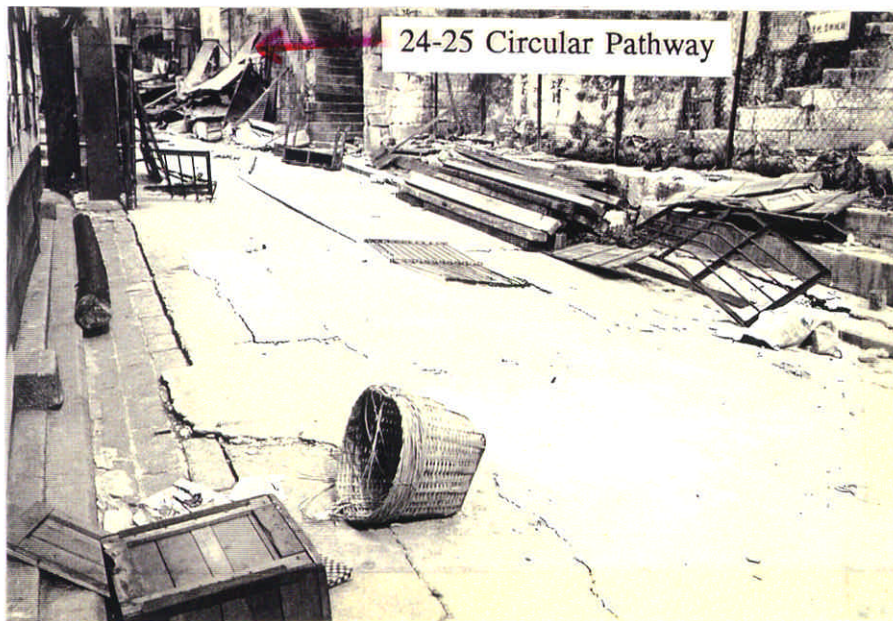
Plate D6.8 - Retaining Wall at Circular Pathway - Western Portion of the Pathway, Looking East (II)

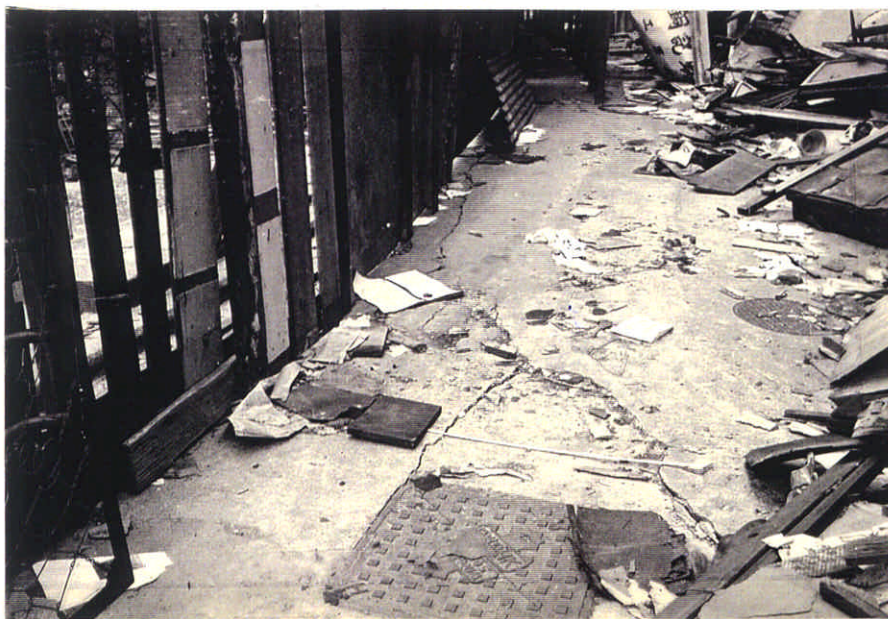
Plate D6.10 - Retaining Wall at Circular Pathway - Eastern Portion of the Pathway,  
Looking East

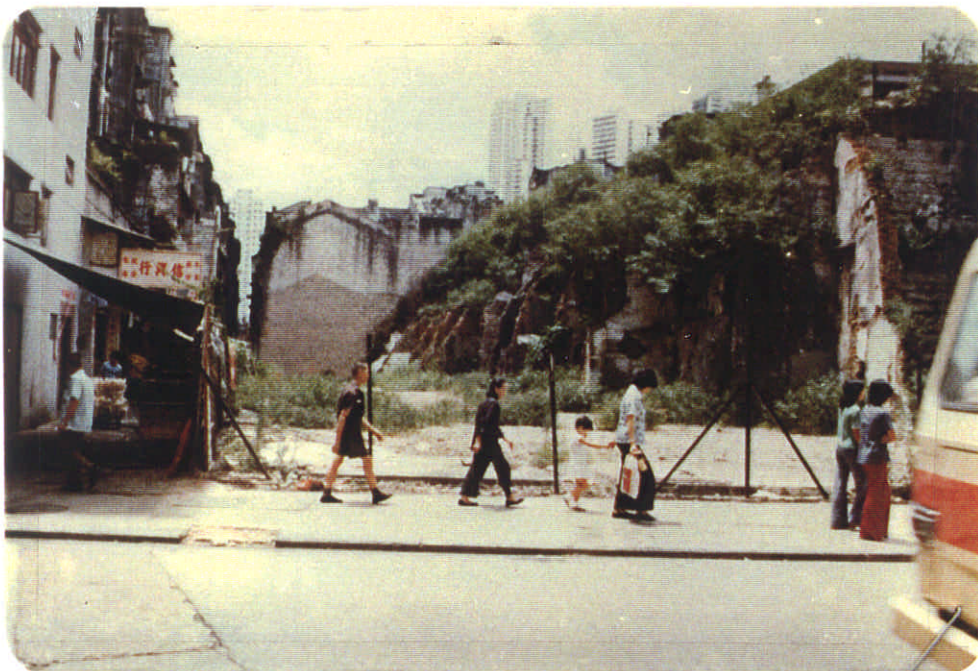
Negative No. R/W 81.17.17

Plate D8.1 - Retaining Wall at Fat Hing Street - View of the Wall before Work Commenced on the Adjacent Site (I)

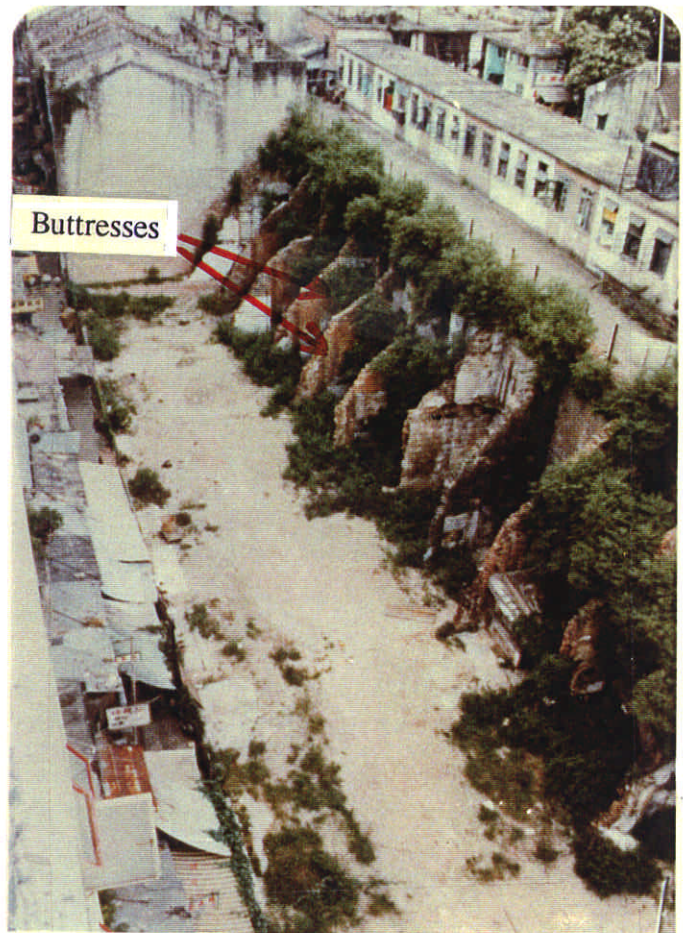
Negative No. R/W 81.17.20

Plate D8.2 -  
Retaining Wall at Fat Hing Street -  
View of the Wall before Work  
Commenced on the Adjacent  
Site (II)

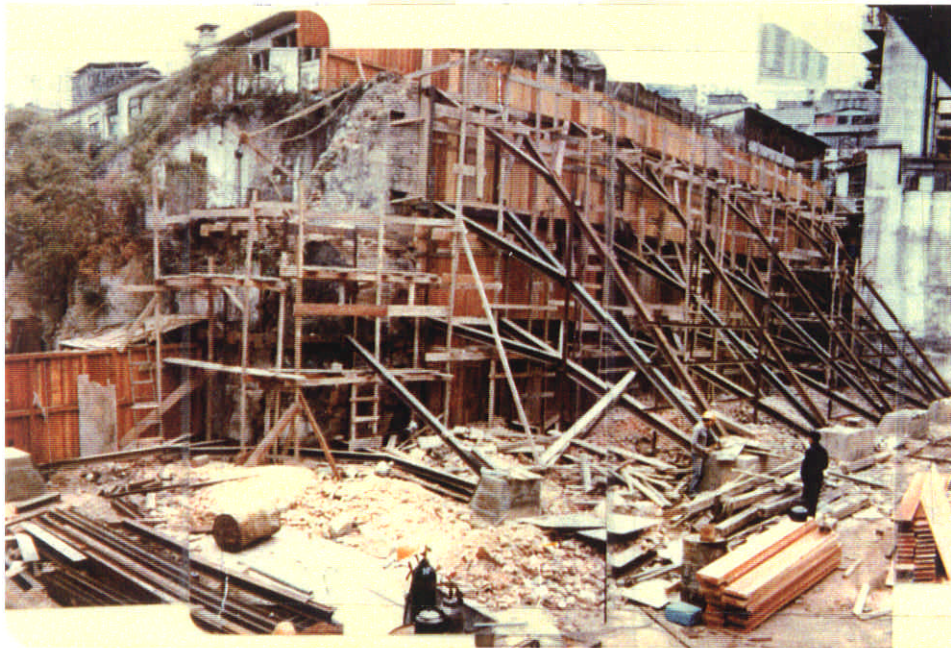
Negative No. R/W 81.17.19

Plate D8.3 - Retaining Wall at Fat Hing Street - Panoramic View of the Shoring to  
the Tied Face Wall at the Adjacent Site (48-56, Queen's Road West)

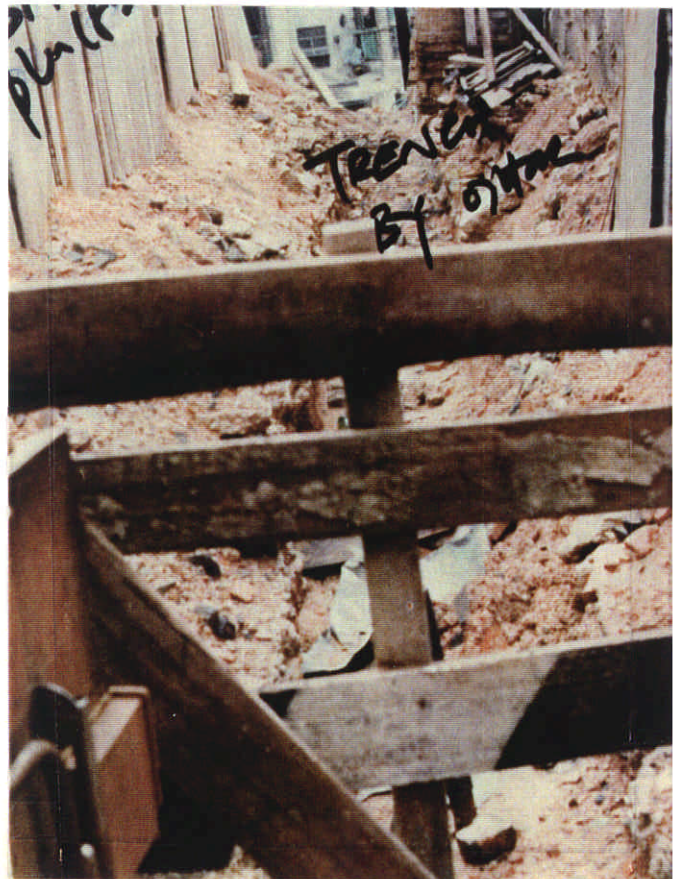
Negative No. R/W 81.17.13

Plate D8.5 - Retaining Wall at Fat Hing Street - Trench Work at the Crest Platform

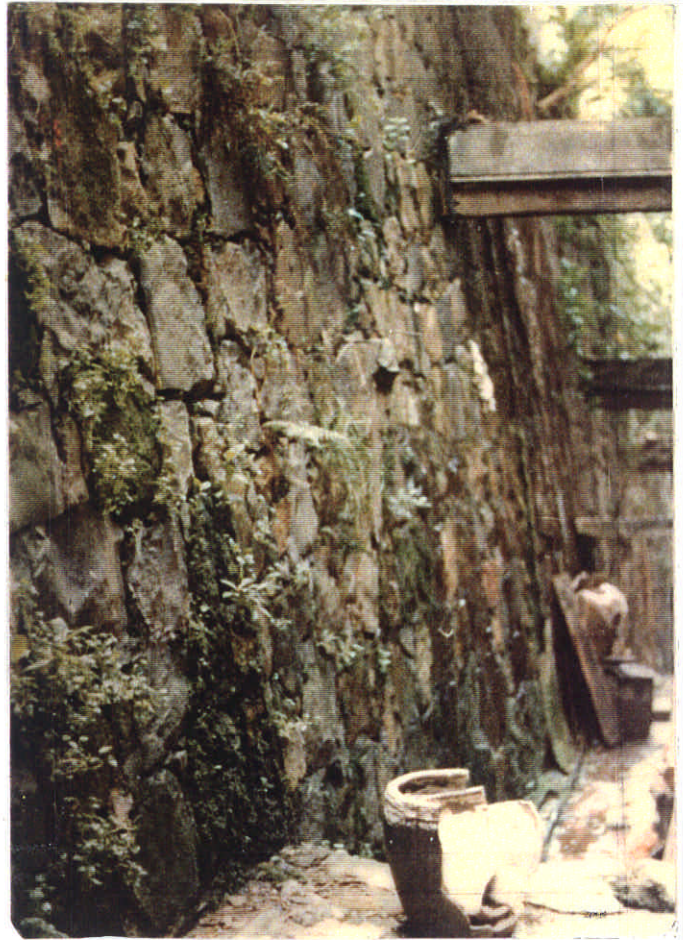
Negative No. R/W 81.09.16

Plate D9.2 - Retaining Wall at Wing Wa Terrace - the Failure, Looking South-East
