STUDY OF DISTRESS ON SLOPE NO. 11SW-D/FR1 BELOW STUBBS ROAD HAPPY VALLEY

GEO REPORT No. 204

Fugro Scott Wilson Joint Venture

**GEOTECHNICAL ENGINEERING OFFICE
CIVIL ENGINEERING AND DEVELOPMENT DEPARTMENT
THE GOVERNMENT OF THE HONG KONG
SPECIAL ADMINISTRATIVE REGION**

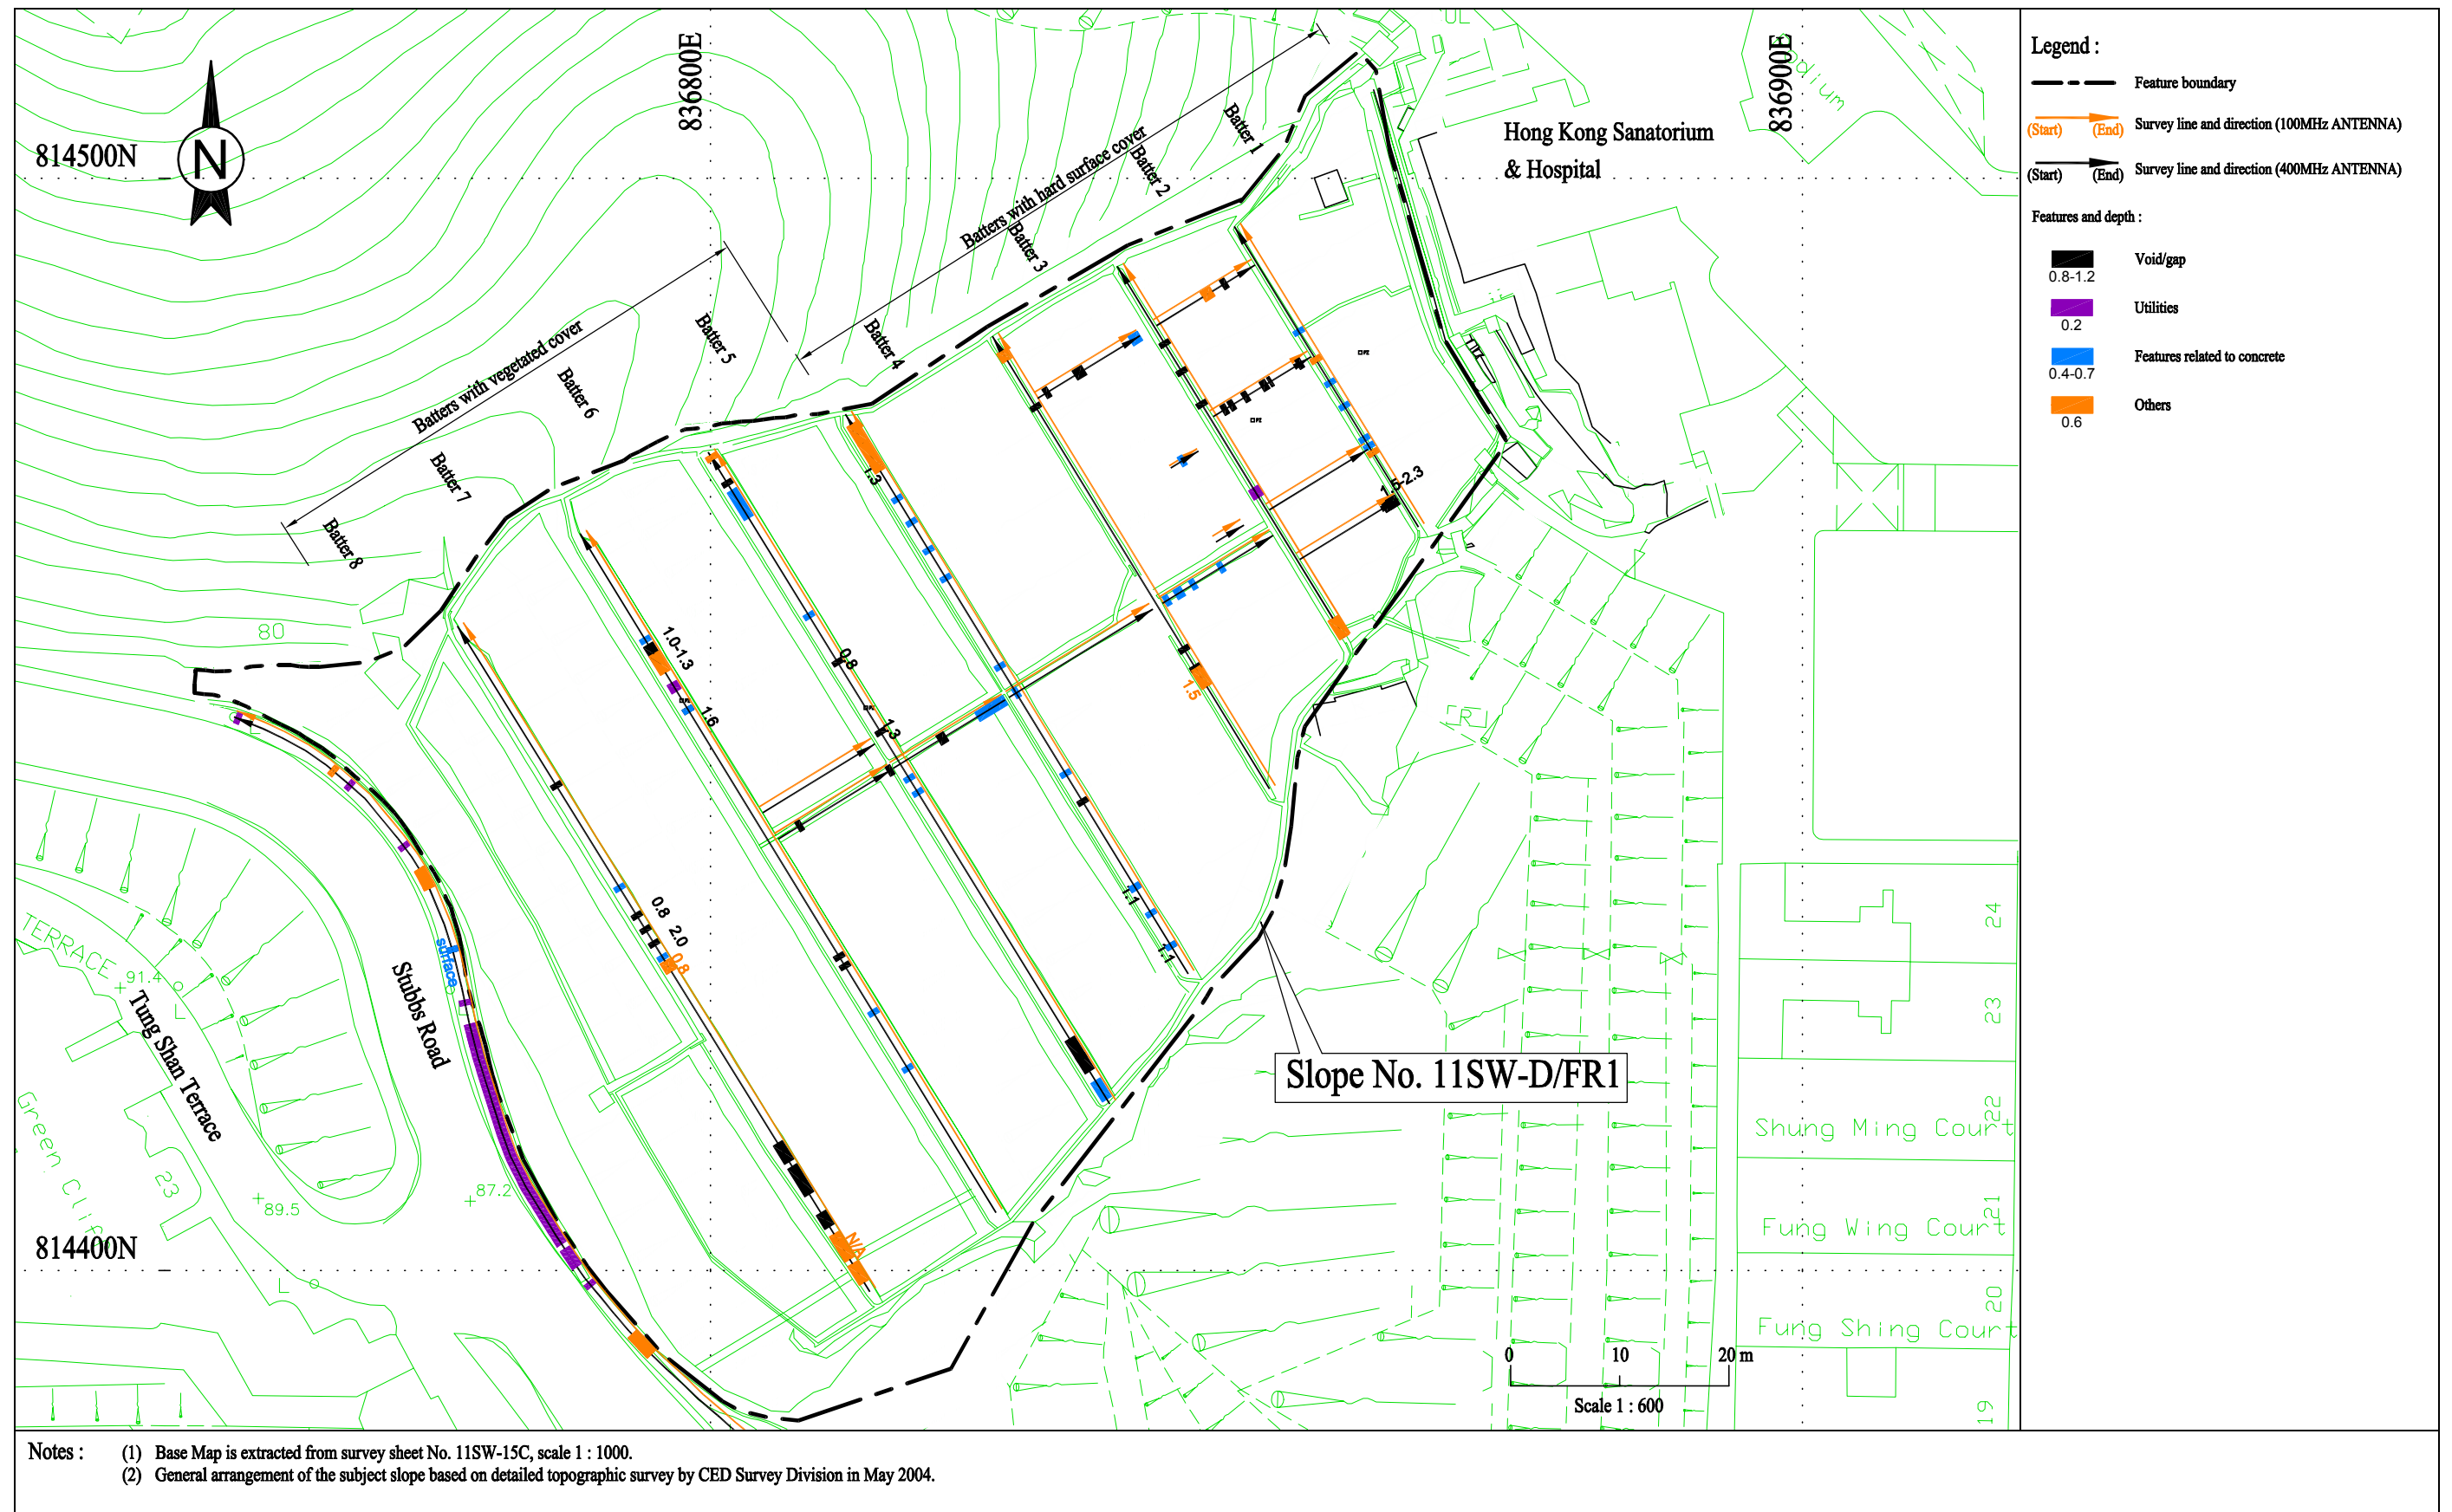
Figure 23 - Ground Penetrating Radar Survey

The interpreted results of the survey are presented on Figure 23 and indicate possible voids and possible large-sized rock blocks within the upper 1 m to 1.5 m of the ground profile at various locations across the slope. No significant anomalies were indicated at greater depths. Utilities are indicated from the single line traverse along the Stubbs Road footpath at the slope crest, generally within 0.6 m to 0.7 m of the ground surface and consistent with the lighting cable indicated on the same alignment, with one sounding from a depth of 1.5 m, which is likely to be the 225 mm diameter road drain that connects with the catchpit at the slope crest (see Figure 2).

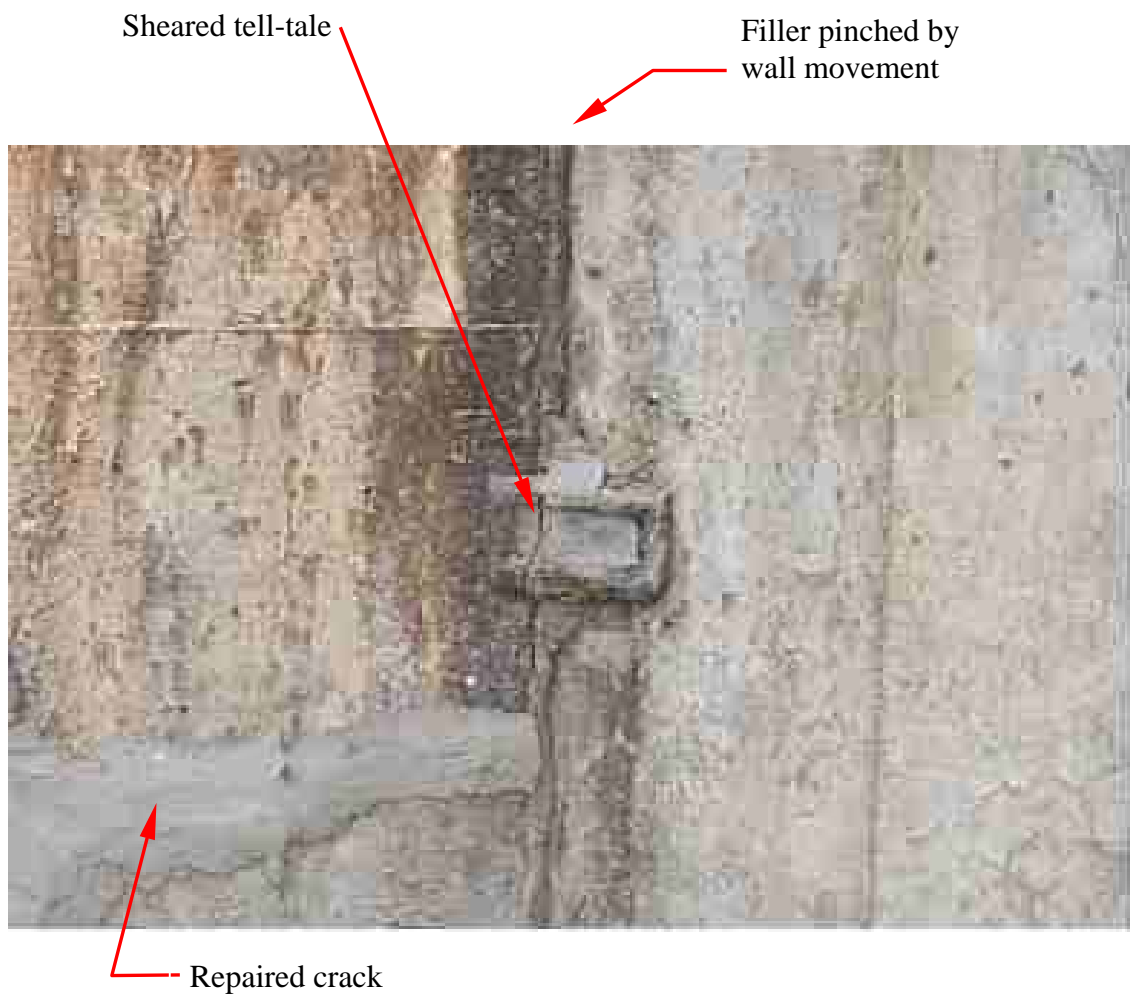
Plate 26 - Expansion Joint in Mass Concrete Gravity Retaining Wall
(Photograph taken on 25 February 2004)

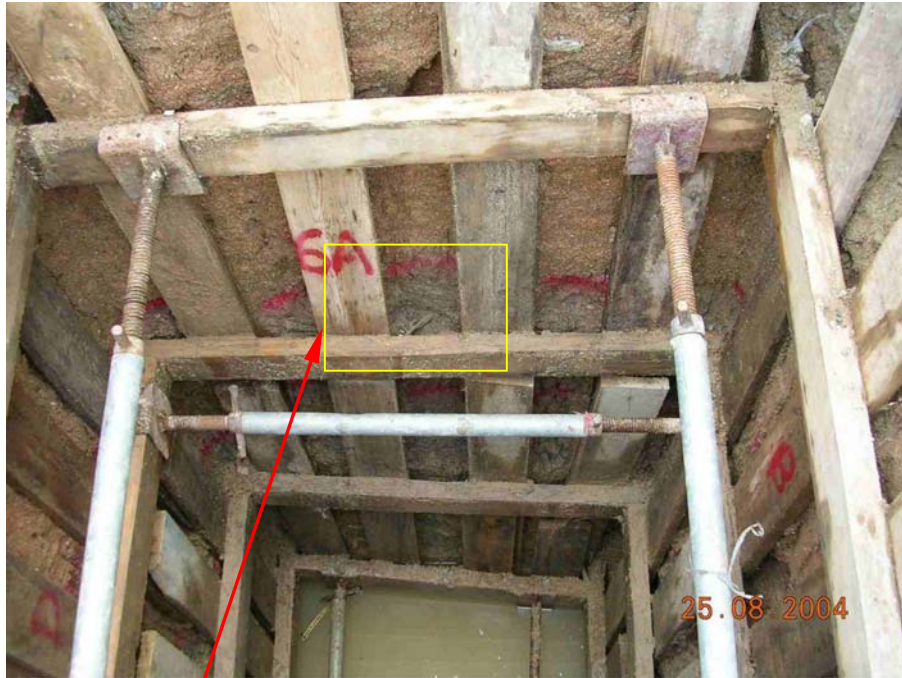
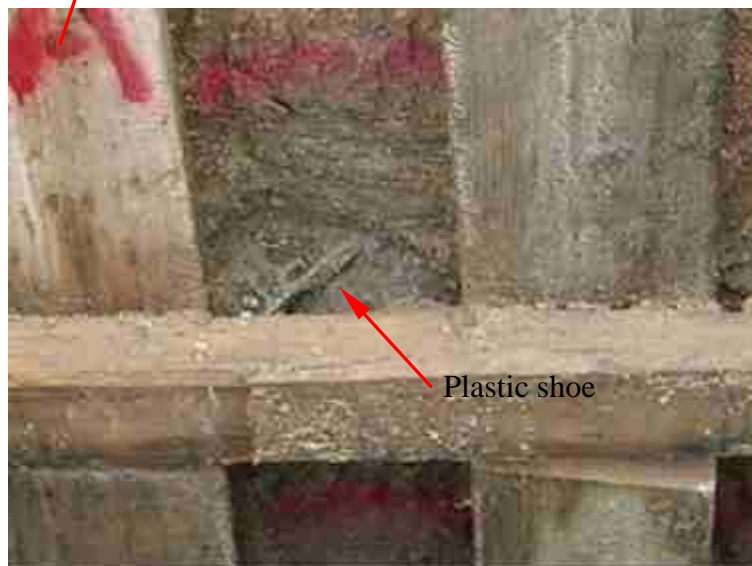
- (c) the presence of more than 2 m of disturbed ground underlying compacted fill near the bottom of the slope (BH7),
- (d) the presence of oversized rock blocks (Plate 28) and foreign material, such as a plastic shoe (Plate 29), within the compacted fill in some of the trial pits,

Plate 29 - Remains of Plastic Shoe Exposed within Compacted Fill Layer
in Trial Pit TP6 (Photograph taken on 25 August 2004)

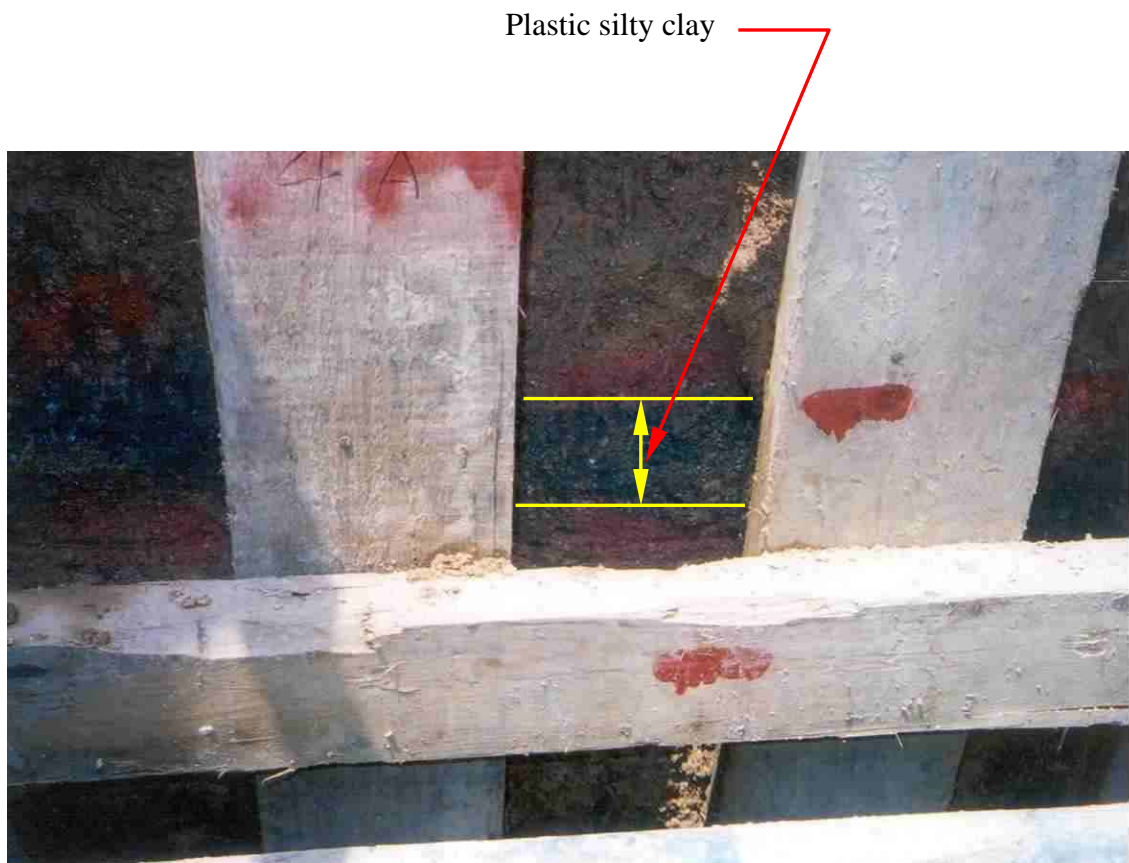
- (e) the presence of layers of plastic sandy silty clay within the compacted fill layer (Plate 30),
- (f) sub-horizontal layering of the compacted fill, some of which appear to comprise a more sandy material (potentially giving rise to a locally high horizontal permeability),

Plate 30 - Layer of Plastic Silty Clay Exposed within Compacted Fill Layer
in Trial Pit TP4 (Photograph taken on 25 August 2004)

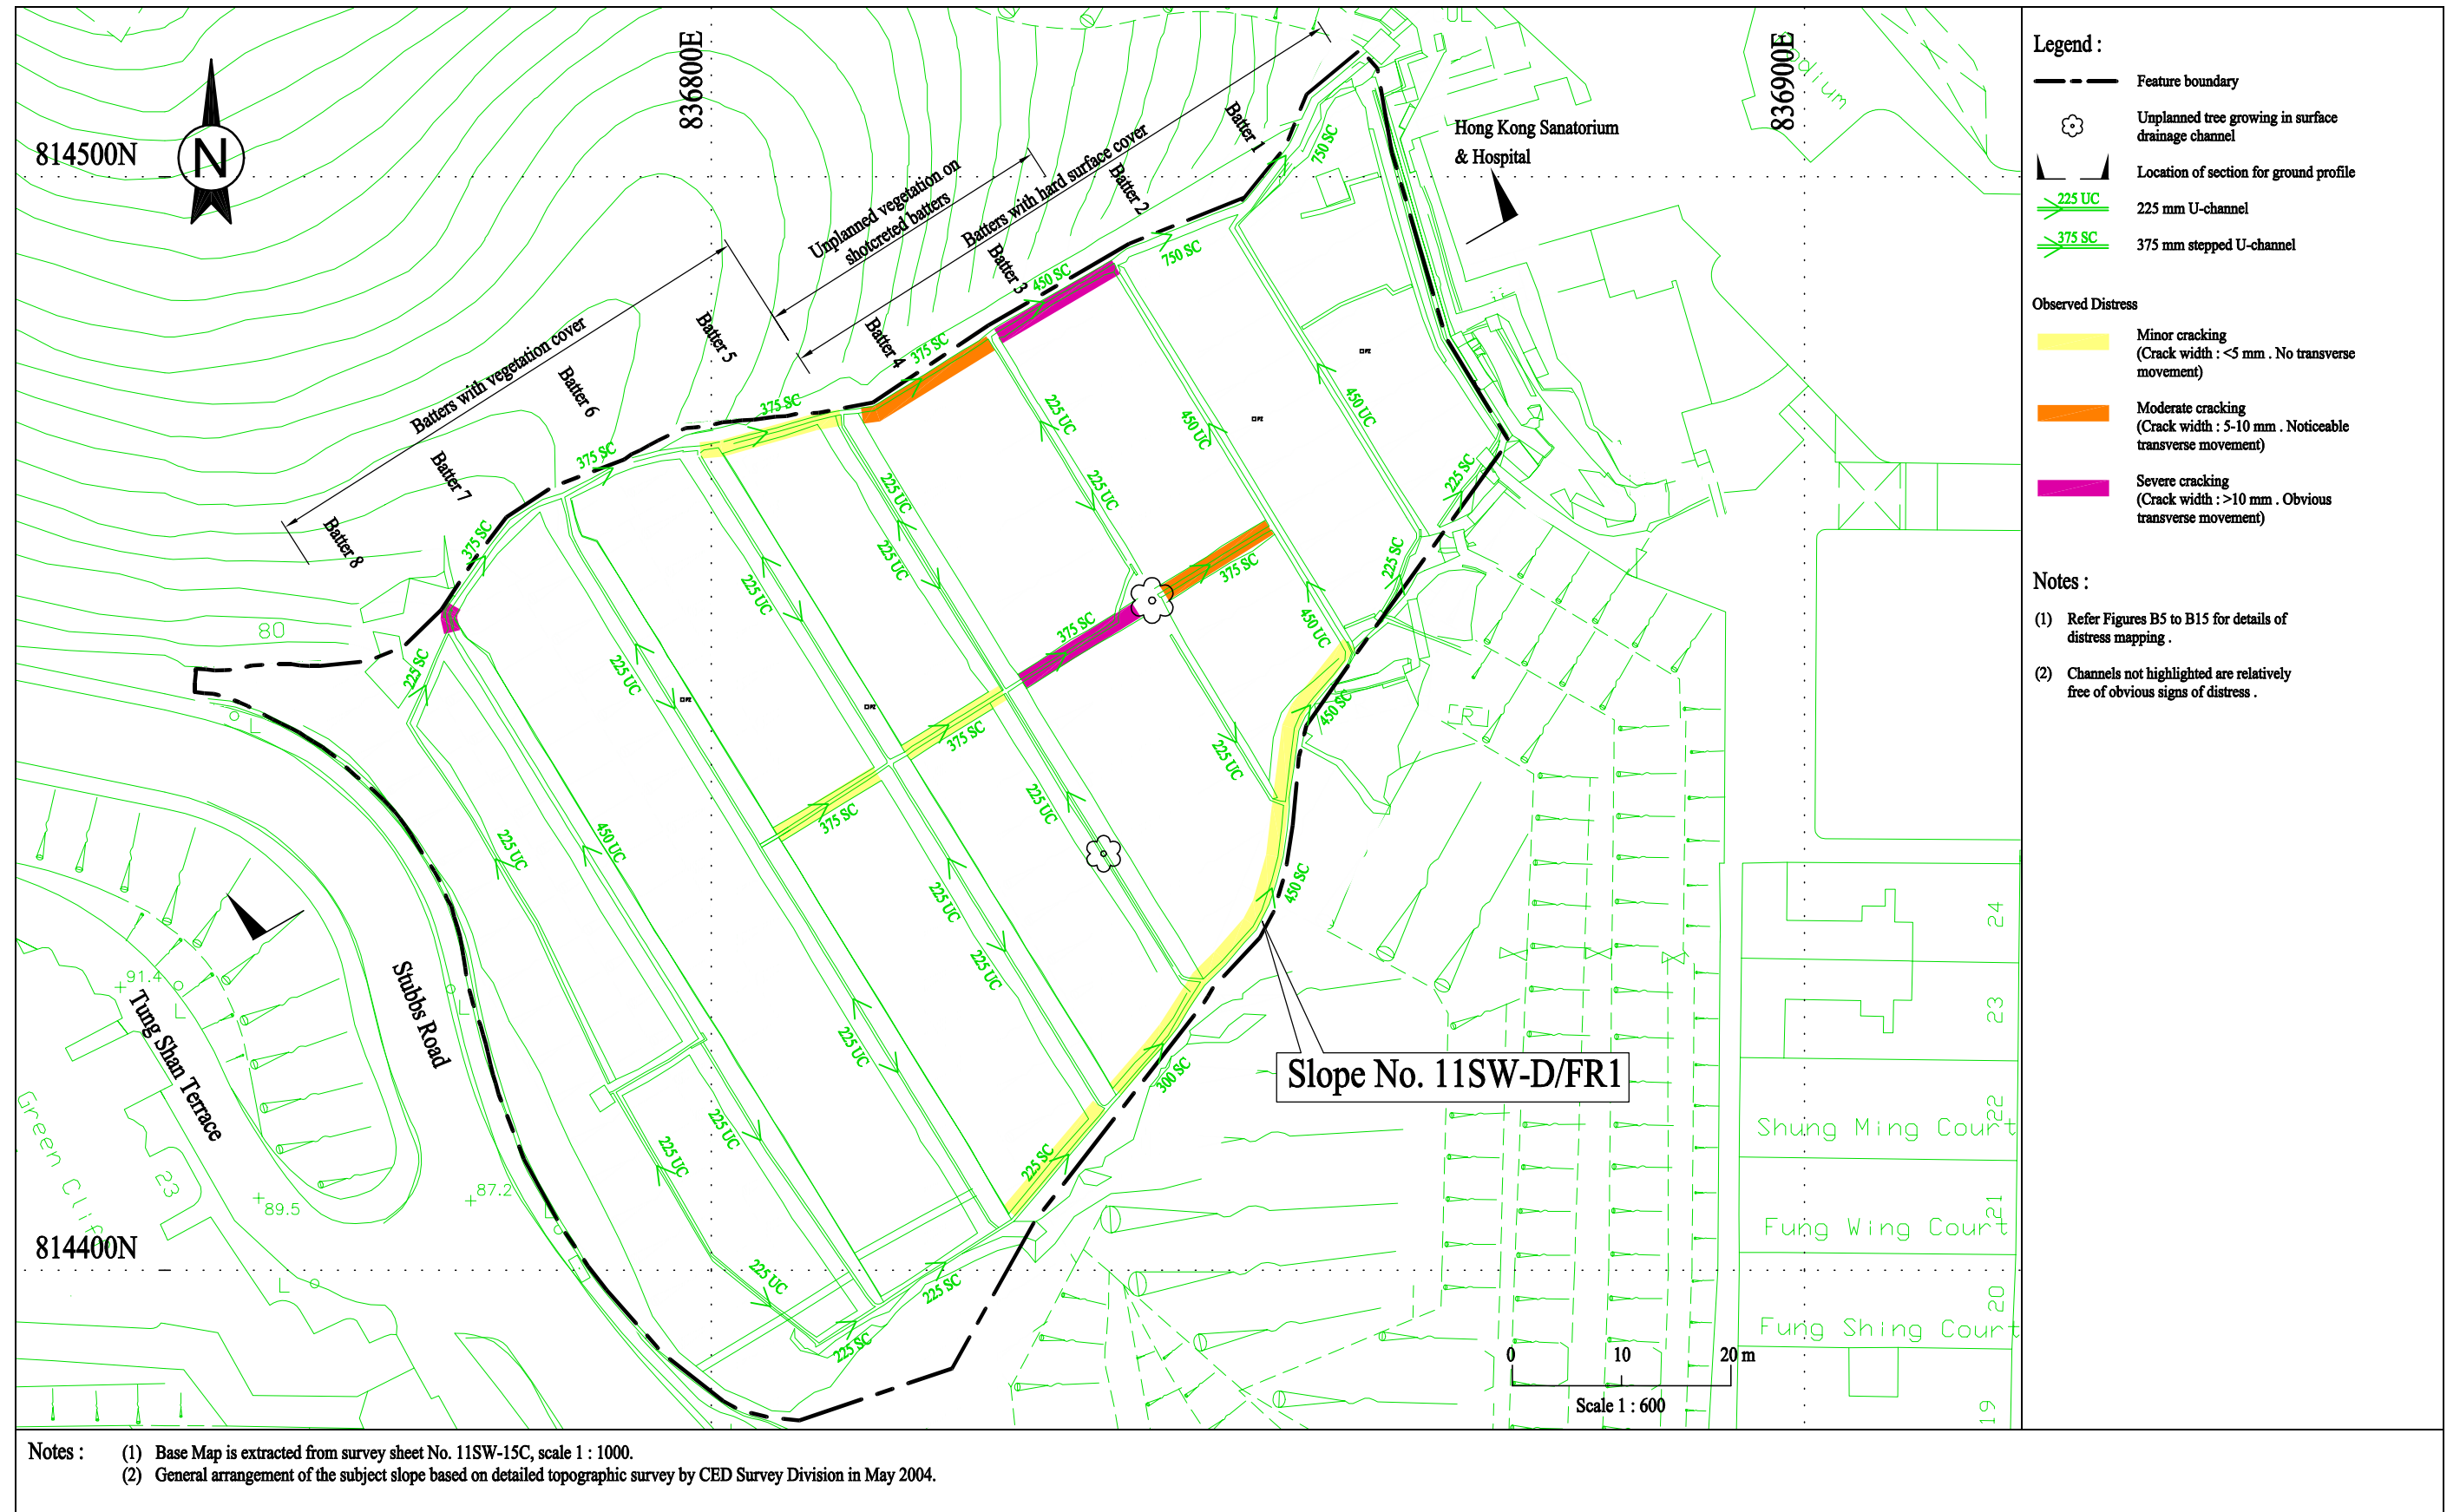
Figure B4 - Distress Mapping of Slope No. 11SW-D/FR1 - Relative Distress in Stepped Channels
