# **TSING SHAN DEBRIS FLOW AND DEBRIS FLOOD**

**GEO REPORT No. 281**

This GEO Report consists of two Landslide Study Reports on the “Tsing Shan Debris Flow and Debris Flood” (LSR 2/2001) and “The 2000 Tsing Shan Debris Flow” (LSR 3/2001).

# **SECTION 1: THE 1990 TSING SHAN DEBRIS FLOW**

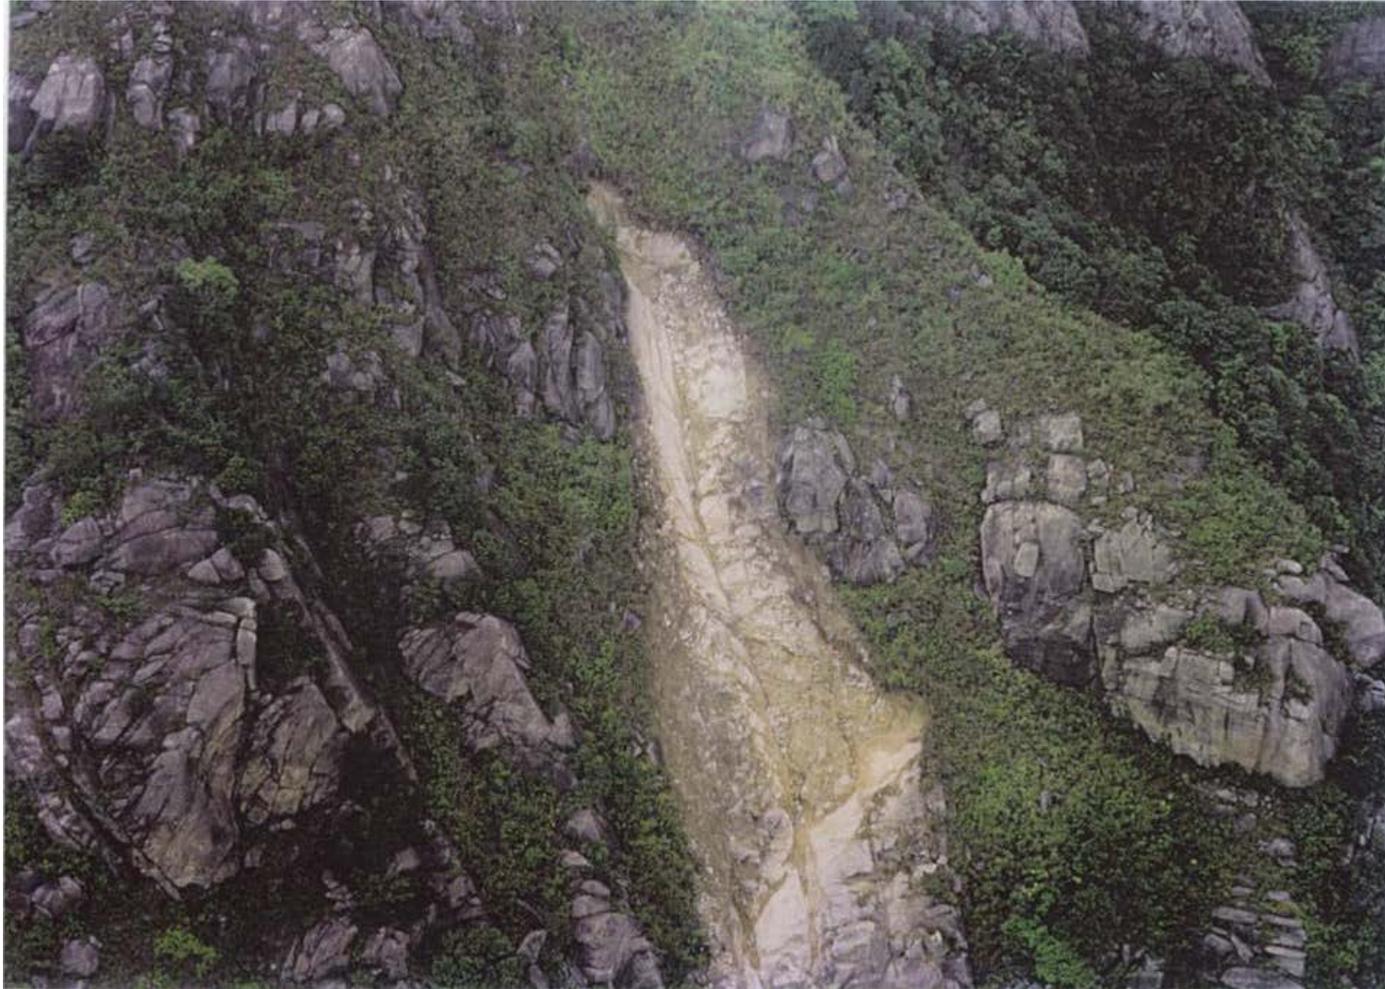
PS 688-11

Plate 2 - Upper Spur (Trigger Landslide)

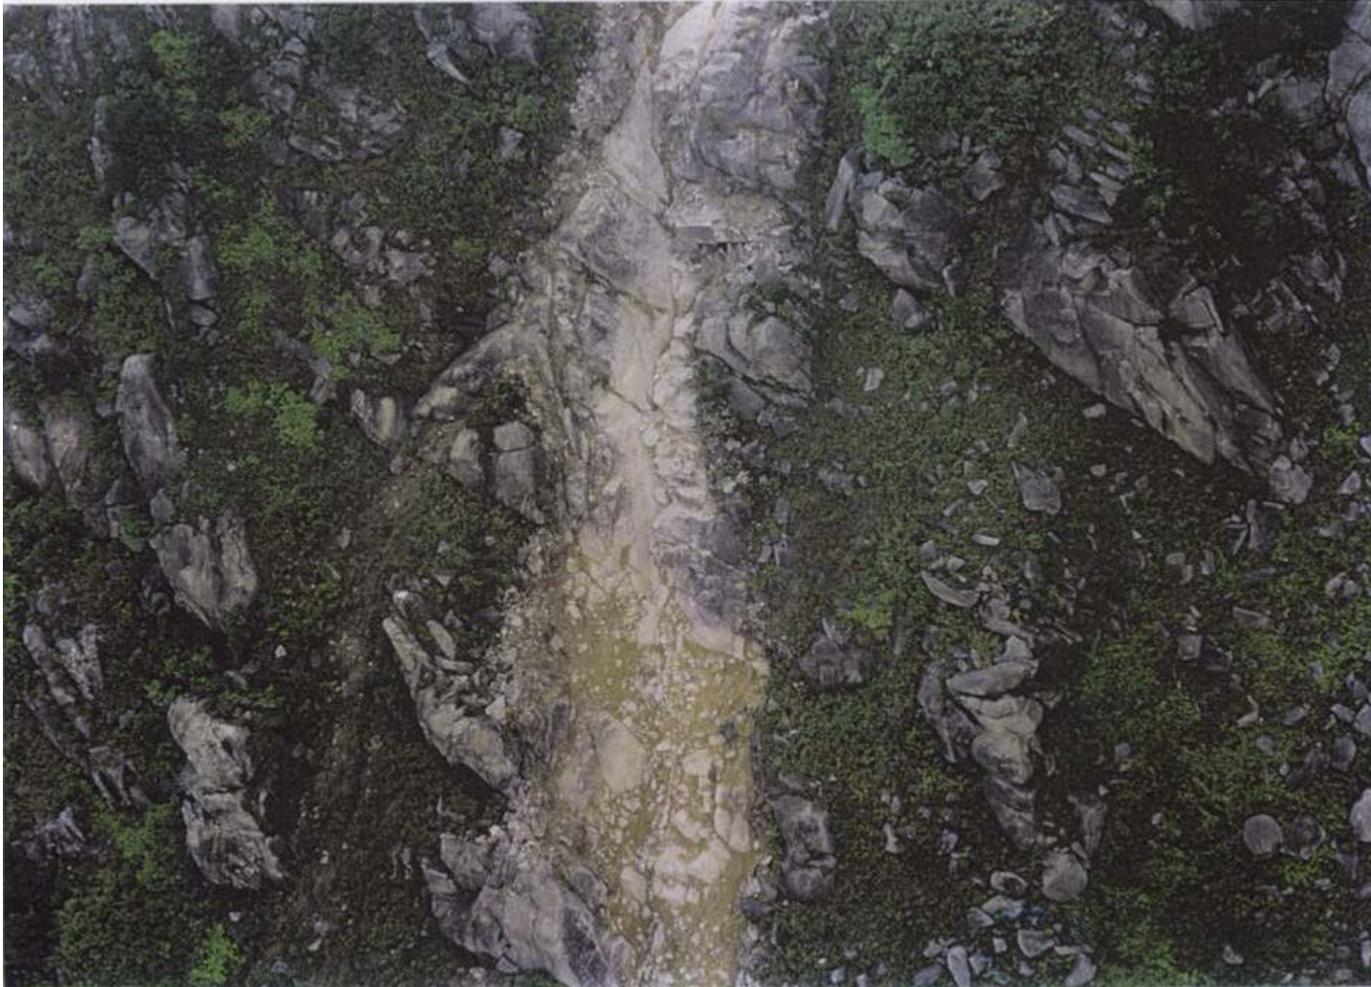
PS 688-4

Plate 3 - Rock Outcrop. Note Scouring in Centre of Scar

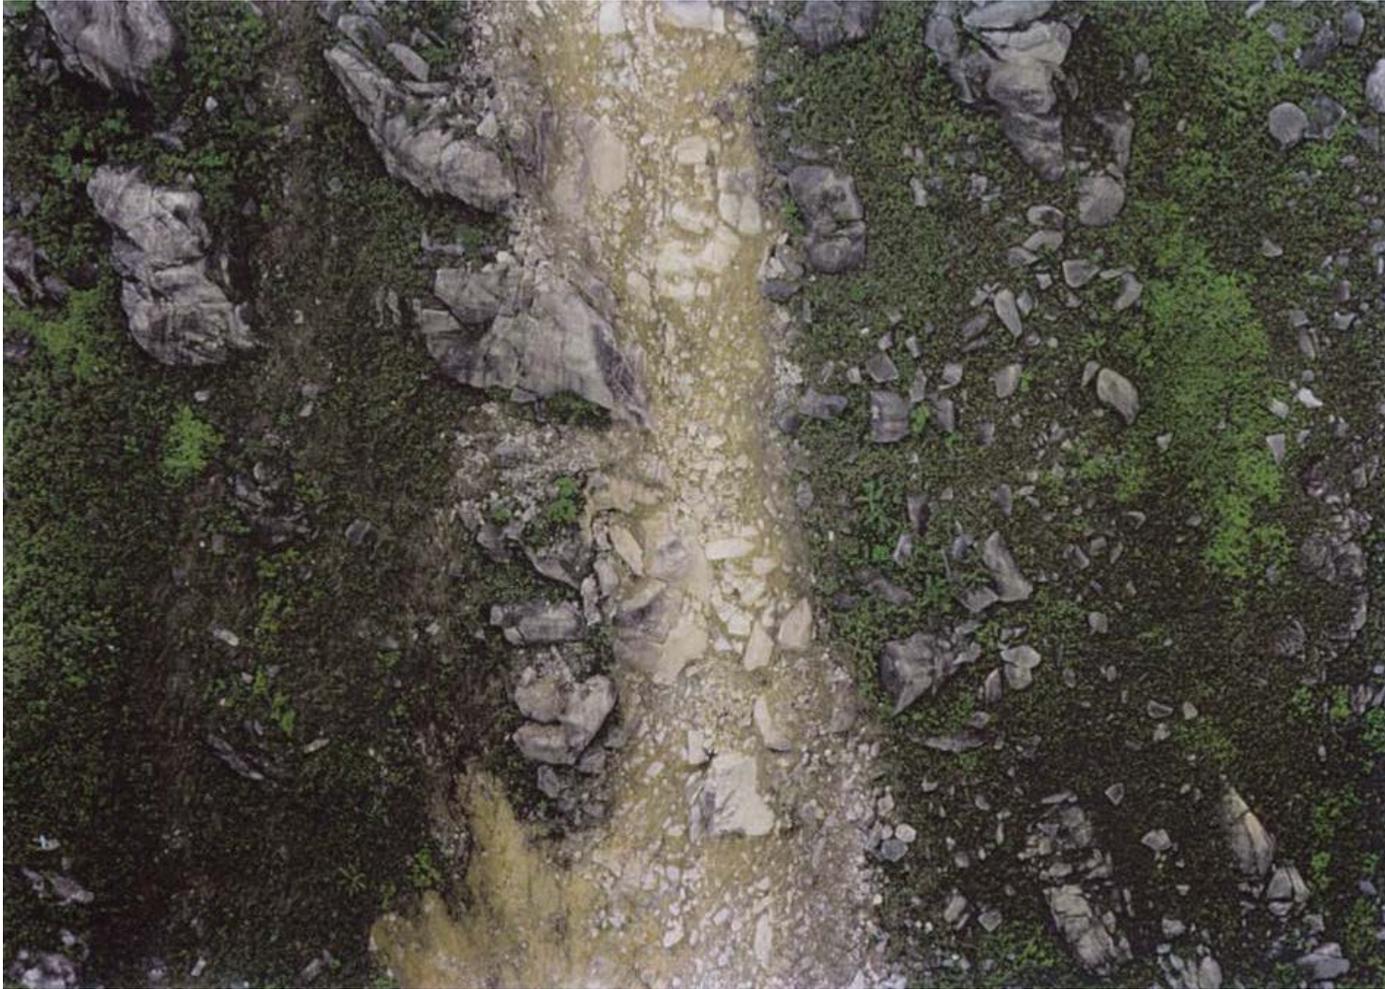
PS 688-9

Plate 4 - Eroded Gully along Colluvium Bedrock Boundary

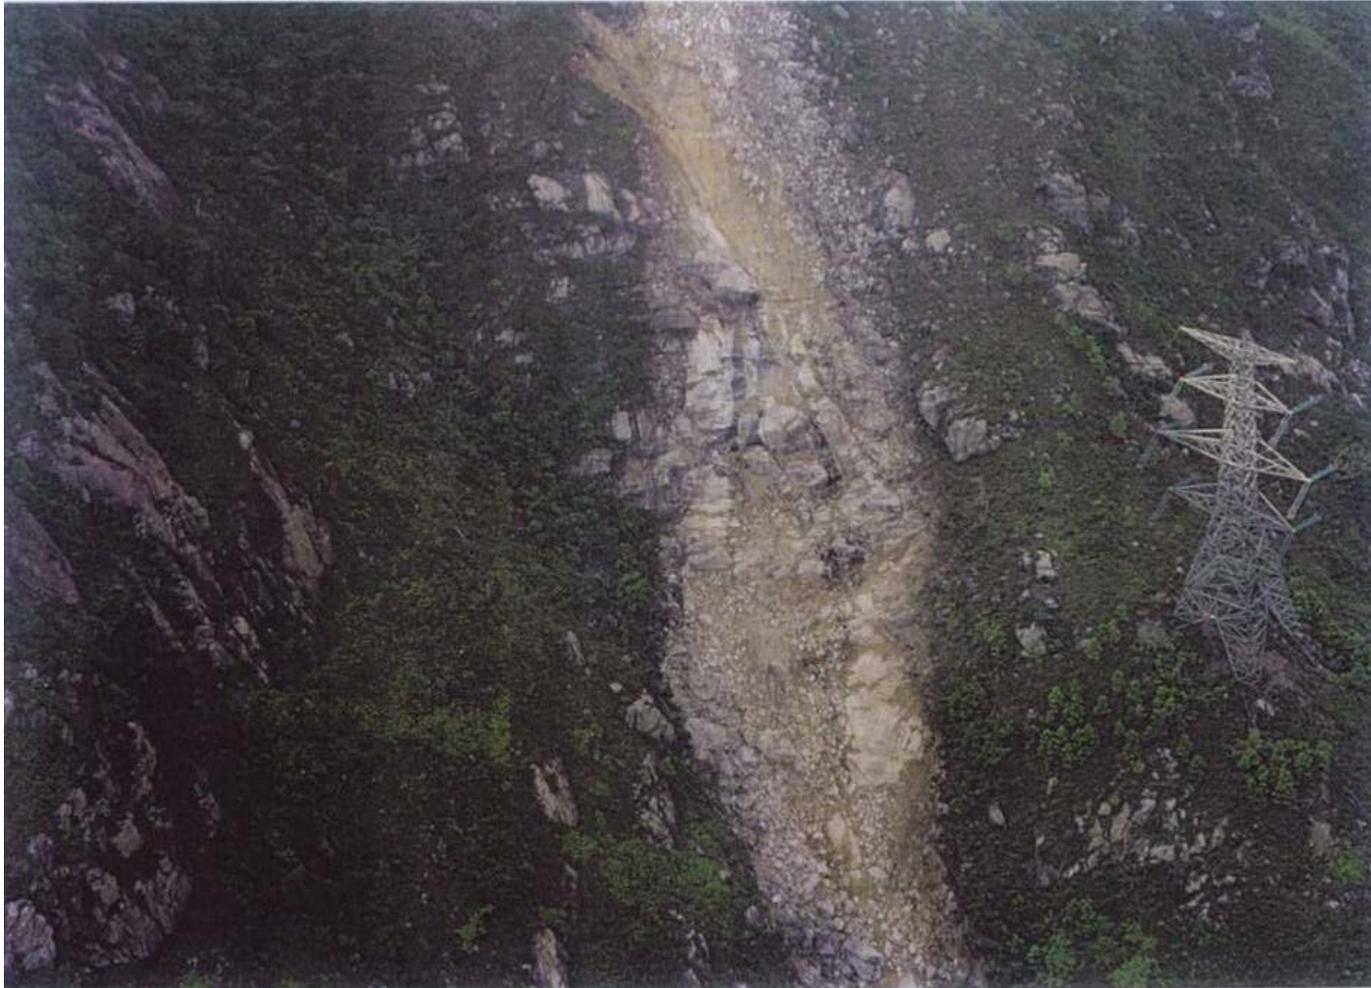
PS 687-6

Plate 6 - Parent Landslide, Sheeting Joint and Valleyside Fan

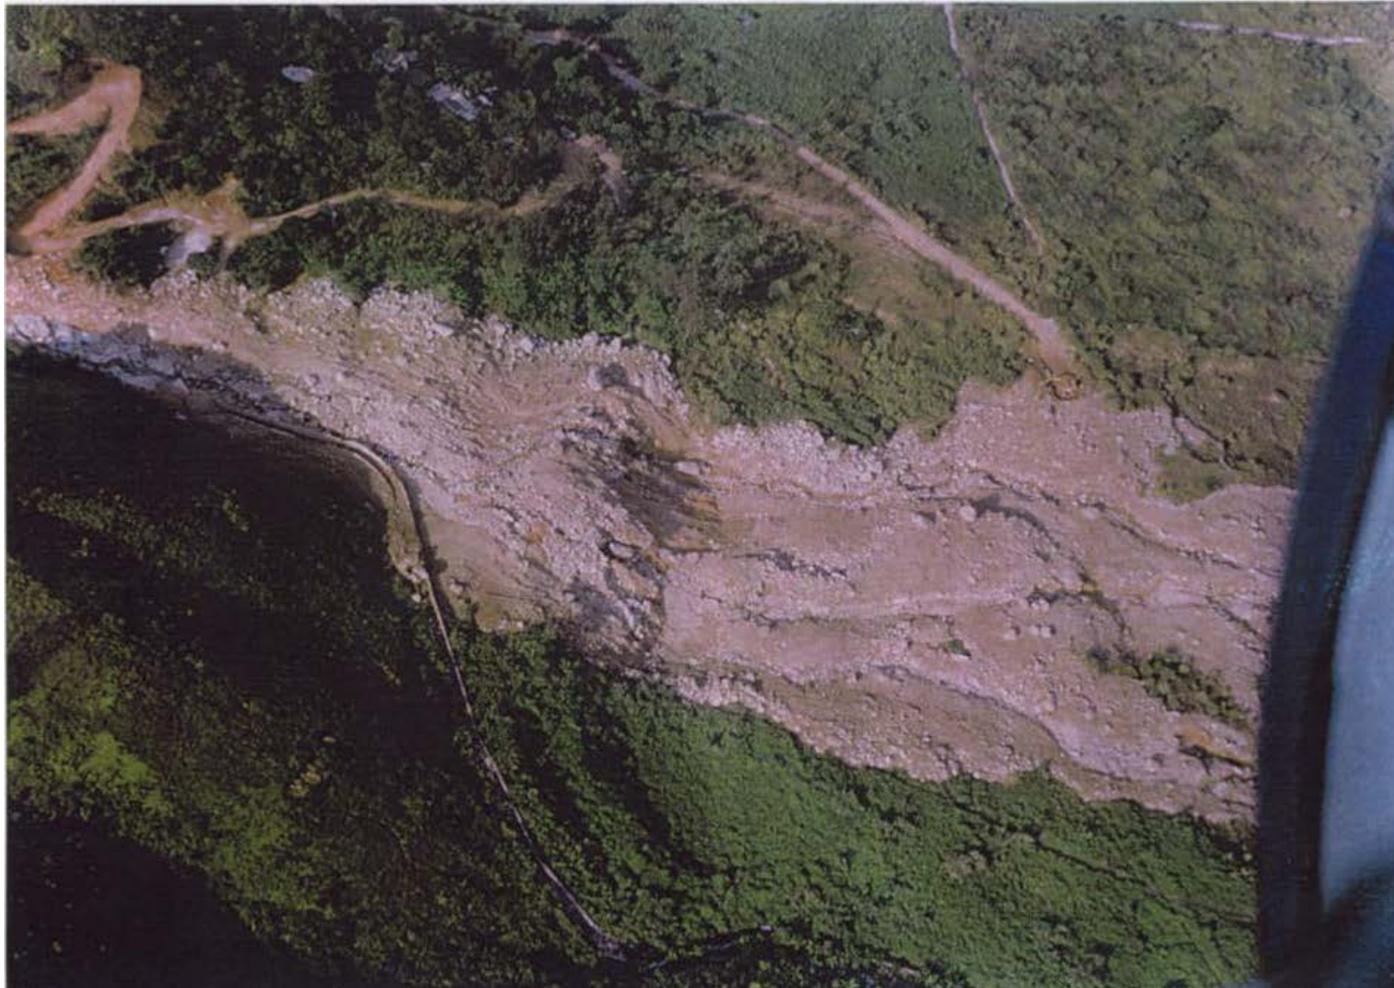
PS 691-18

Plate 11 - Intake to Access Track, Primary Debris Lobes

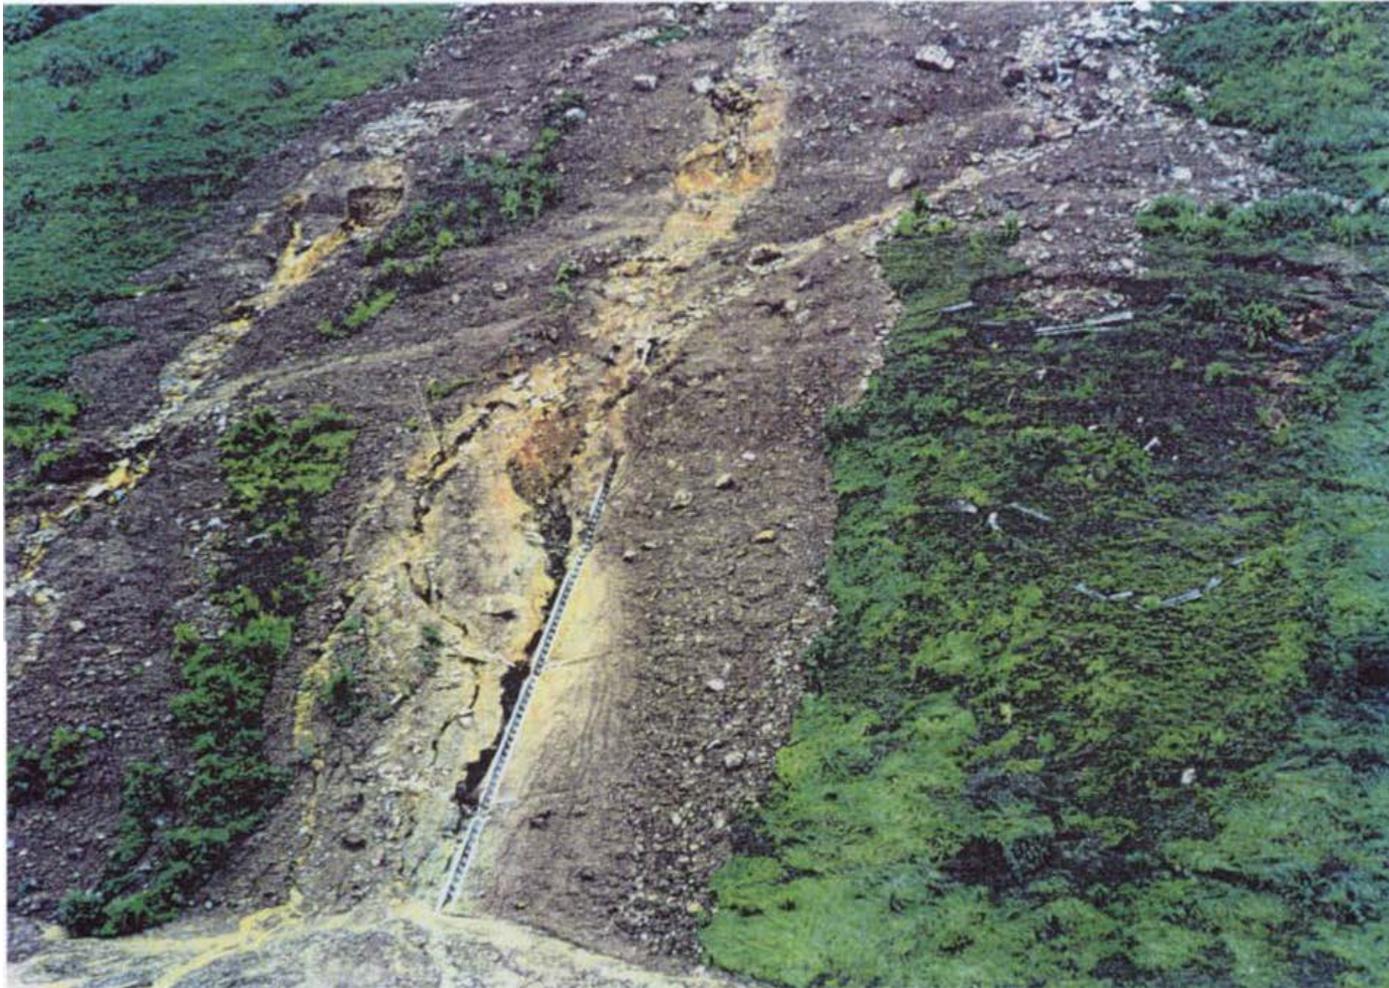
MW 90165c/20

Plate 15 - Cut Slope 12.9.90

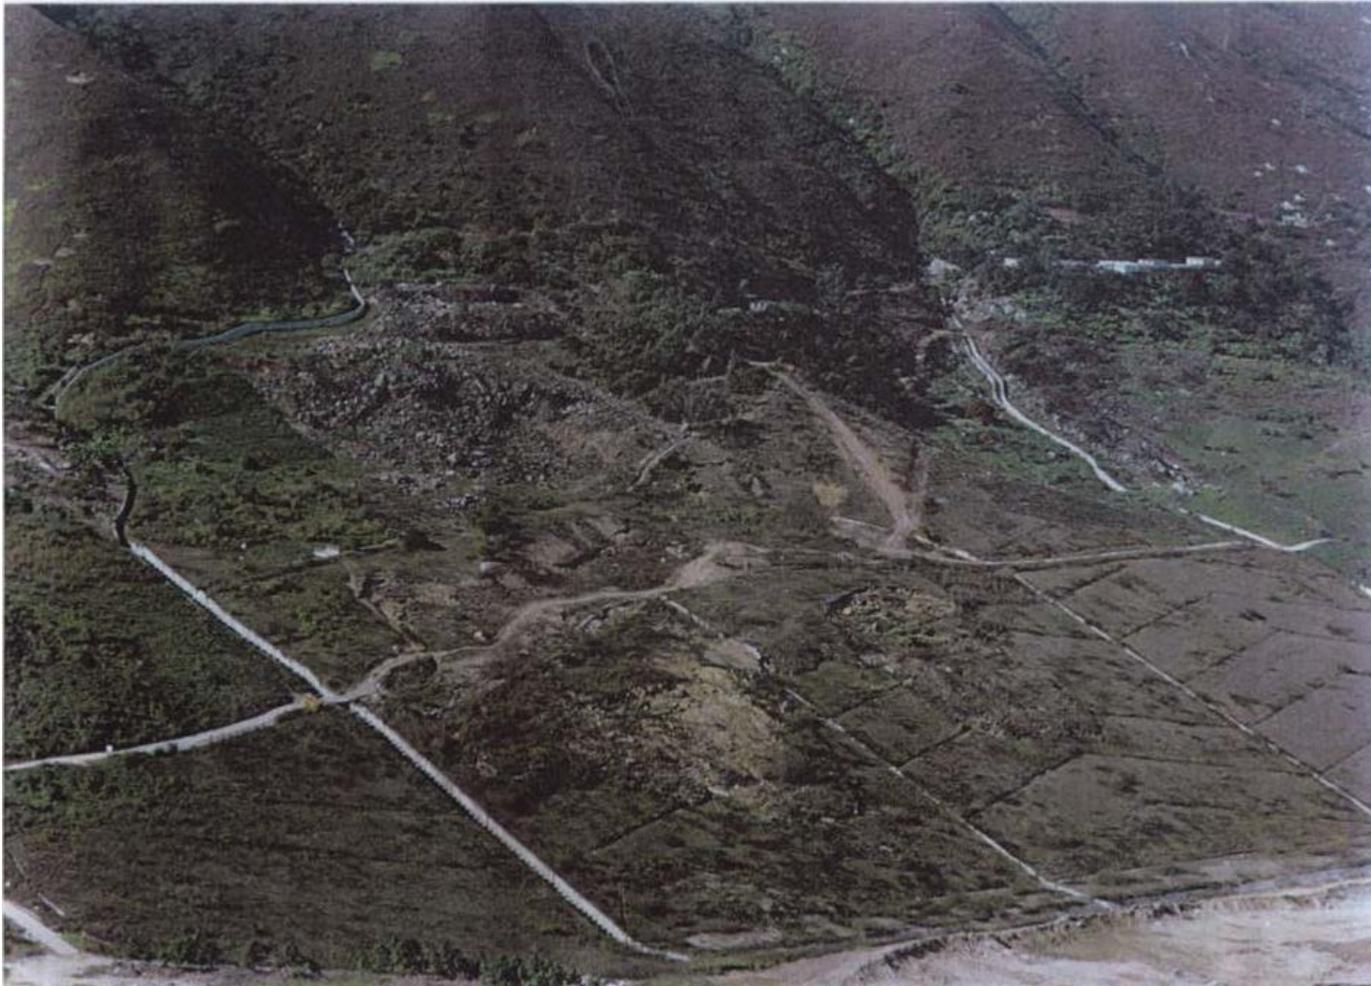
PS 569/8

After the works in 1984 the area above the main cut slope was left as a gently sloping, irregular, boulder-strewn platform (Plate 16). The upper limits of the borrow excavation was a steep, excavated scarp located immediately downslope from the abandoned house platforms and access track (Plate 17). The creeping slope movements continued after 1984 and resulted in the development of small scarps and areas of heave on and above the cut slope.

Plate 16 - View of Deposition Area 24.11.86 with Overlay of Debris Flow

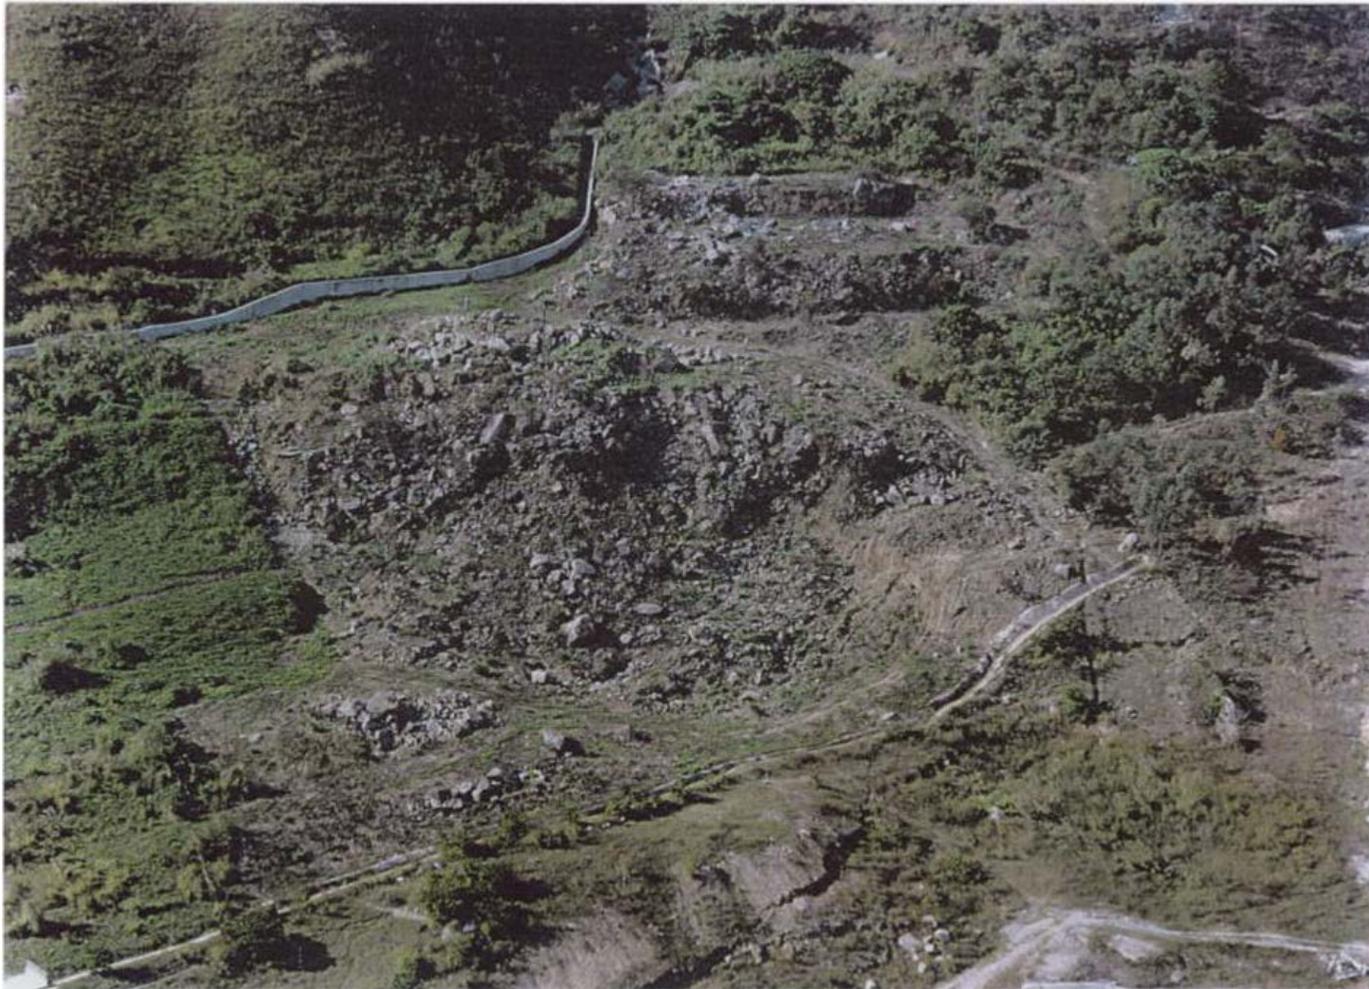
PS 571/5

Plate 17 - View of House Platforms and Borrow Scarp 24.11.86. Note Loose Rock at the Surface and Scarp from Slump Failure

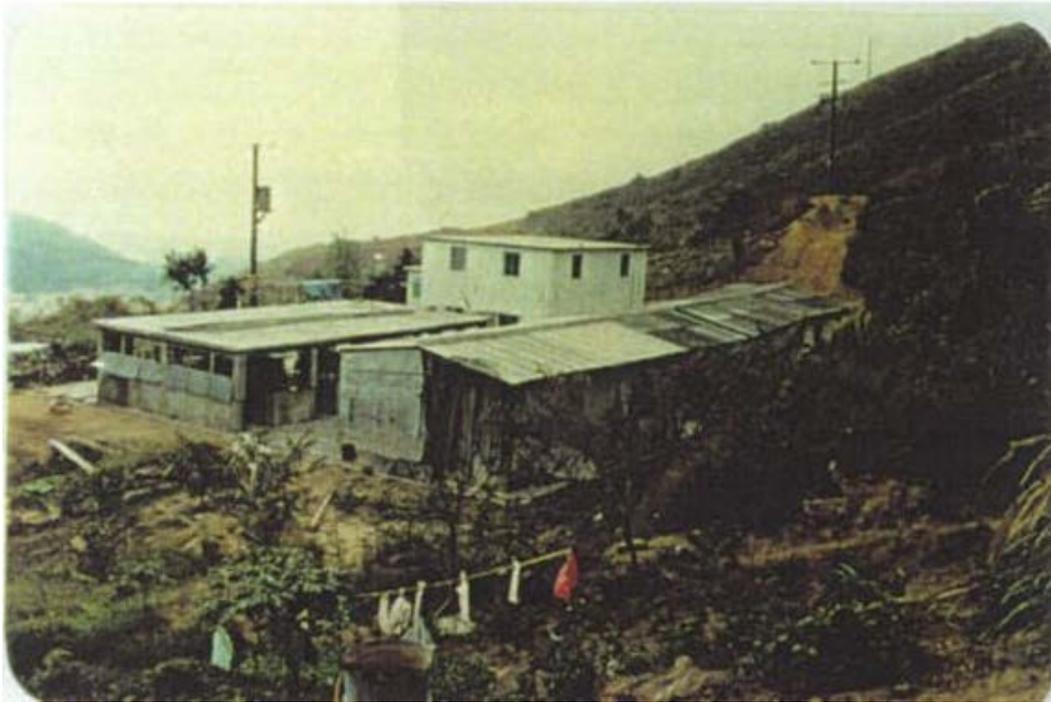
TP 205-35

Excavation of the borrow area commenced in 1977. At the same time four house platforms and an access track were constructed across the drainage line just above the borrow area. Houses were constructed on the platforms in 1978 (Plate 18) but were demolished in 1980.

Plate 18 - Occupied House Platforms 1979

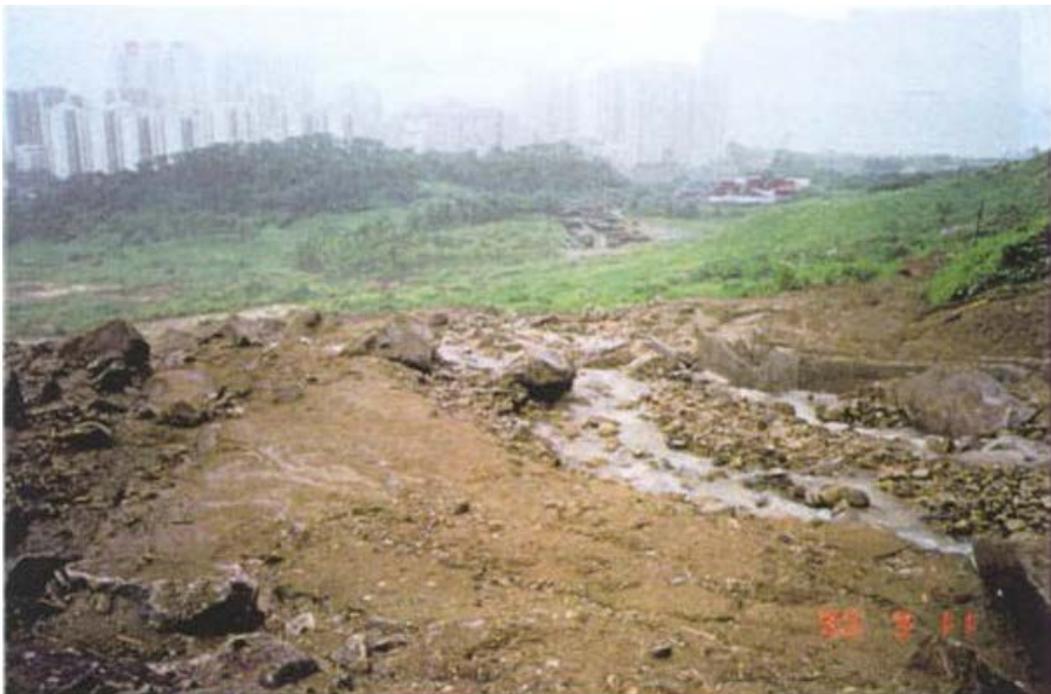
TE 95146-24

Mr Chow was woken at about 02:30 hrs by the noise of heavy rain, light vibrations and noises. These continued at a similar level until there was a particularly loud noise at about 03:00. Some time from 5 to 30 minutes after 03:00 hrs his telephone and electricity lines were cut and the noises stopped soon after. Mr Chow visited the drainage line at Ch 500 before 07:00 on 11th September. He found muddy water flowing down the drainage line at a level similar to that shown in photographs taken near Ch 500 later in the morning (Plate 19 and Appendix D).

Plate 19 - House Platform after Debris Flow 11.9.90

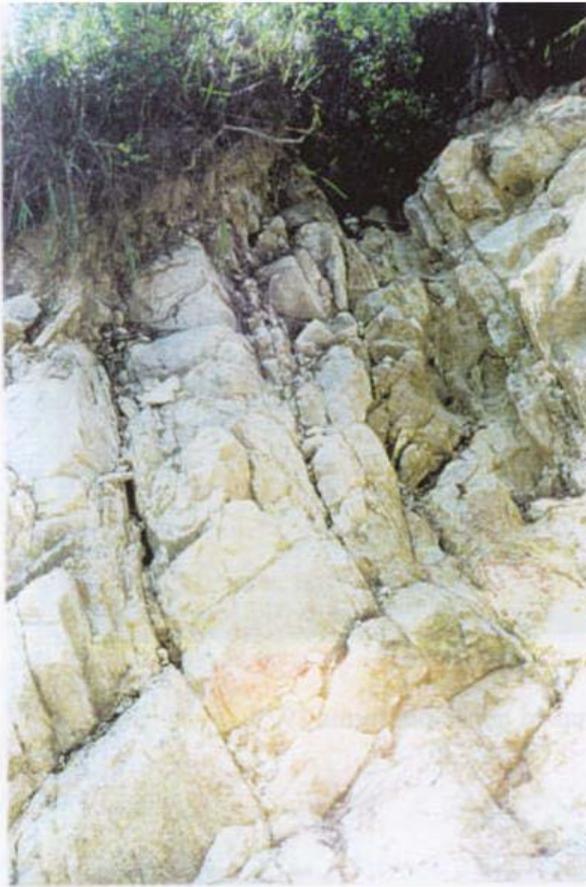
Extremely decomposed (ED) to highly decomposed (HD) granite occurs at the head of the scar in a 2 m wide linear zone striking 060° (Plate 20) and as a wider zone just above the rock outcrop at Ch 30 to Ch 40 (Plate 22). The most extensive ED to HD zone in the debris flow scar is the parent landslide area from Ch 120 to Ch 170 (Plates 32 & 33). Here the rock mass has been intruded by quartz veins and basalt dykes and has weathered to homogenous highly to extremely decomposed granite. The only other ED to HD granite exposed in the scar is at Ch 265, just above the contact with the sedimentary rock. This is exposed in the scar from a secondary slump failure on the south western side of the debris flow (Plate 45).

Plate 20 - Weathered Zone with Pipes and Quartz Veins at Head of the Scar

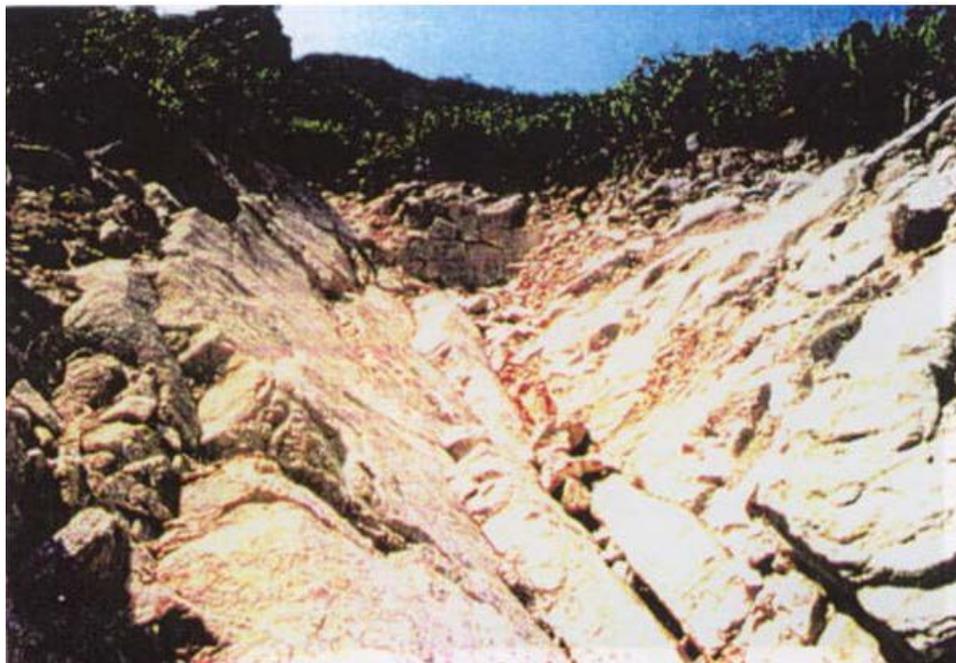
MW 90211-03

Plate 21 - V-shaped Gully

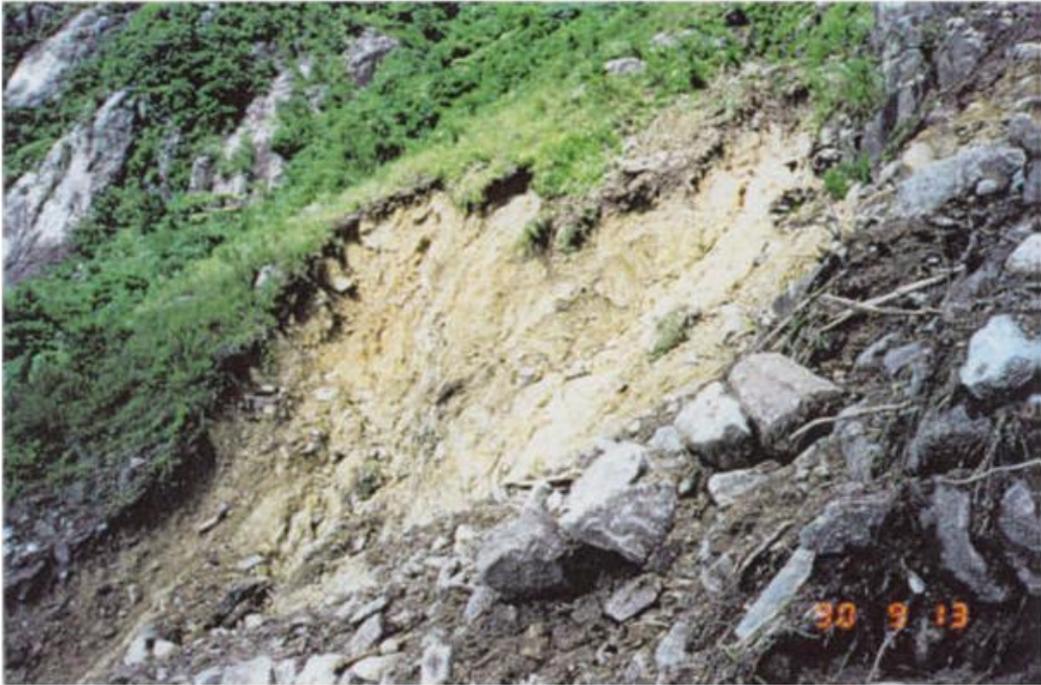
TP 127-3

Plate 29 - Spur Colluvium at Ch 125

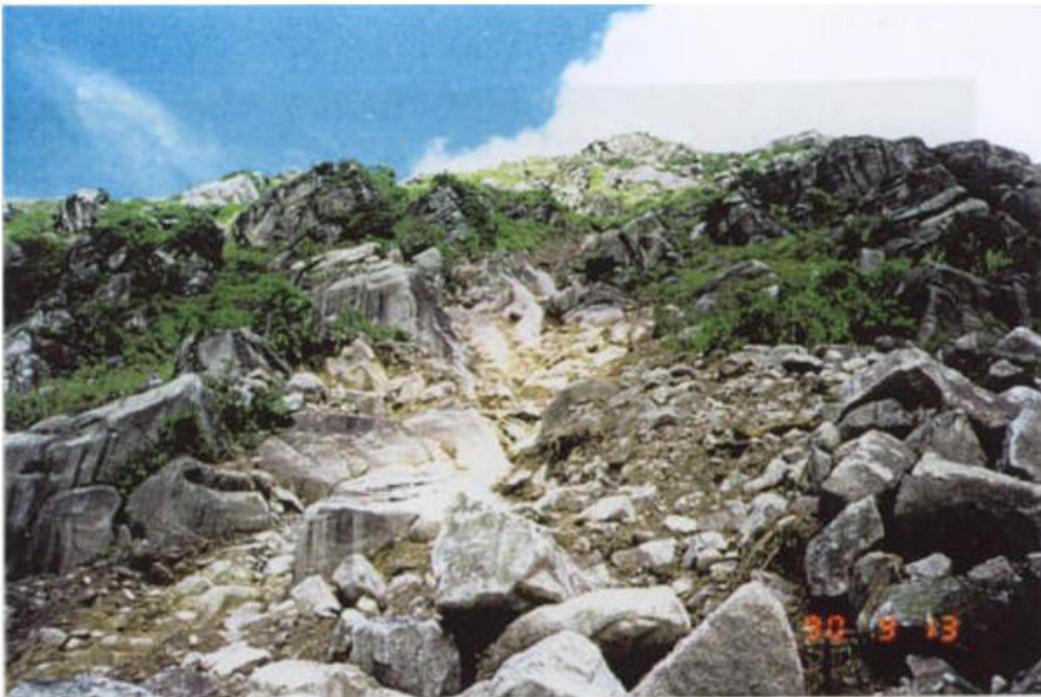
TE 95145-33

Plate 30 - Secondary Scar in Decomposed Granite at Ch 135

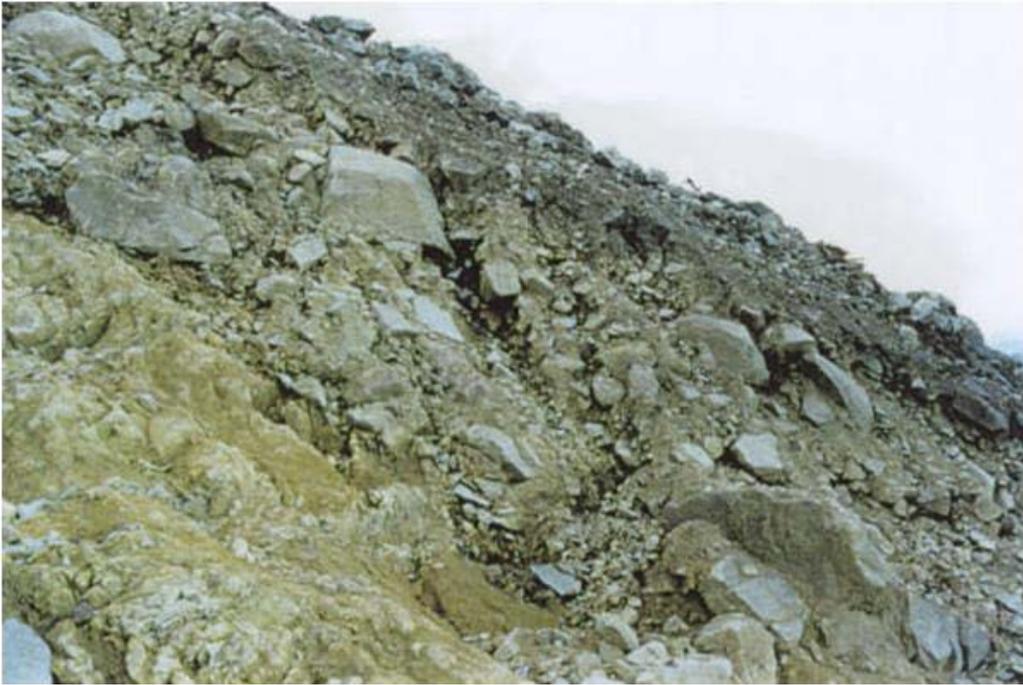
TE 95146-1

Plate 31 - Eroded Gully from Ch 135. Note Remoulded Debris and Boulders on the Ground Surface beside the Scar

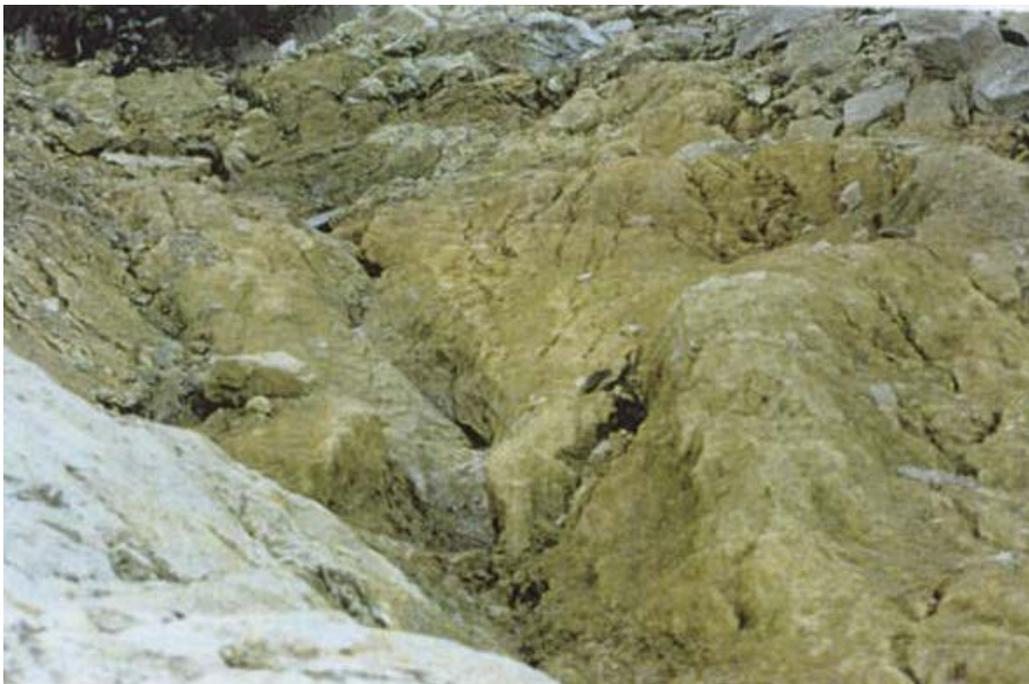
TP 108-30

Plate 32 - Spur Colluvium over CDG in the Side Scarp of the Parent Landslide.  
A Basalt Dyke Is in the Foreground

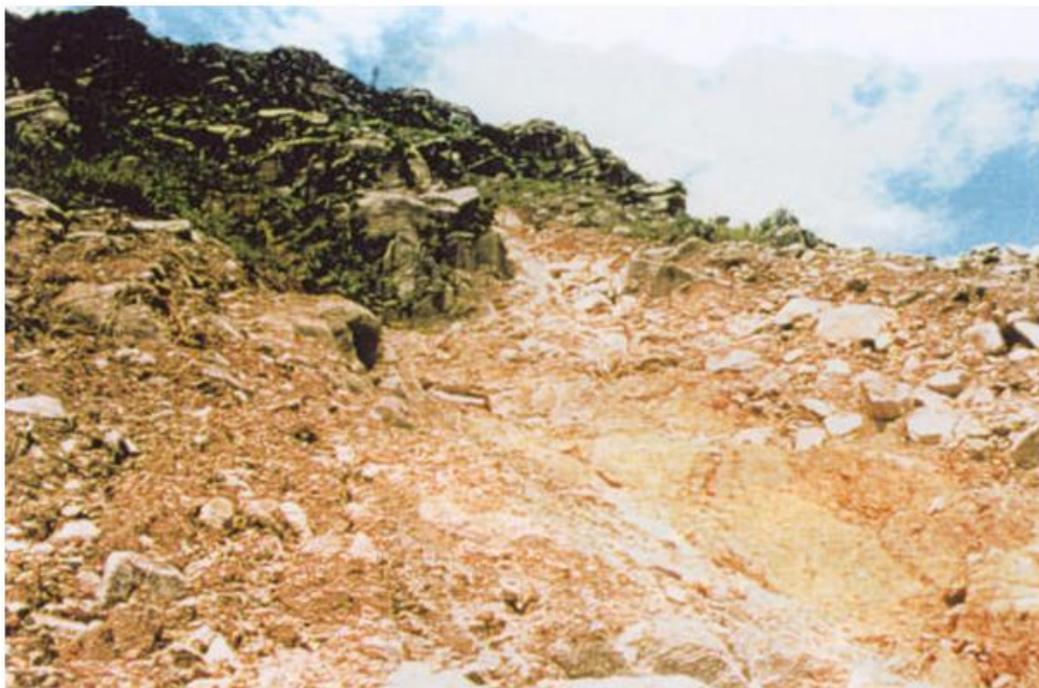
TP 108-27

Plate 33 - Completely Decomposed, Kaolinised Granite in the Floor of the  
Parent Landslide at Ch 135

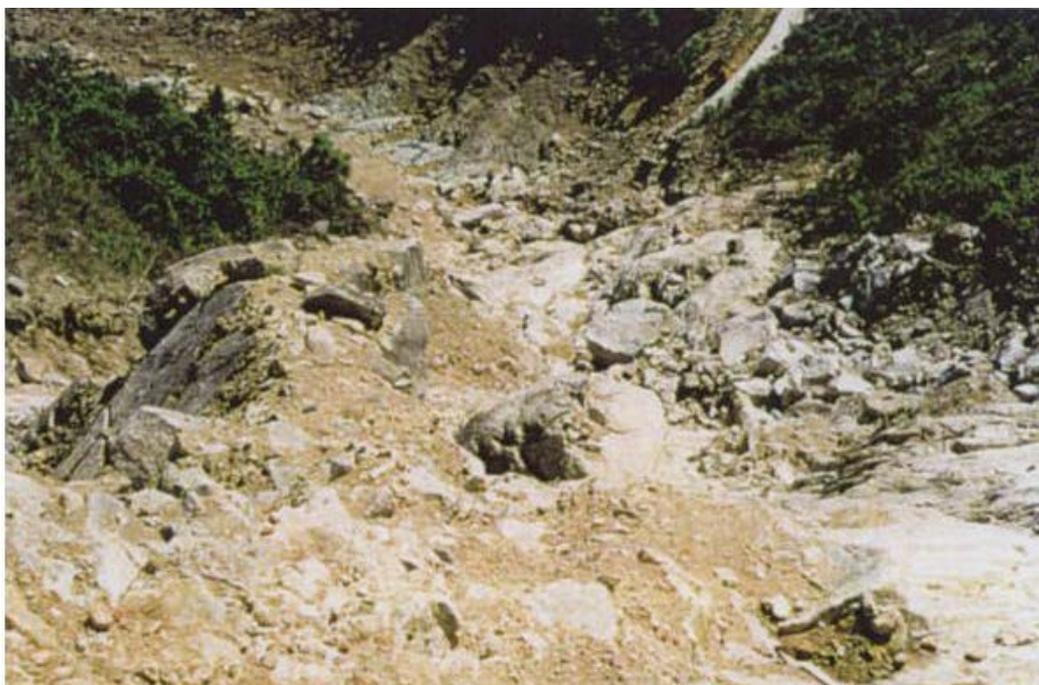
TP 134A-6

Plate 34 - Matrix Rich Remoulded Debris with Abundant Vegetation at Ch 150

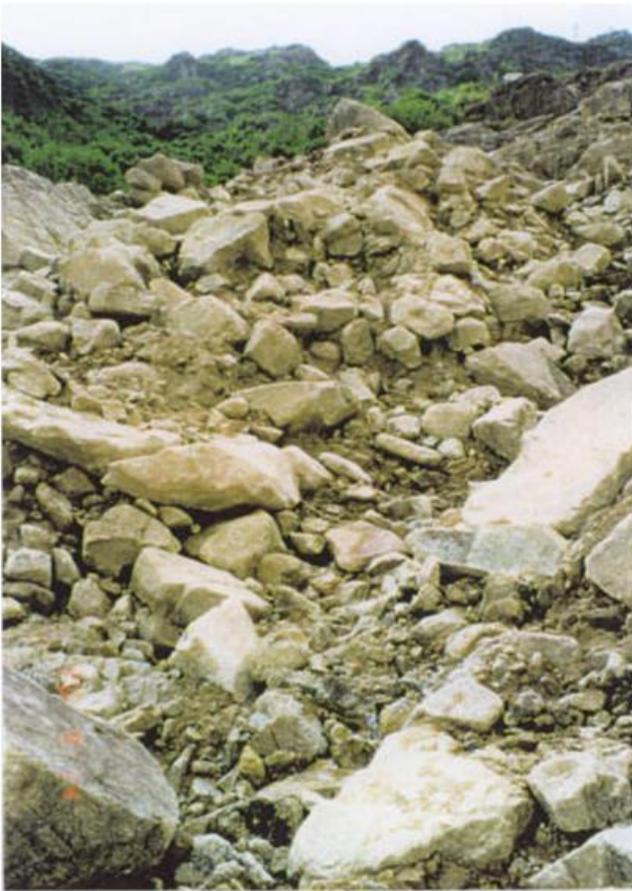
MW 90210-17

Plate 35 - Debris on Joint Bounded Rock Outcrop at the Top of the Sheeting Joint

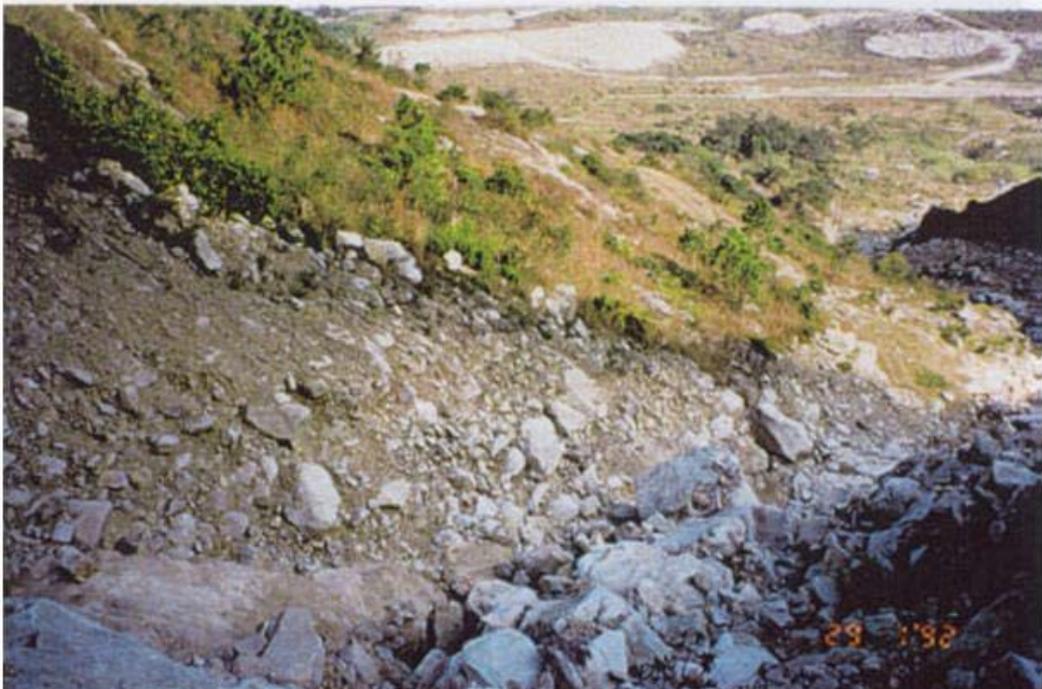
MW 90191-24

the upper valley (Plates 37, 40 & 41) and forms most of the valley side fan below the sheeting joint (Plate 36).

Plate 36 - Eroded Remains of the  
Valleyside Fan (Ch 175)

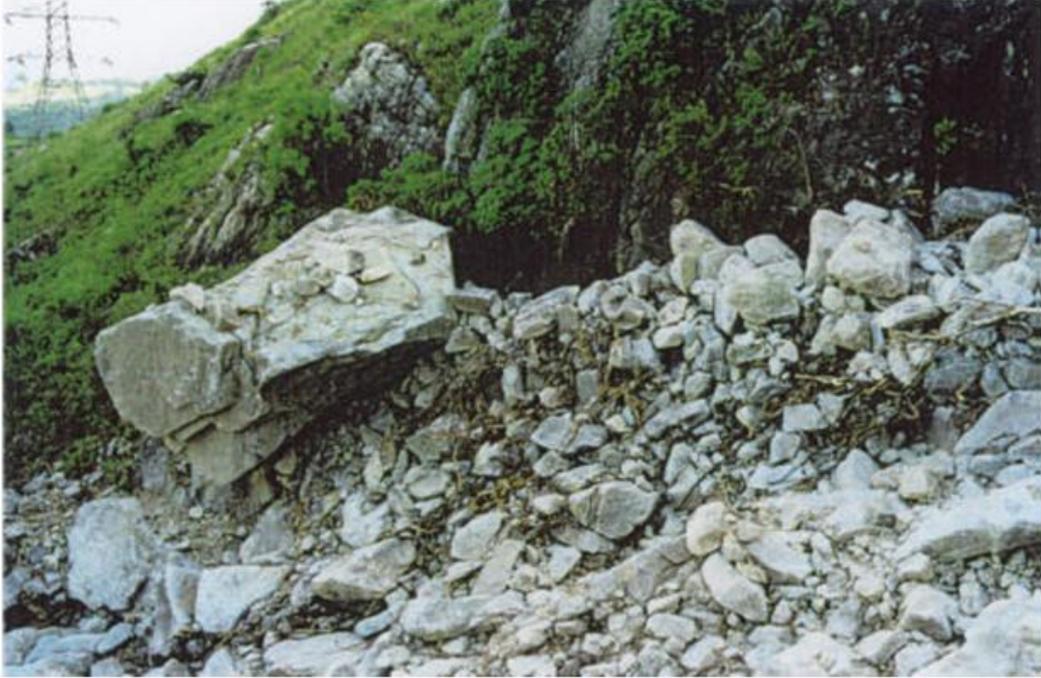
TP 127-15

Plate 37 - Upper Valley Colluvium Ch 225 - 275

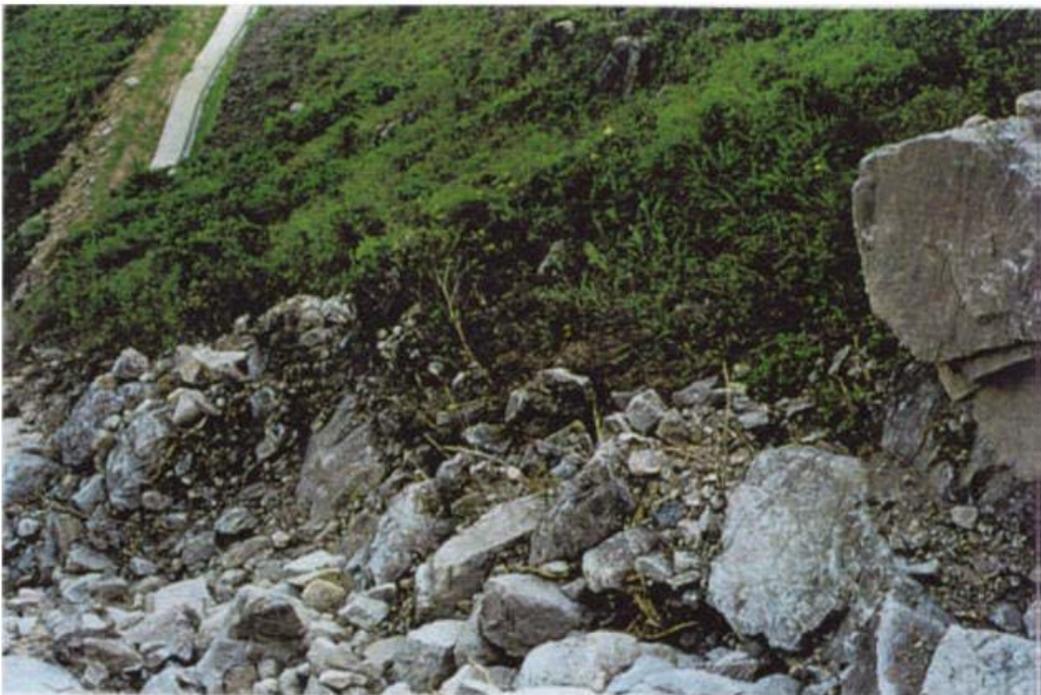
TP 108-0

Plate 38 - Large Boulder at Ch 175 with Accumulation of Boulders Upslope.  
Note Impact Marks from Bouncing Boulders on the Rock Outcrop

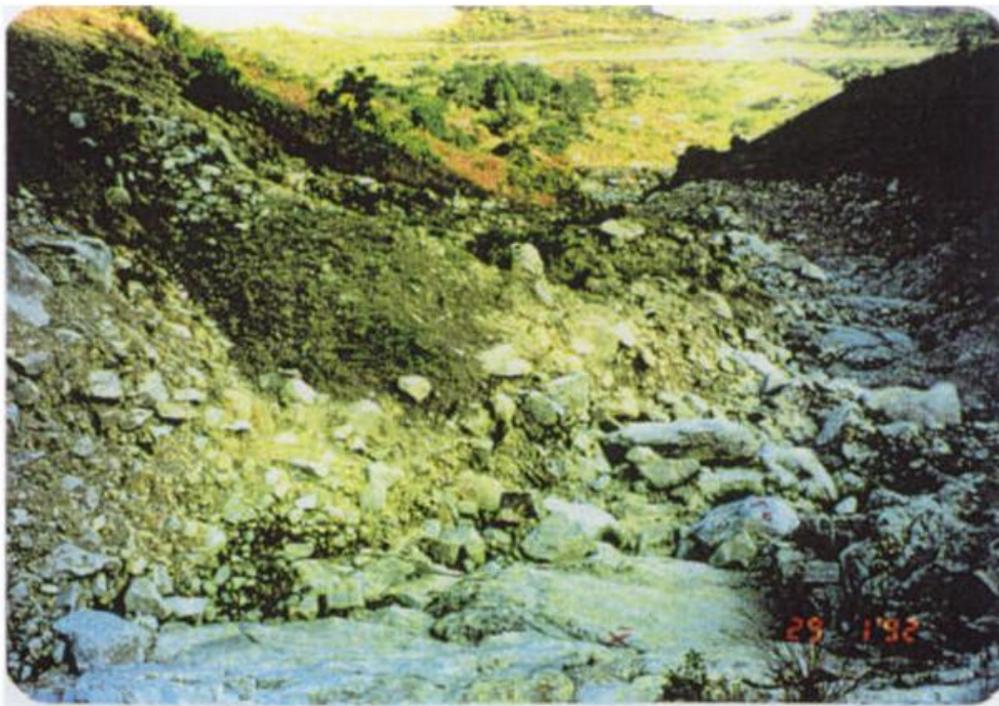
TP 170-7

Plate 40 - Spur/Upper Valley  
Colluvium Exposed by the  
Debris Flow. Note Water  
Replacement Insitu  
Density Test D11 in  
Progress

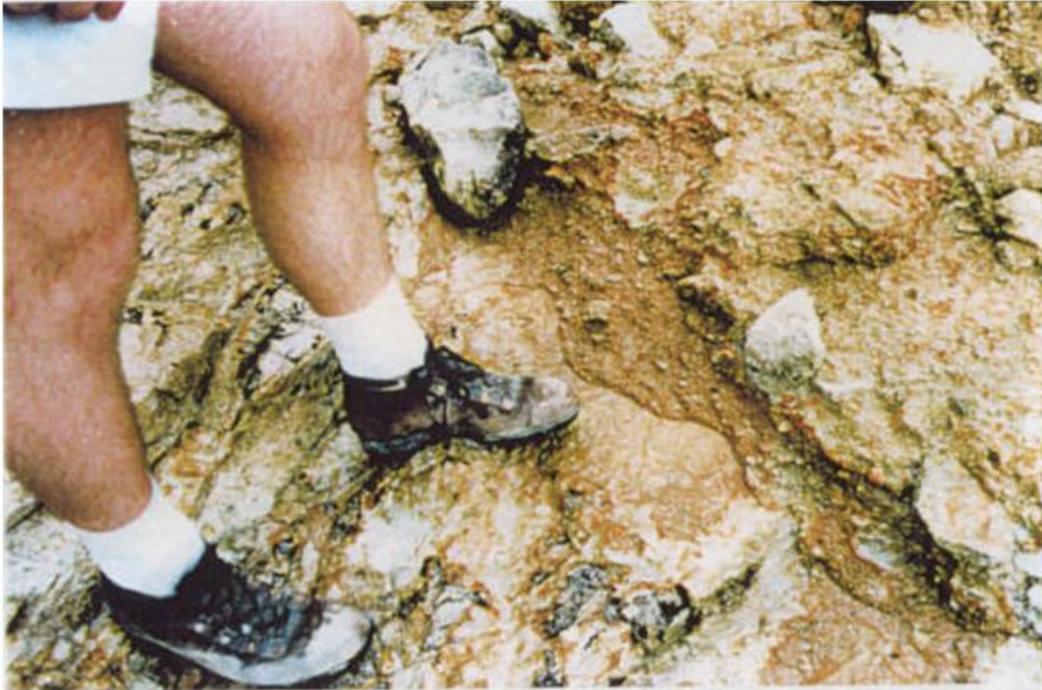
TP 127-19

Plate 41 - Upper Valley Colluvium Ch 275 - 325
