# **TSING SHAN DEBRIS FLOW AND DEBRIS FLOOD**

**GEO REPORT No. 281**

This GEO Report consists of two Landslide Study Reports on the “Tsing Shan Debris Flow and Debris Flood” (LSR 2/2001) and “The 2000 Tsing Shan Debris Flow” (LSR 3/2001).

# **SECTION 1: THE 1990 TSING SHAN DEBRIS FLOW**

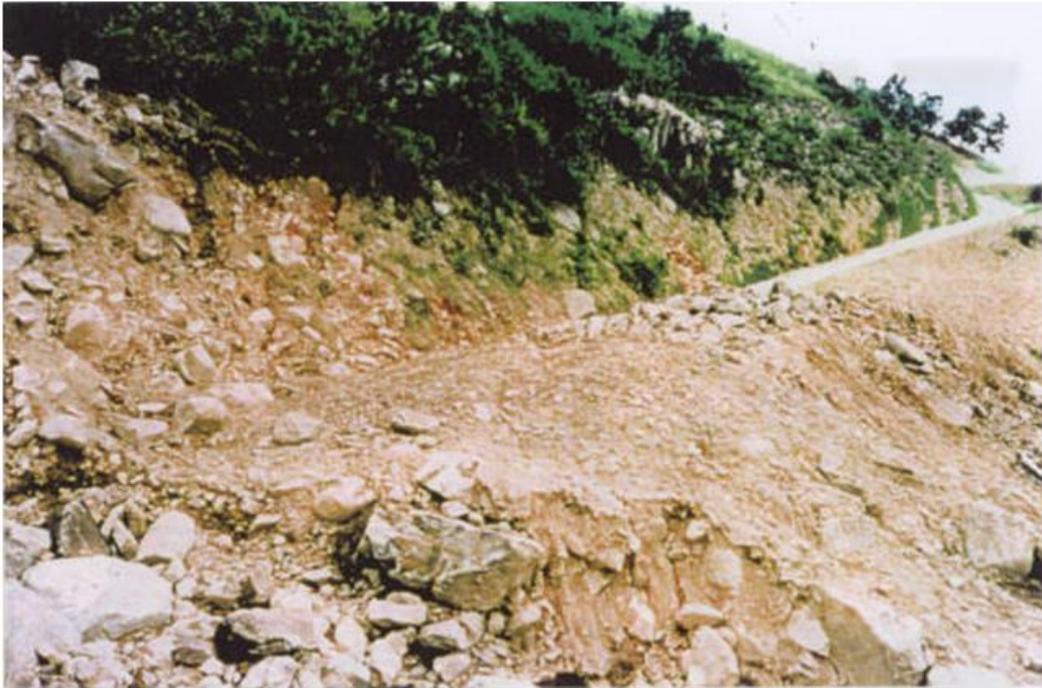
TP 160-8

Plate 43 - Remoulded Debris Accumulation Downslope from an Insitu Boulder (1993)

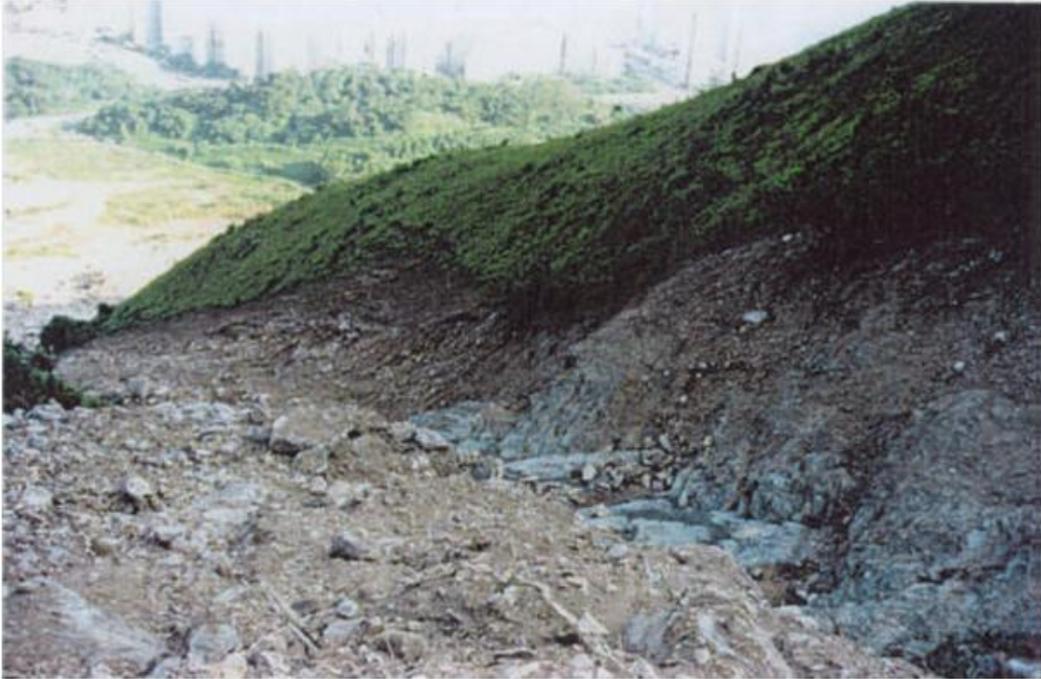
TP 109-3

Plate 45 - Secondary Failure at Ch 265. Note Trail Downslope from Scar on LHS

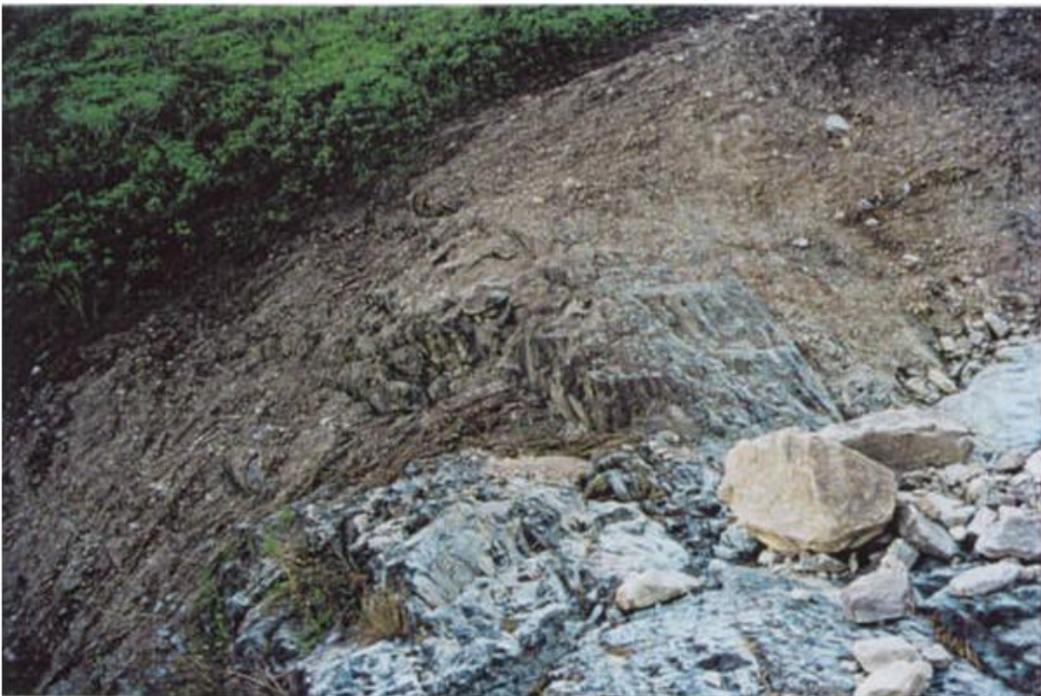
TP 109-6

Plate 46 - Trail below Path. Note Remoulded Debris in the Foreground

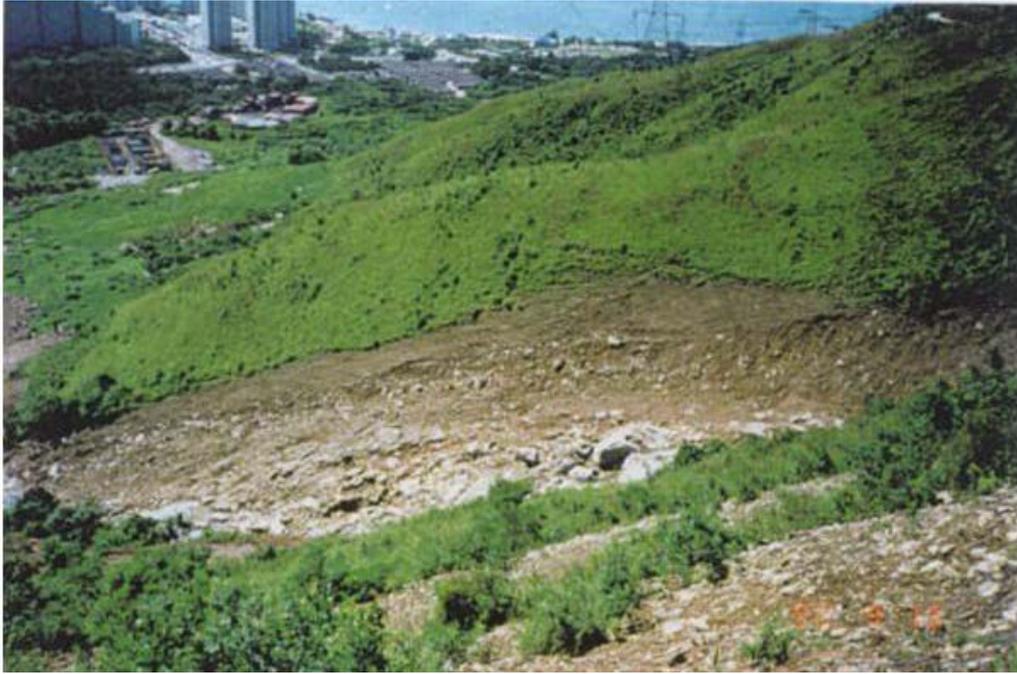
TP 109-21

Throughout the scar alluvial debris deposits locally overlay the other types of debris. At many locations Class 1 remoulded debris occurs adjacent to or either side of a central area washed clean of debris (Plates 47 & 50). At the mouth of the drainage line Class 1 remoulded debris has been locally completely eroded or the surface has been washed and the fines removed to form a thin sorted alluvial surficial deposit overlying remoulded debris (Plate 54). These observations indicate reworking and deposition from streamflow late in the event.

Plate 47 - Undisturbed Vegetation at Waterfall. The Central Part of the Scar Has Been Washed Clean by Streamflow

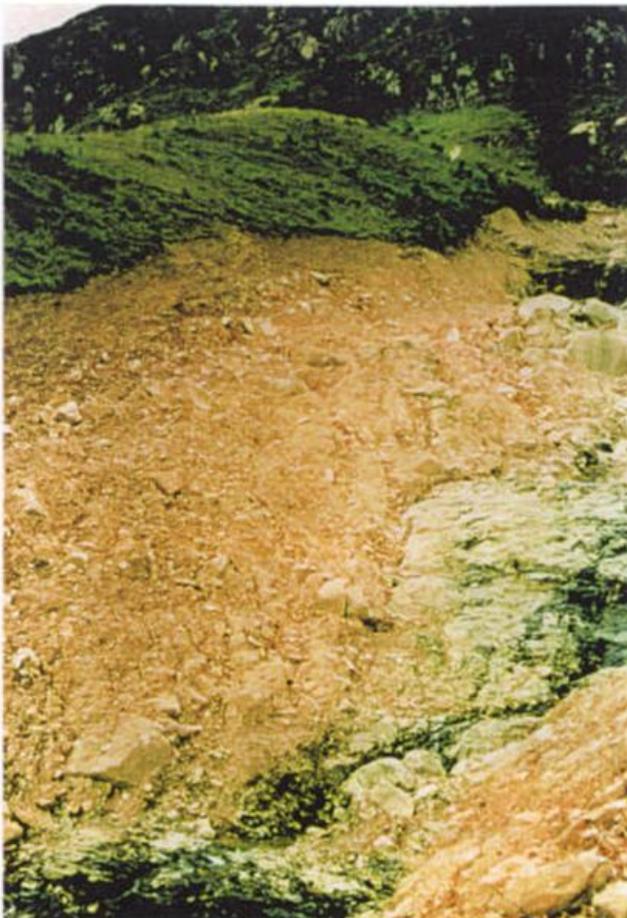
TE 95145-13

Plate 48 - Trail on Lower Valley. Note Edge of the Trail Dies Out in Vegetation

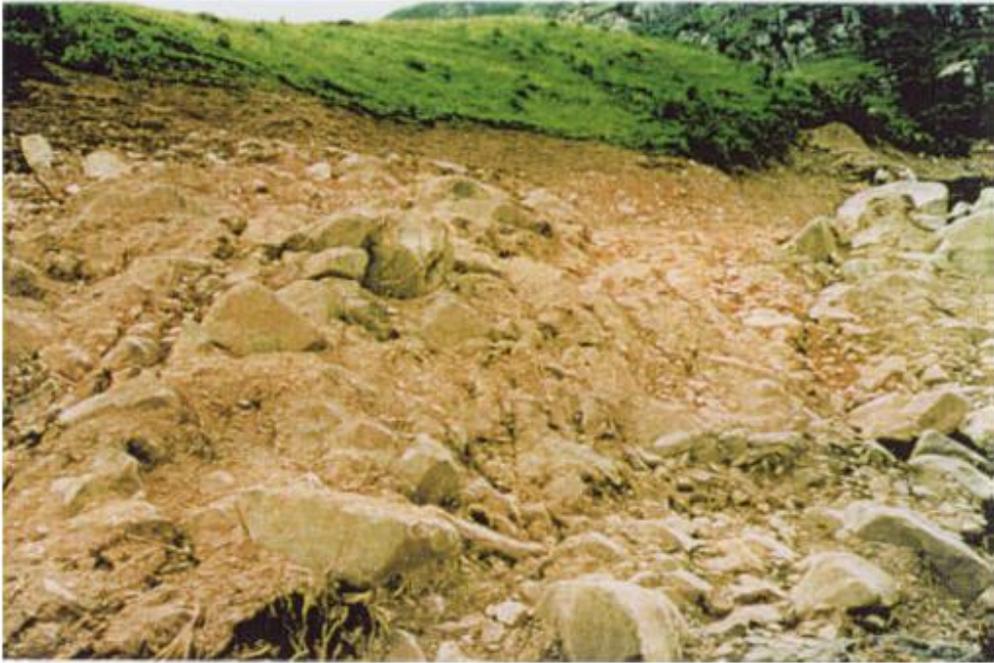
TP 134B-5

Plate 49 - Lower Valley Looking up to the Waterfall. Note Freshly Exposed Bedrock and the Class 1 Debris Overlying Colluvium

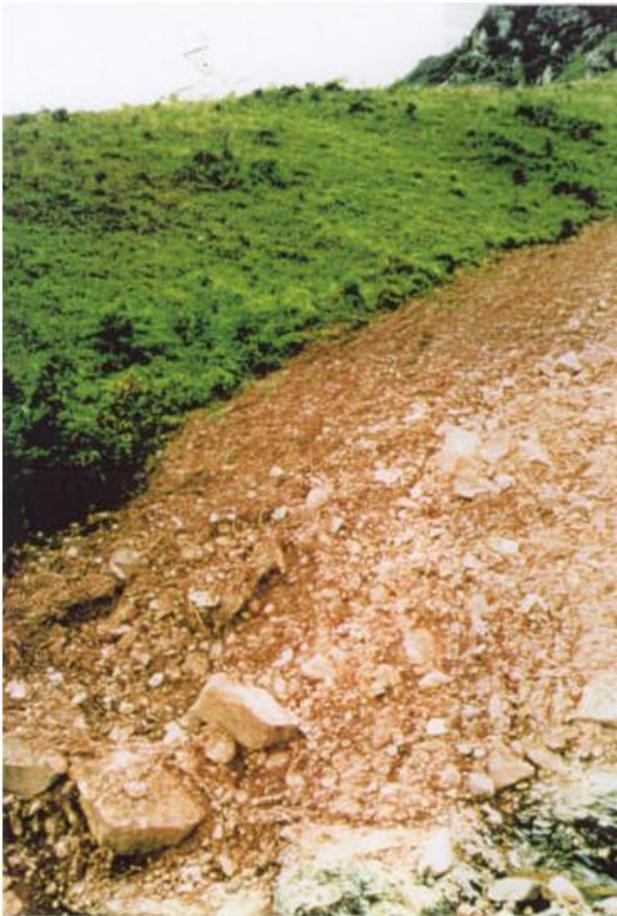
TP 134-35A

Plate 50 - Boulders Overlain by New Class 1 Debris in Lower Valley

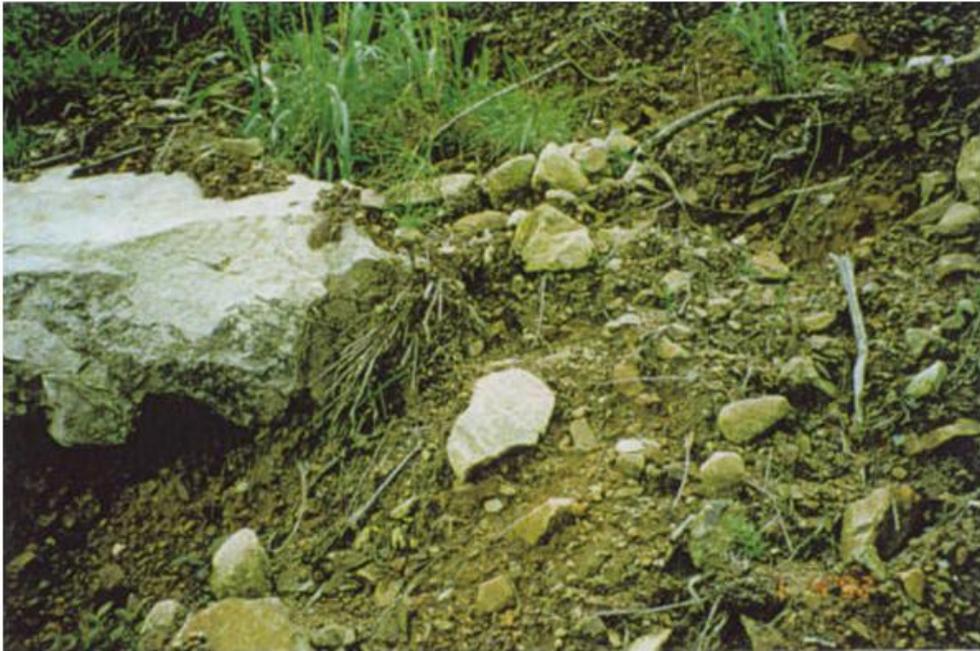
TP 134B-7

Plate 51 - Trail and Debris Boulders  
near Mouth of the  
Drainageline

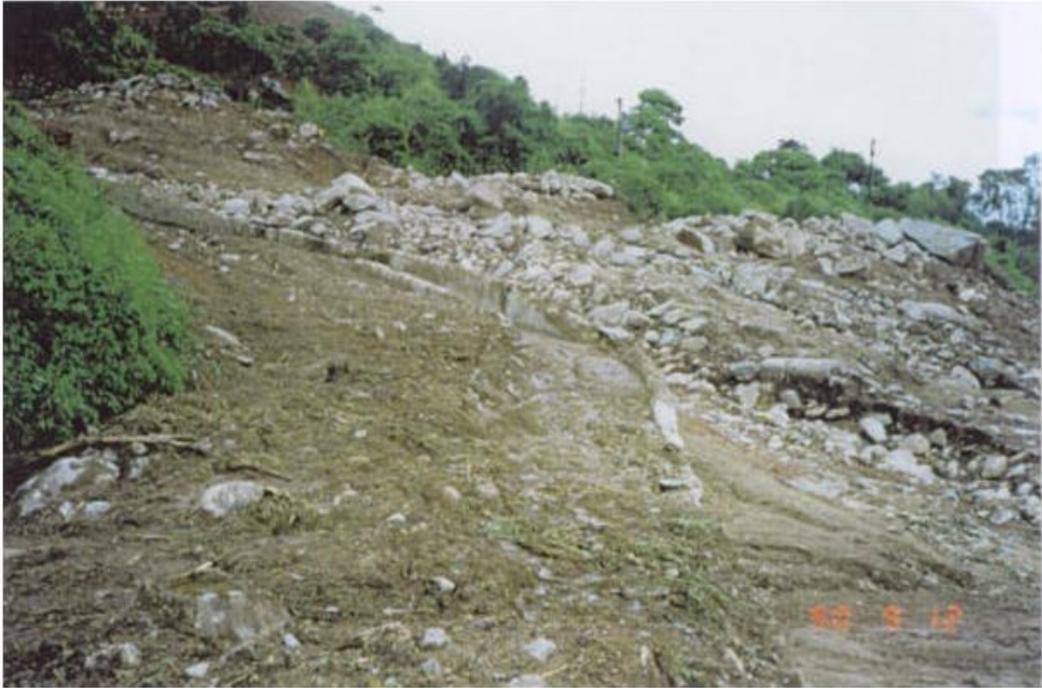
MW 90178-00

In the lower valley, on the house platforms and in the borrow area, large confined pulses of flowing debris with many large boulders caused intense erosion and damaged concrete structures (Plates 53, 54 & 55). Any housing in these locations would have been extremely vulnerable to impact from moving debris (Plates 18 & 19). These areas of primary deposition are relatively limited and easy to define. They have a high probability of being affected should a debris flow occur in the drainage line.

Plate 55 - Remains of Concrete Channel

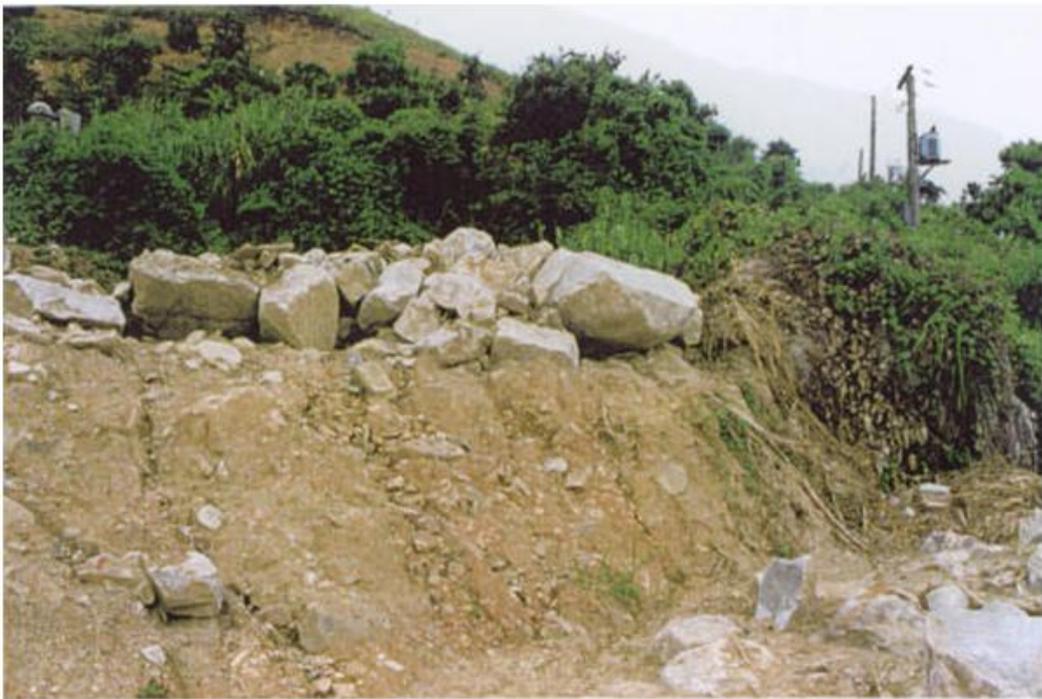
TE 95144-18

Plate 56 - House Platform after Debris Flow Looking from Blocked Channel, 12.9.90

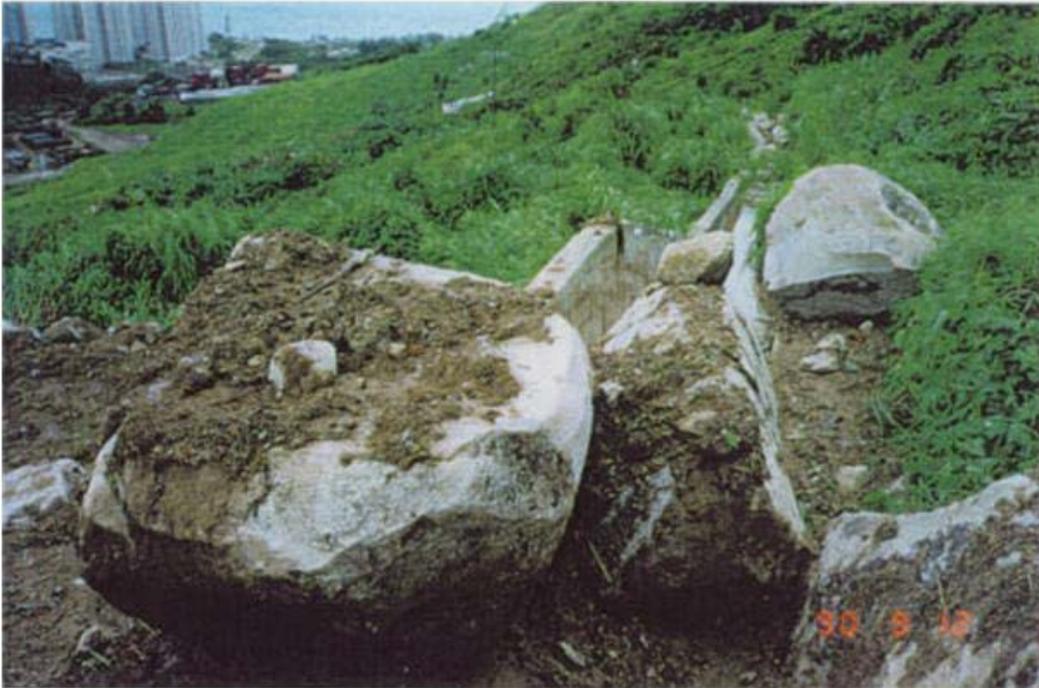
MW 90192-09

Plate 57 - Large Boulders on Abandoned House Platform Ch 525

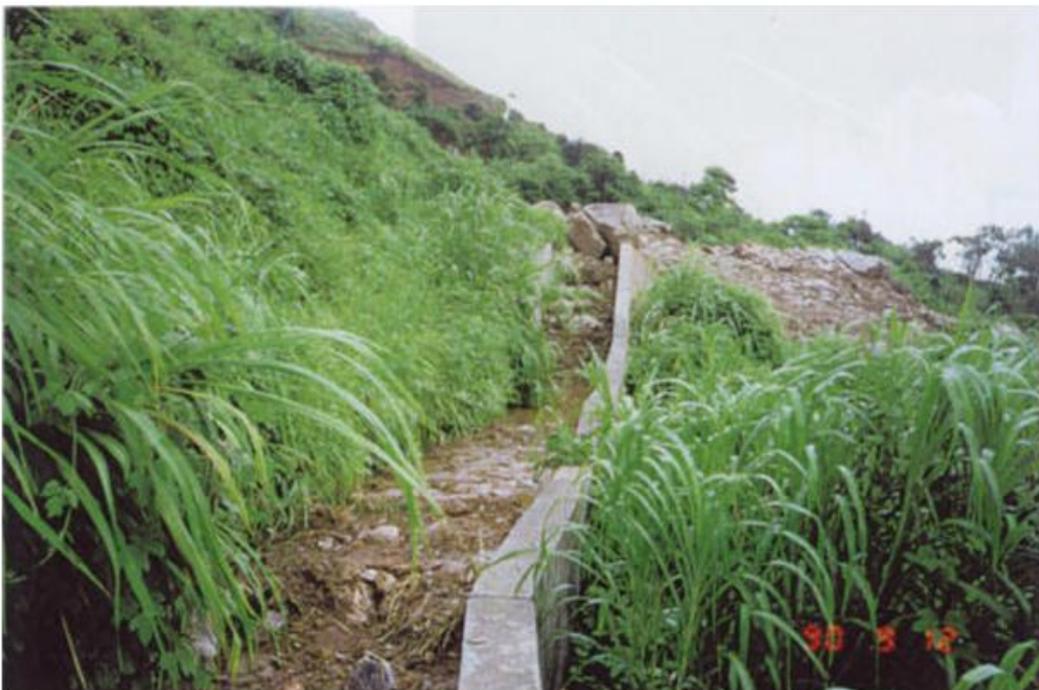
TE 95144-13

Plate 58 - Proximal Blockage of the Channel

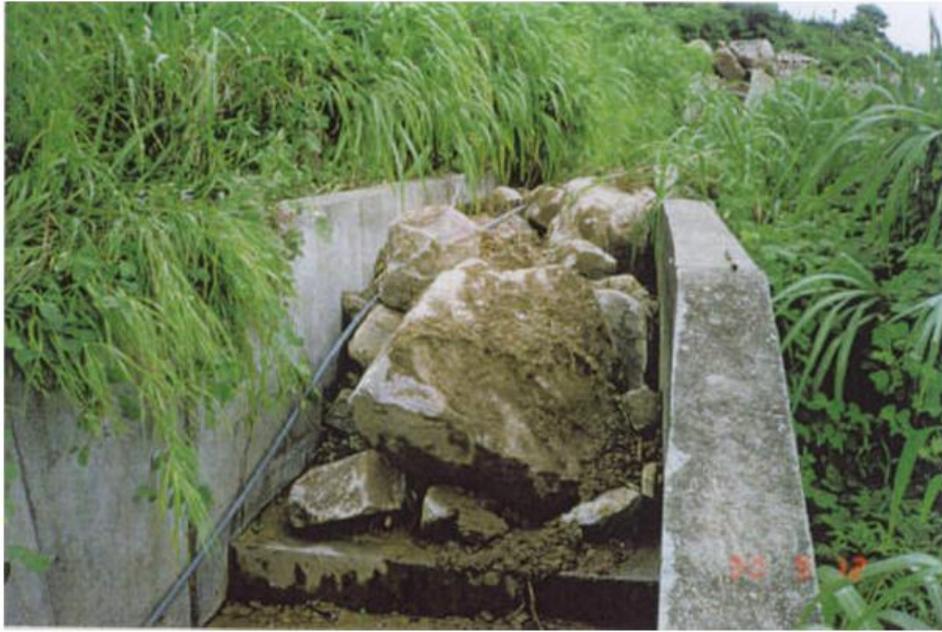
TE 95144-27

Plate 59 - Proximal Blockage from below

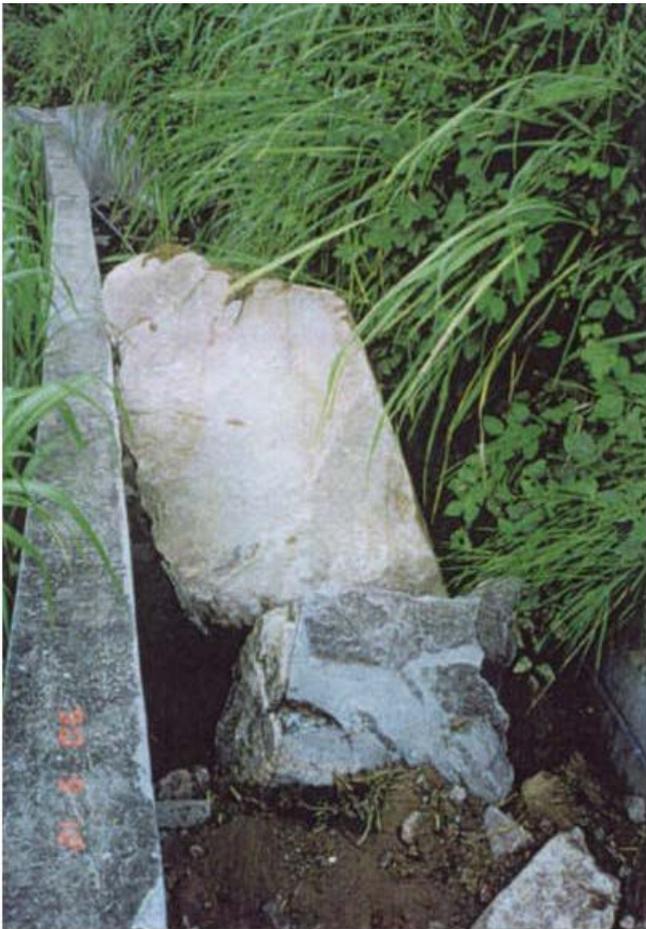
TE 95144-28

Plate 60 - The Second Blockage. Boulders and Remoulded Debris

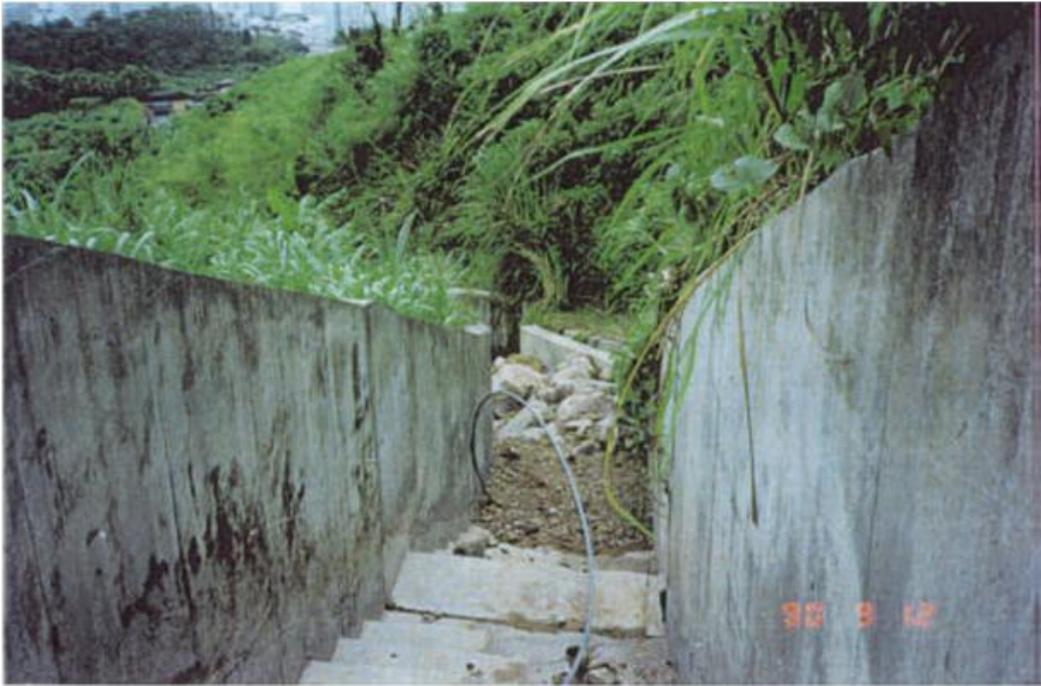
TE 95144-30

preserved around the boulders. However, just downslope from them, a large boulder (2 m diameter) jammed in the channel has an alluvial deposit of sandy gravel at its base (Plate 61). Some 20 m downslope from here a distal blockage is formed of boulders up to about 0.5 m diameter with alluvial deposits and flow aligned vegetation (Plates 62 & 63).

The large boulder was probably emplaced by debris slurry as indicated by its size and the traces of remoulded debris capping it (Plate 61). However, both it, and the distal blockage, are associated with alluvial deposits and therefore these blockages were affected by water flowing in the channel before the un-washed, proximal blockage of remoulded debris closed the channel. Thus, early in the event a pulse of debris, including the large boulder, reached the channel inlet and was diverted into it. Following this there was a period when water flow was diverted down the channel before the final proximal blockage by remoulded debris. At this time the diversion bund may still have been functioning or an early deposit from the debris flow may have acted to divert the debris.

Plate 61 - Washed Boulders 10 m  
Downstream from Second  
Blockage

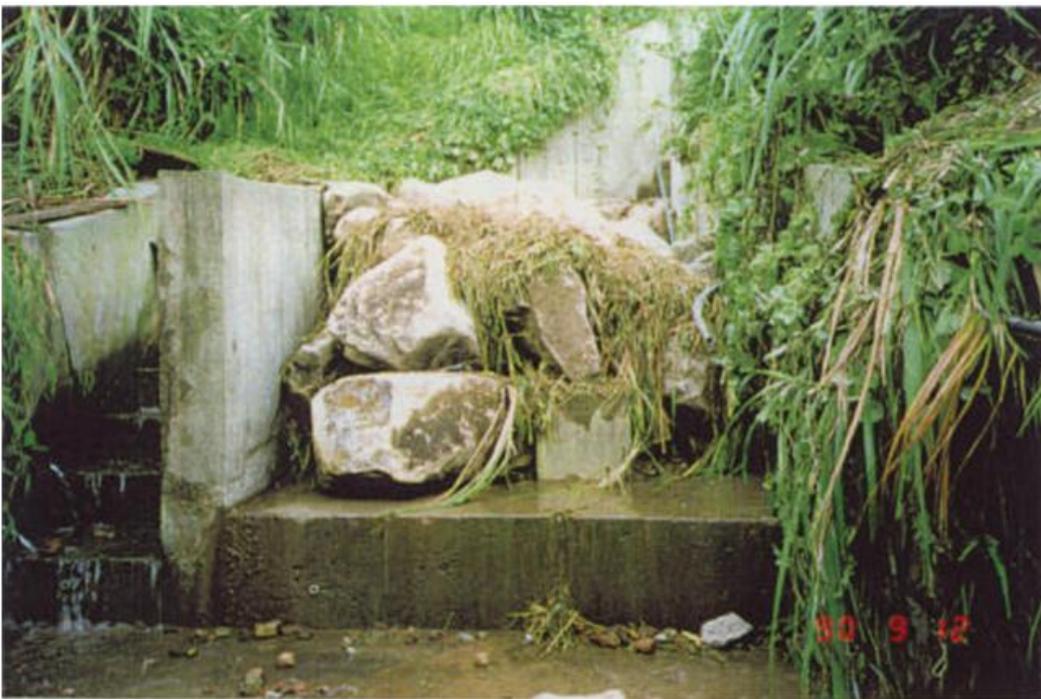
TE 95144-33

Plate 62 - Washed Distal Blockage from above

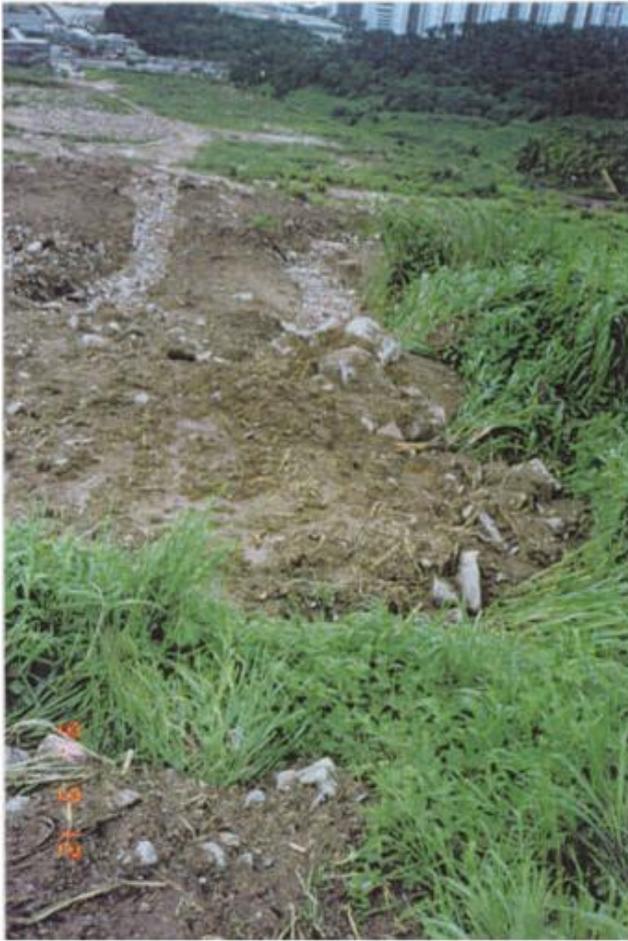
TE 95144-34

Plate 63 - Washed Distal Blockage from below

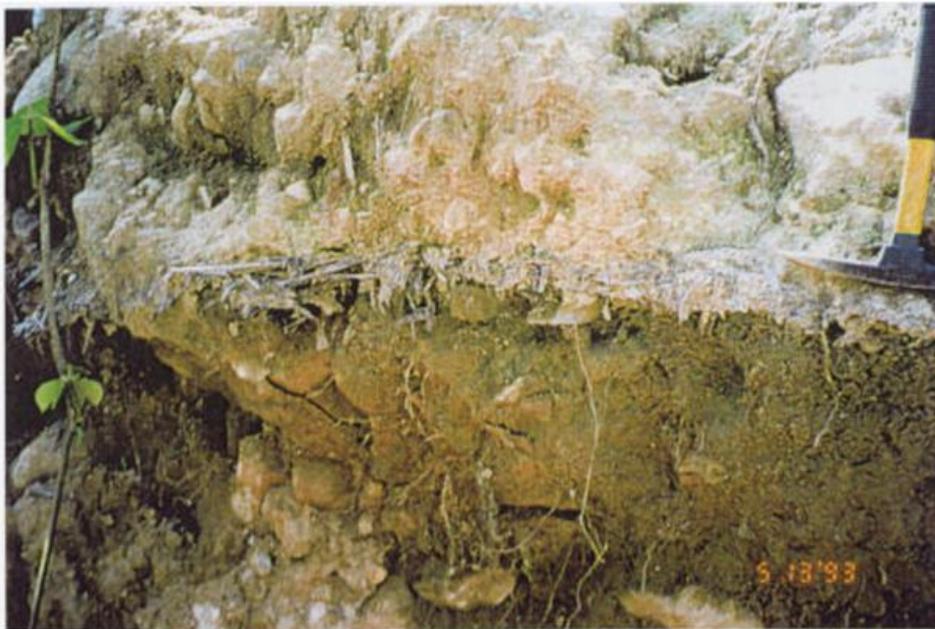
TE 95144-23

Plate 64 - Matrix Rich Debris above Scarp. Note Channels 1 and 2 below the Scarp

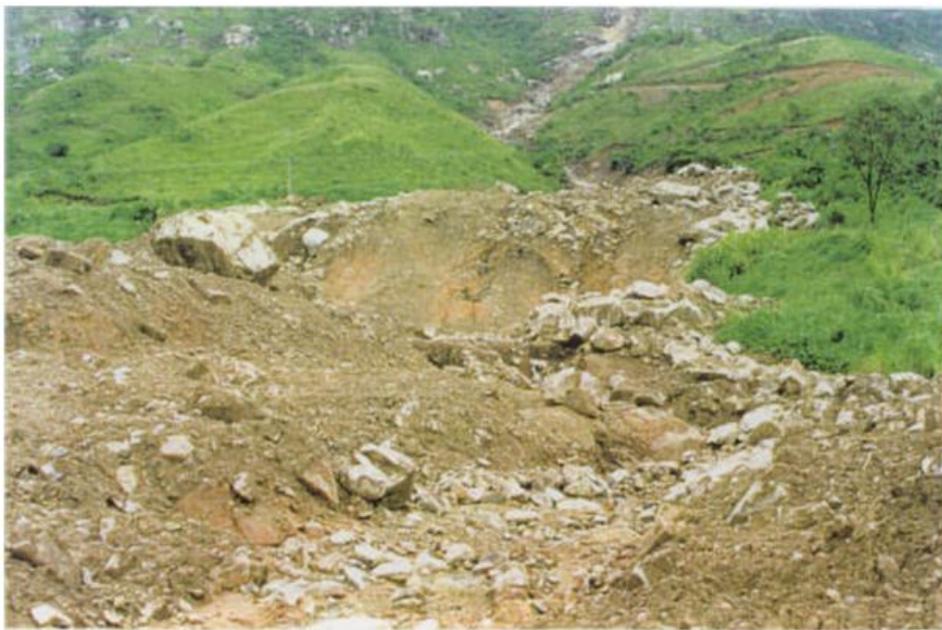
MW 90186-03

Plate 66 - Channel Eroded into  
Borrow Scarp. Note  
Orange Insitu Soil and  
Brown Debris

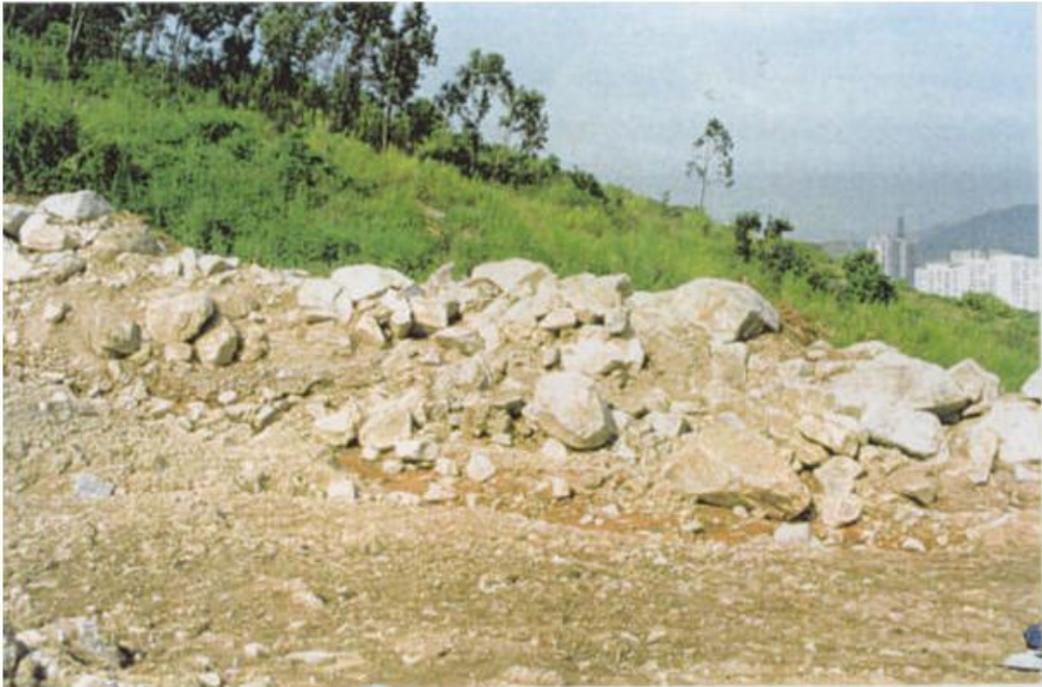
D 290/284-15

Plate 67 - Borrow Scarp, Channel 3 and Stranded Boulder

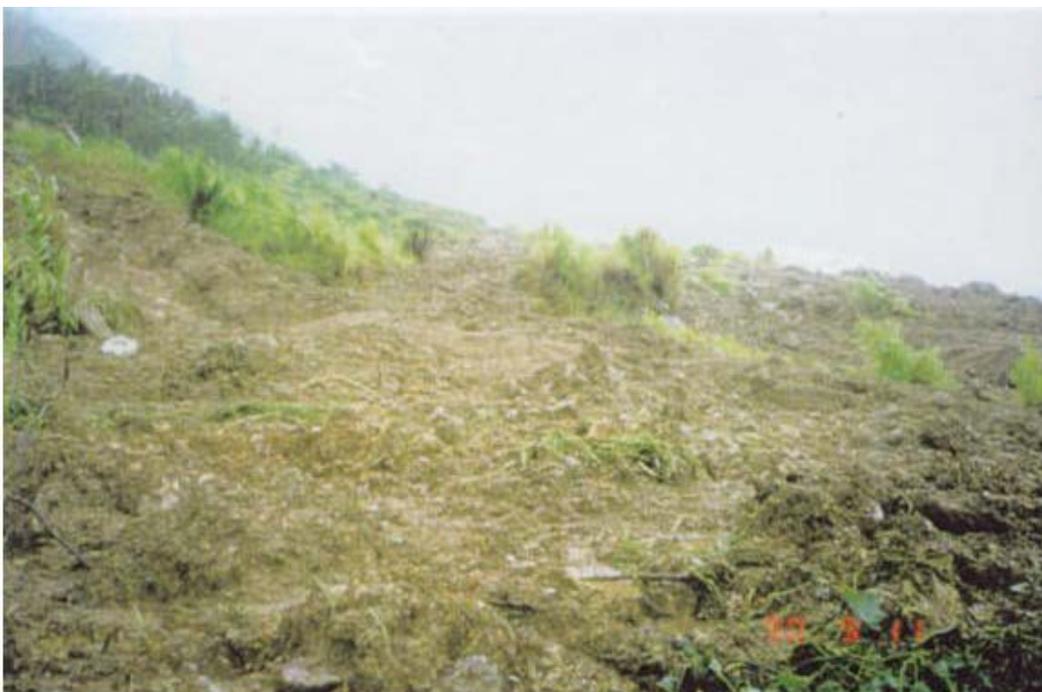
MW 90184-02

Plate 68 - Bouldery Debris Ridge on LHS of Borrow Area

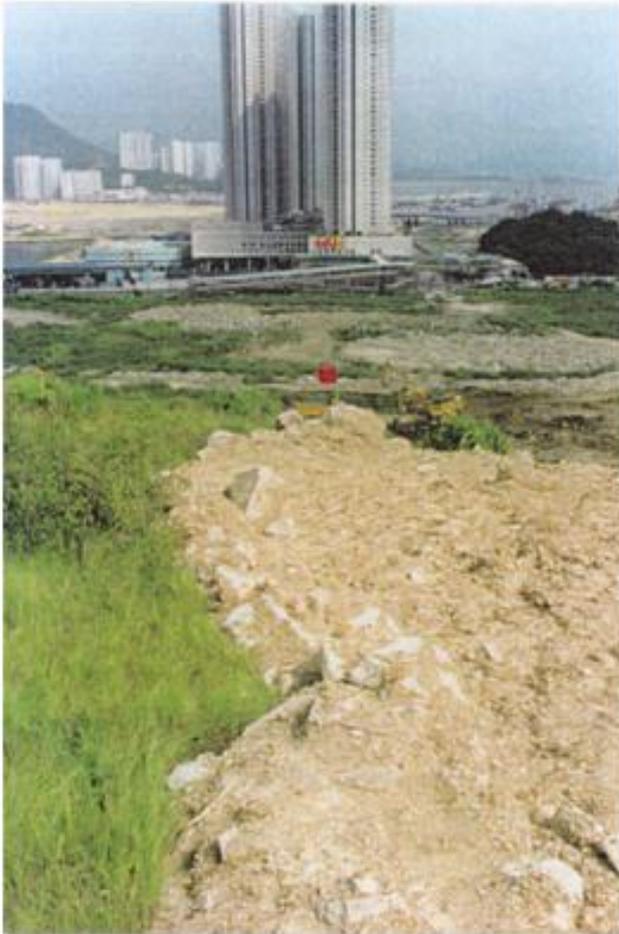
TE 95144-6

Plate 69 - Debris along Access Track on 11.9.90. Reported to be So Soft That a Man Would Sink in

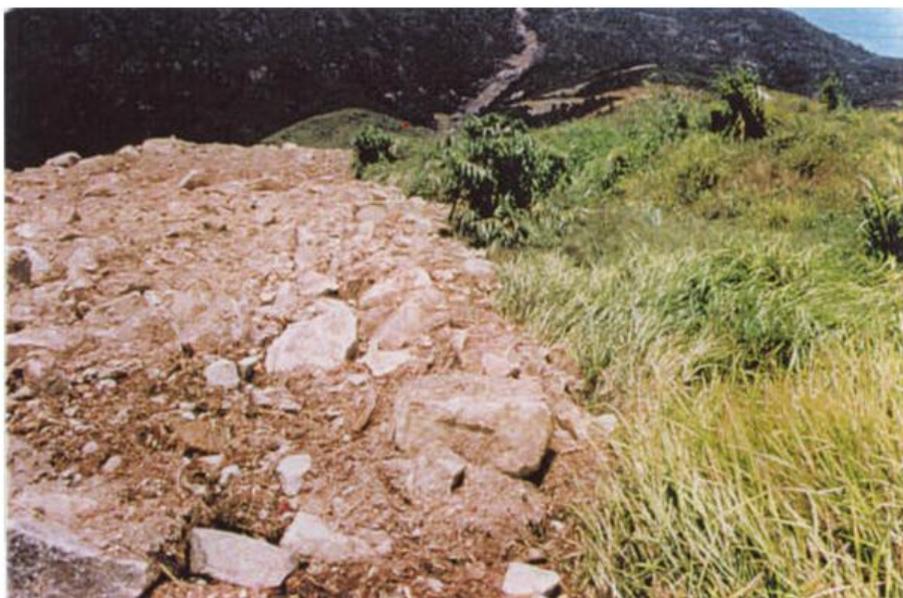
MW 90183-17

Plate 70 - Lateral Ridge of Matrix-rich Debris on Cut Slope (Ch 725)

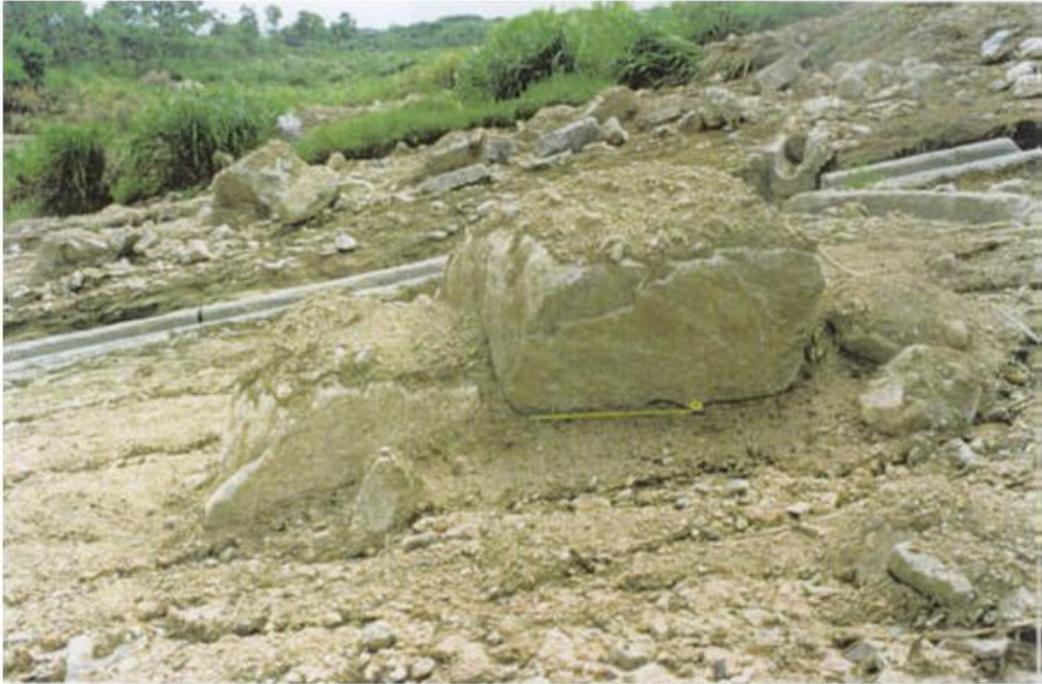
TP 134B-31

Plate 71 - Steep Sided Edge of Vegetation and Matrix Rich Debris on the Cut Slope (Ch 775)

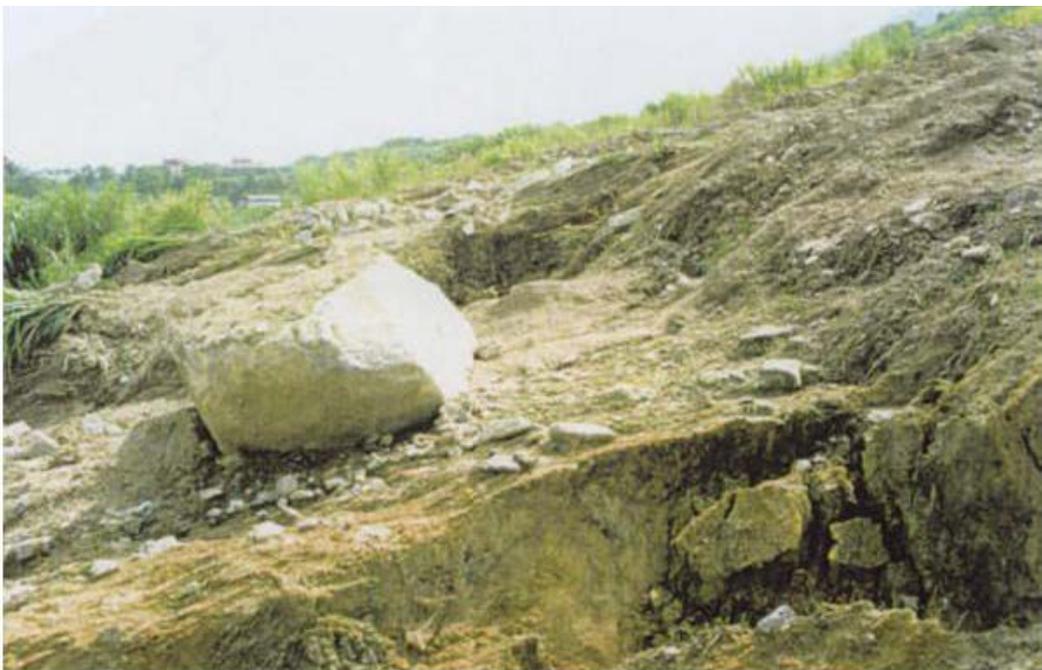
MW 90183-00

Plate 72 - Boulder Capped with Remoulded Class 1 Debris on Cut Slope

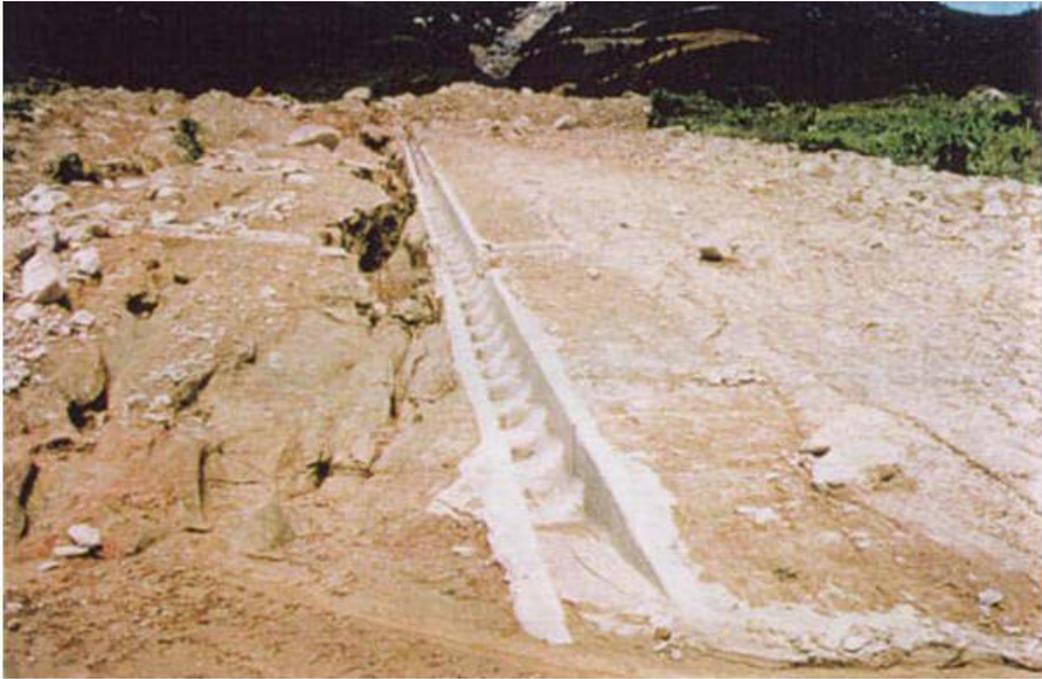
MW 90181-24

Plate 73 - Boulder Capped with Remoulded Class 1 Debris and Gully Eroded into Decomposed Andesite on Cut Slope (Ch 775)

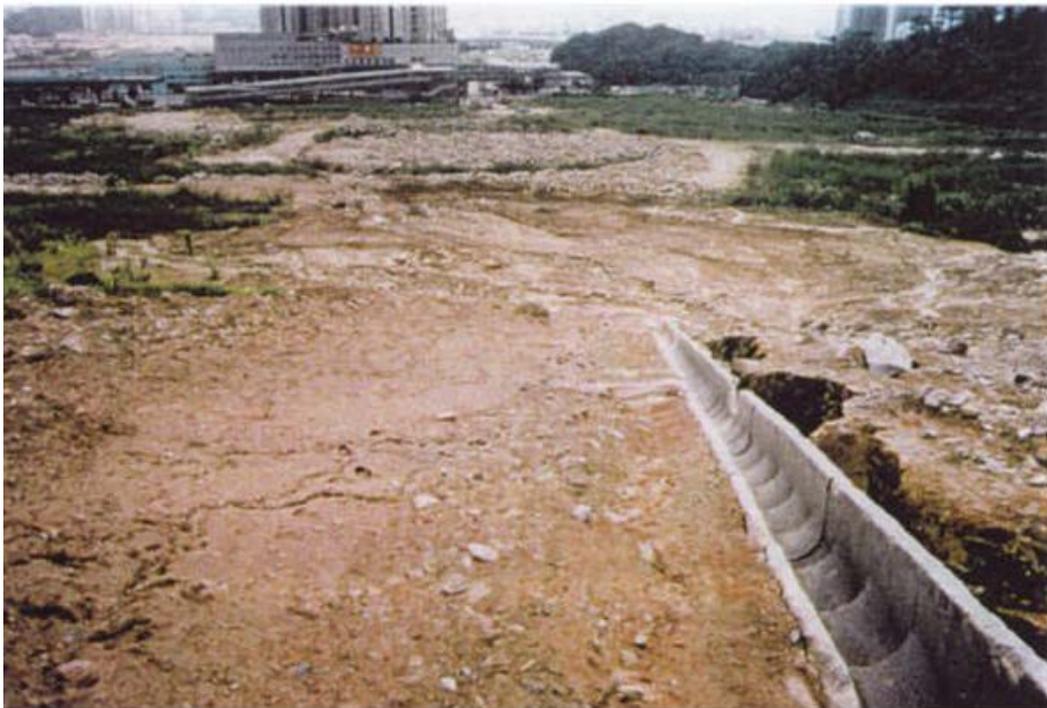
TP 134B-24

Plate 74 - Washed Area Next to a Concrete Channel on the Lower Part of the Cut Slope 16.9.90

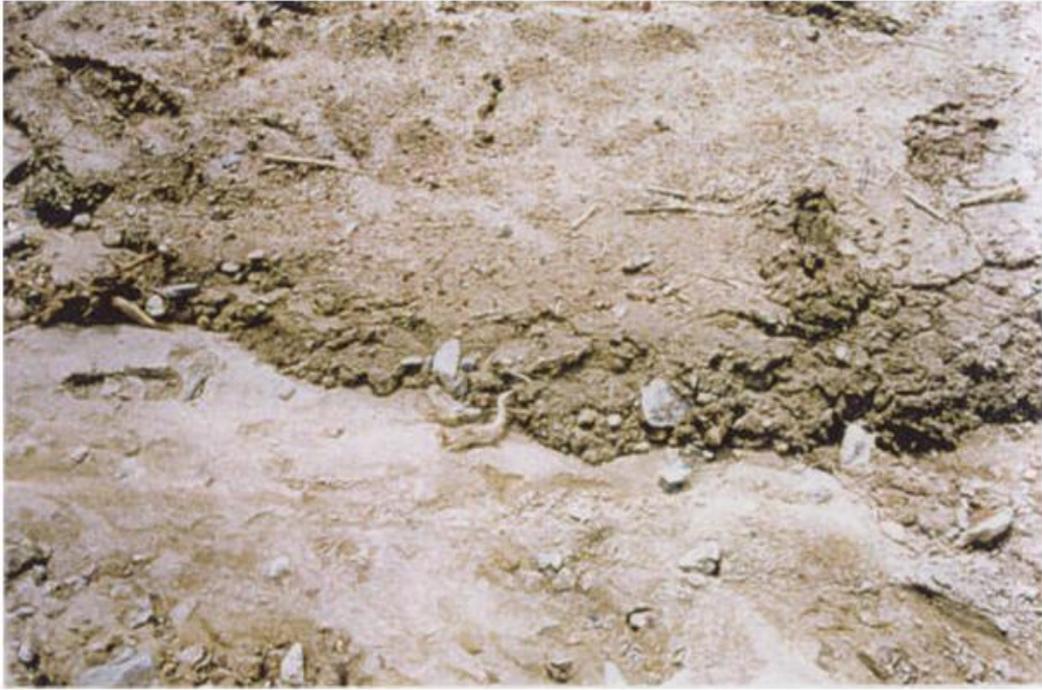
TP 134B-27

Plate 75 - Washed Area from above

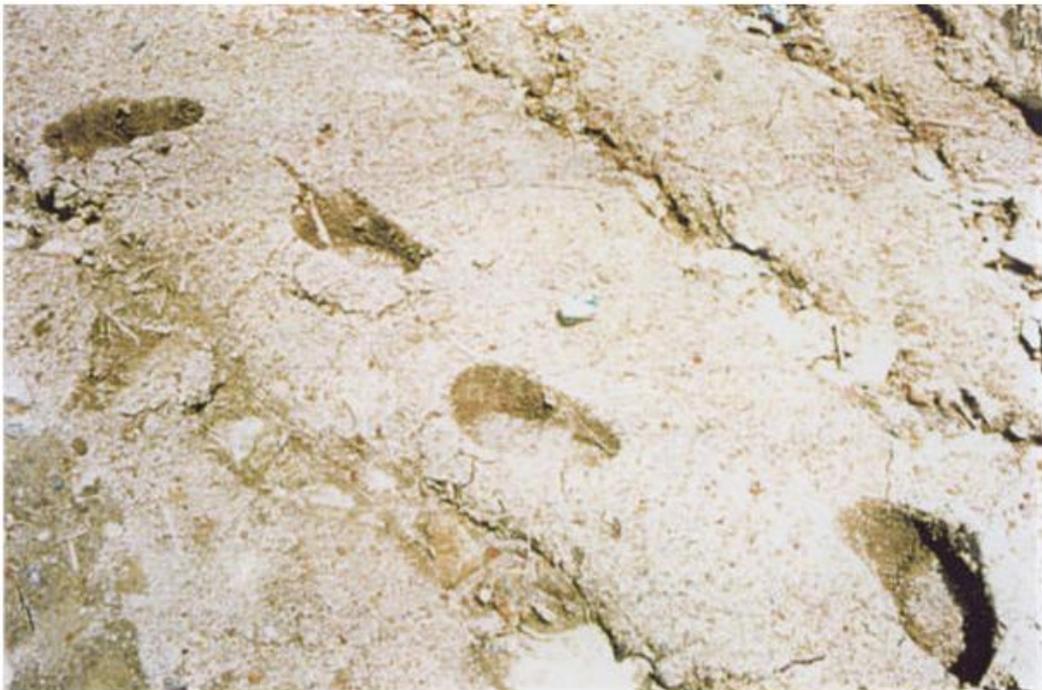
TP 134B-33

Plate 76 - Contact between Mobile Remoulded Debris and the Washed Area

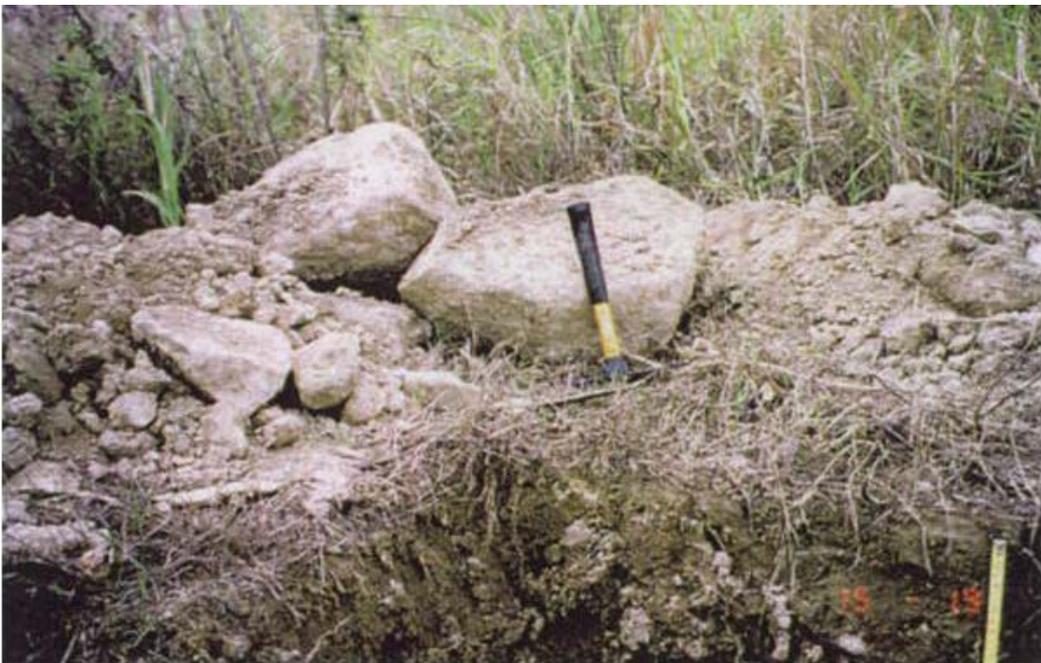
TP 134B-17

Plate 78 - Channel Eroded onto Matrix Rich Debris at Slope Toe. Note Linear Cracks Where Debris Has Slumped towards the Eroded Gully

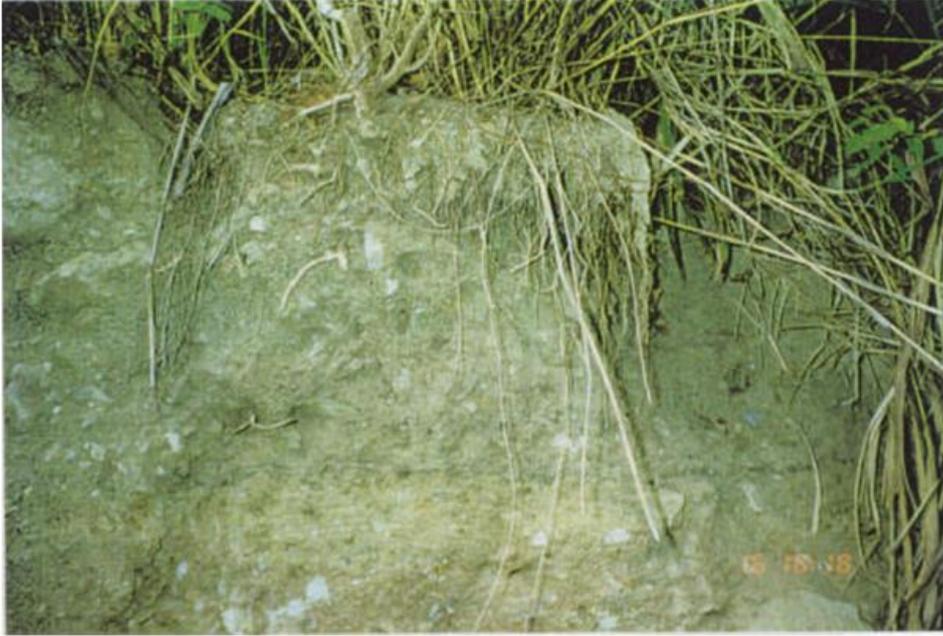
TP 173-33

Plate 79 - Small Boulders Removed from Class 1 Remoulded Debris in TP36 at the Distal Part of the Deposit (Ch 970)

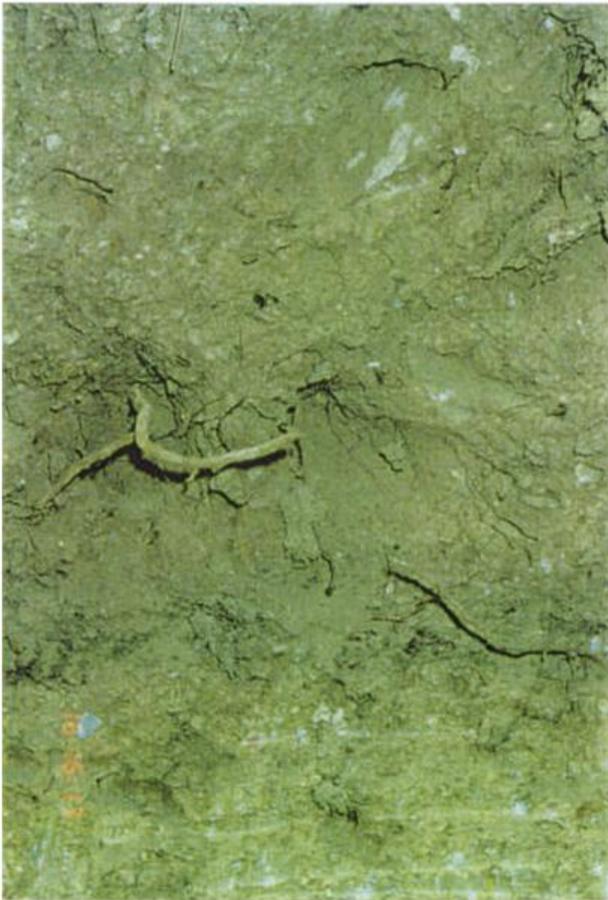
TP 166-4

Plate 80 - Debris Class 1 over Contact Type 1, at TP24
