# **TSING SHAN DEBRIS FLOW AND DEBRIS FLOOD**

**GEO REPORT No. 281**

This GEO Report consists of two Landslide Study Reports on the “Tsing Shan Debris Flow and Debris Flood” (LSR 2/2001) and “The 2000 Tsing Shan Debris Flow” (LSR 3/2001).

# **SECTION 1: THE 1990 TSING SHAN DEBRIS FLOW**

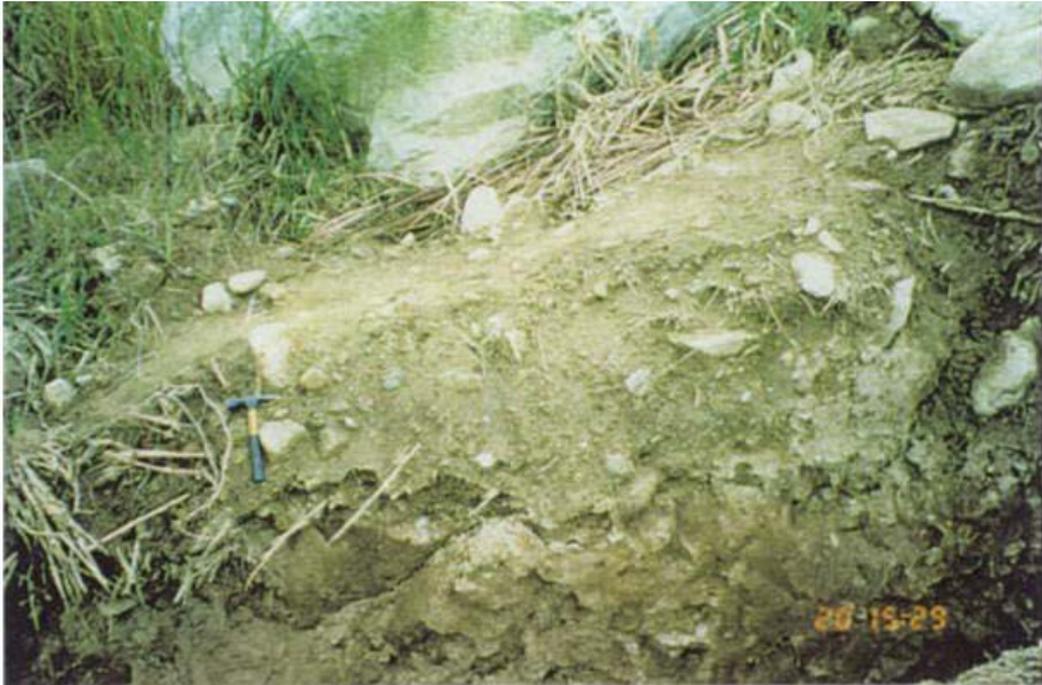
TP 166-3

Plate 81 - Close-up of Contact Type 1,  
at TP24

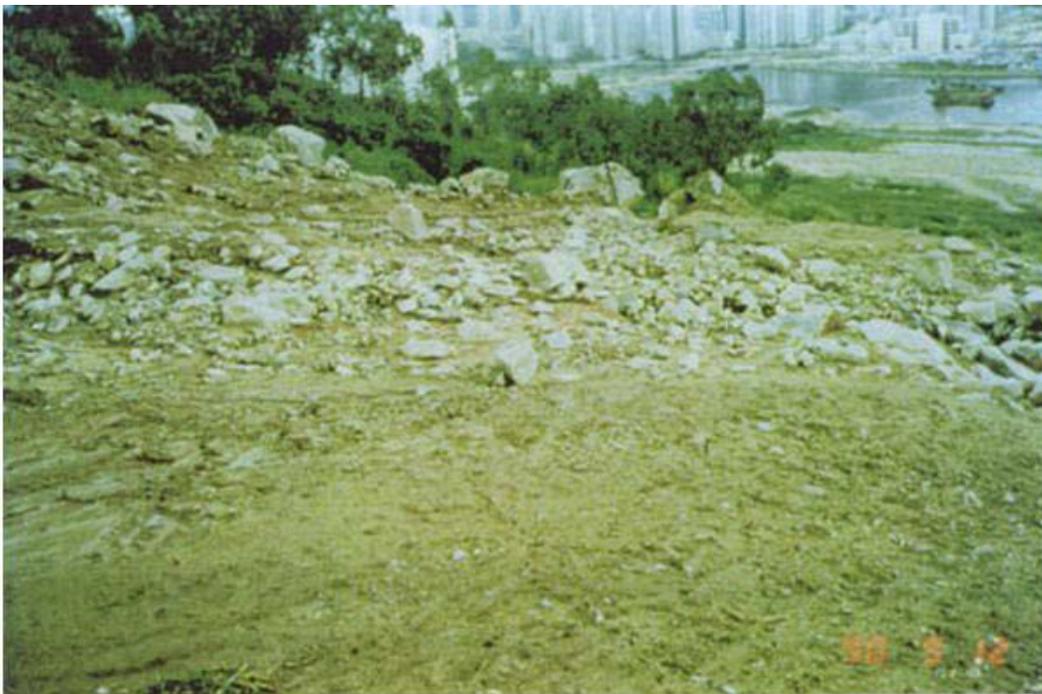
TP 189-1

Plate 82 - Debris Class 1 and Contact Type 3 at Trench 2 Ch 78

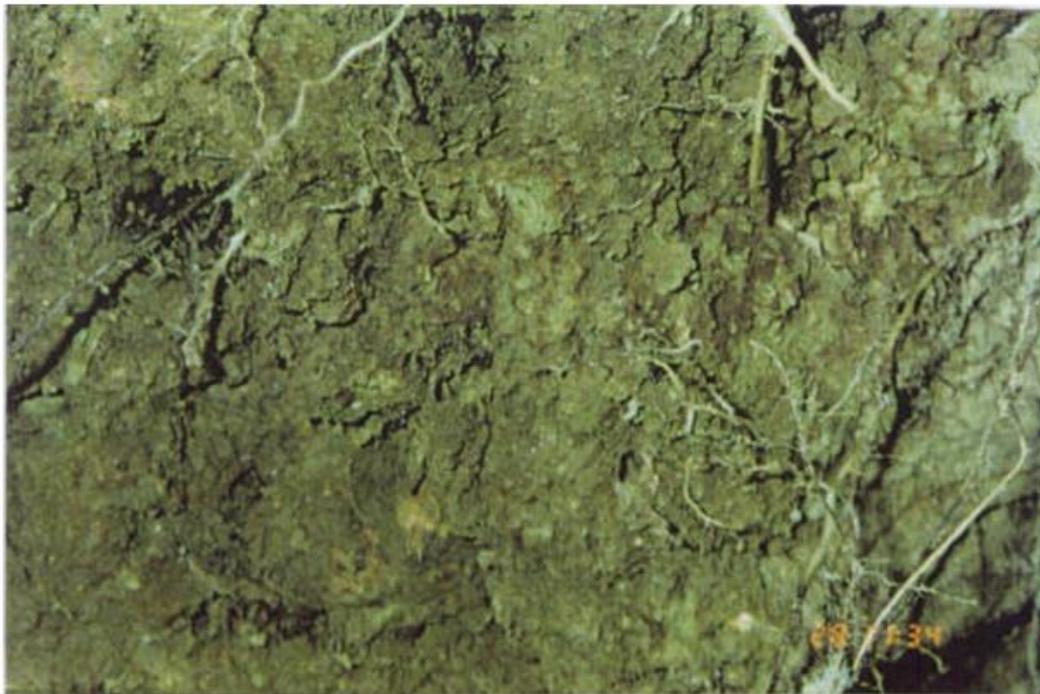
TP 179-13

Plate 84 - Debris Class 2 Overlying Orange Fill with Contact Type 2/3 at Trench 1 Ch 20

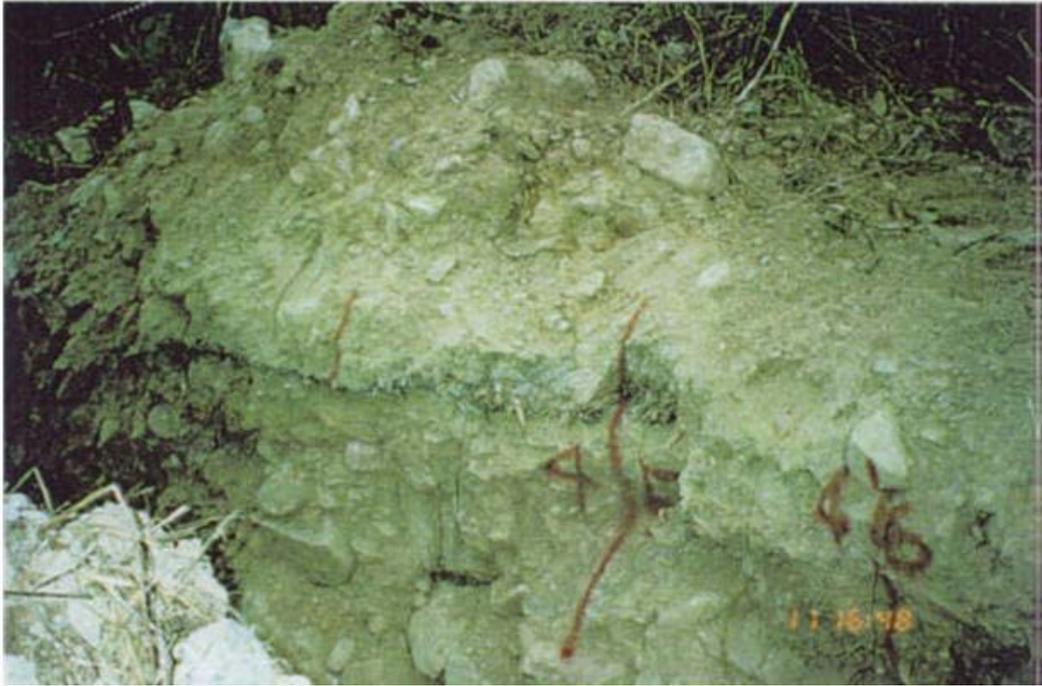
TP 190-14

Plate 85 - Debris Class 2, Close-up

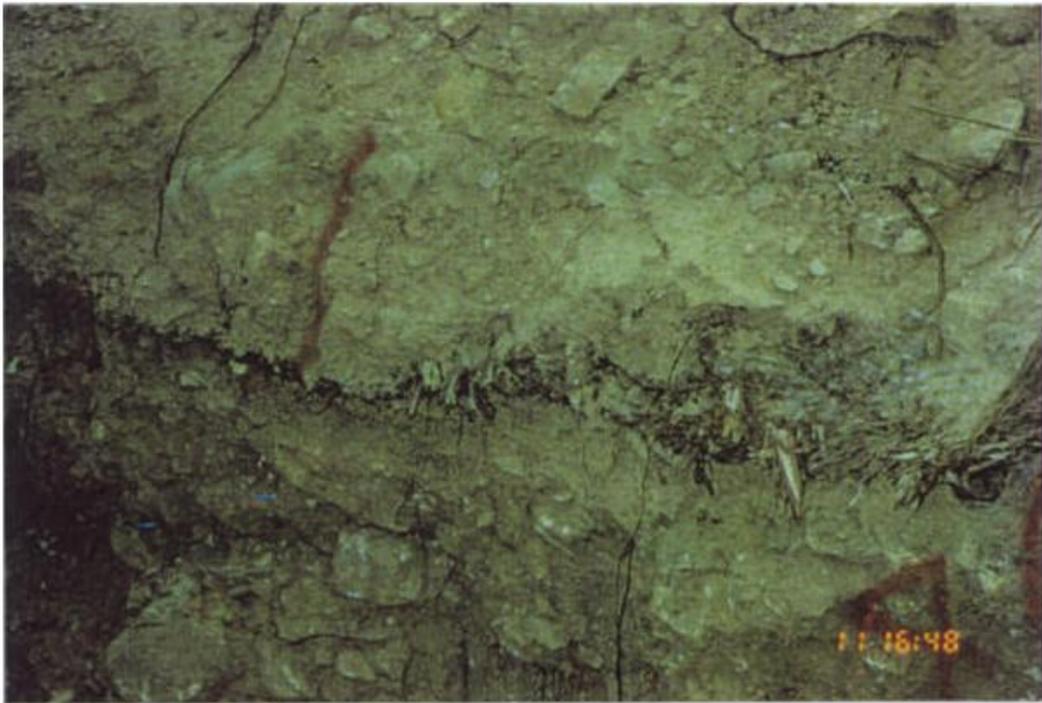
TP 181-9

Plate 86 - Contact Type 1. Class 2 Debris Overlying Fill at Trench 2 Ch 43

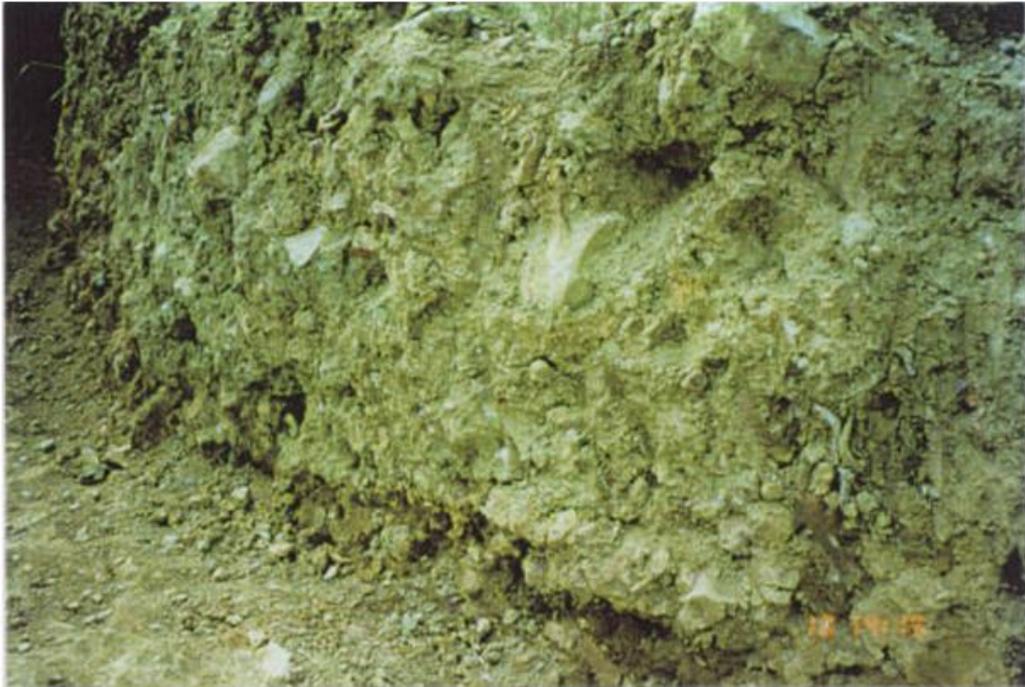
TP 181-10

Plate 87 - Close-up of Contact Type 1 at Trench 2 Ch 43

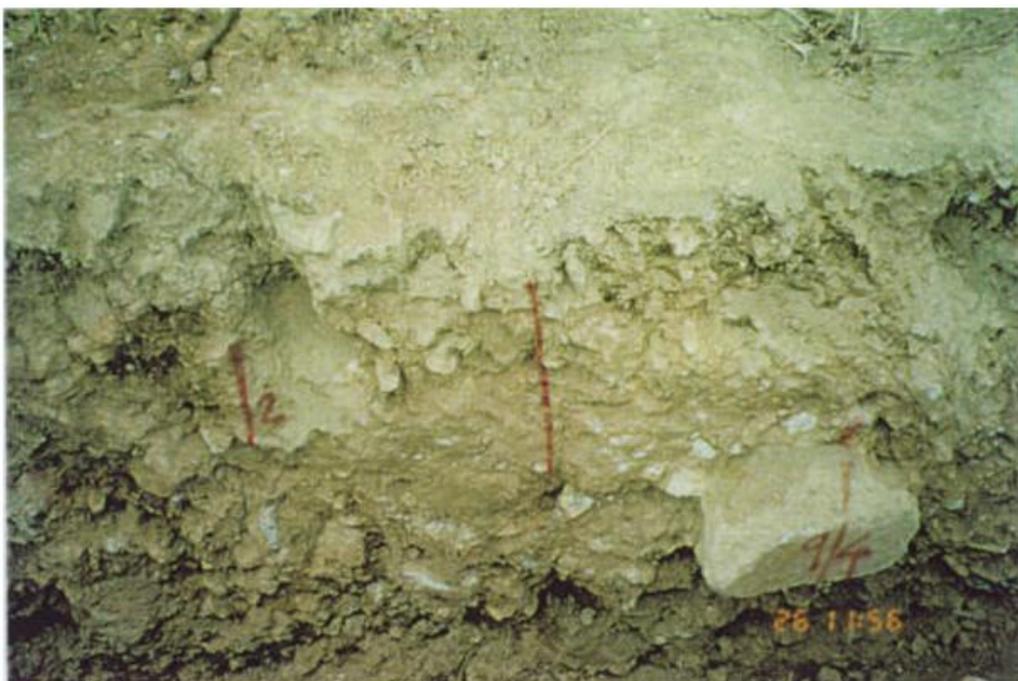
TP 186-21

Plate 89 - Close-up of Contact Type 2. Brown Moist Debris with Inclusion of Grey Fill at Trench 2 Ch 47

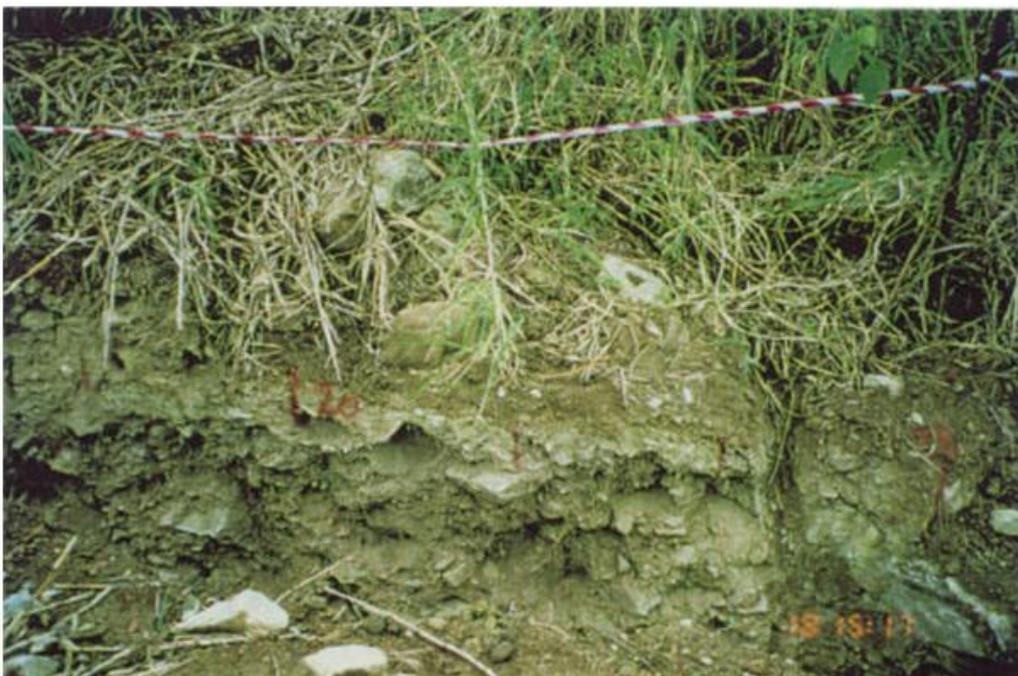
TP 189-19

Plate 90 - Contact Type 2. Boulder in Class 2 Debris Is Pushed into Clayey Fill at Trench 2 Ch 93

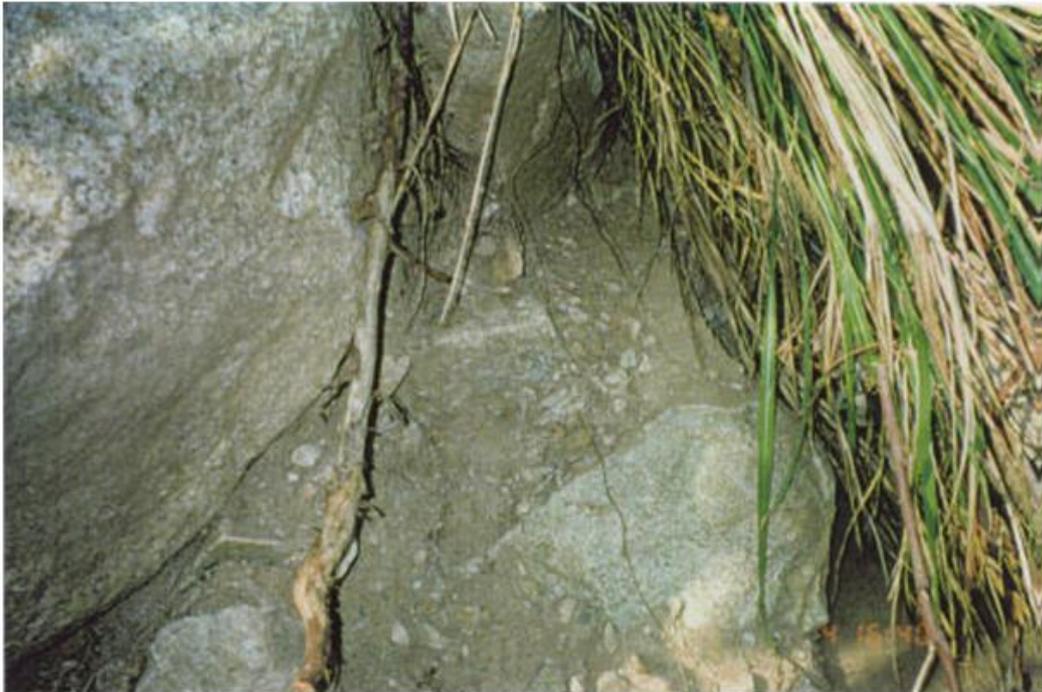
TP 186-11

Plate 91 - Contact Type 3. Class 2 Debris Is Darker Surface Layer over Fill at Trench 2 Ch 20

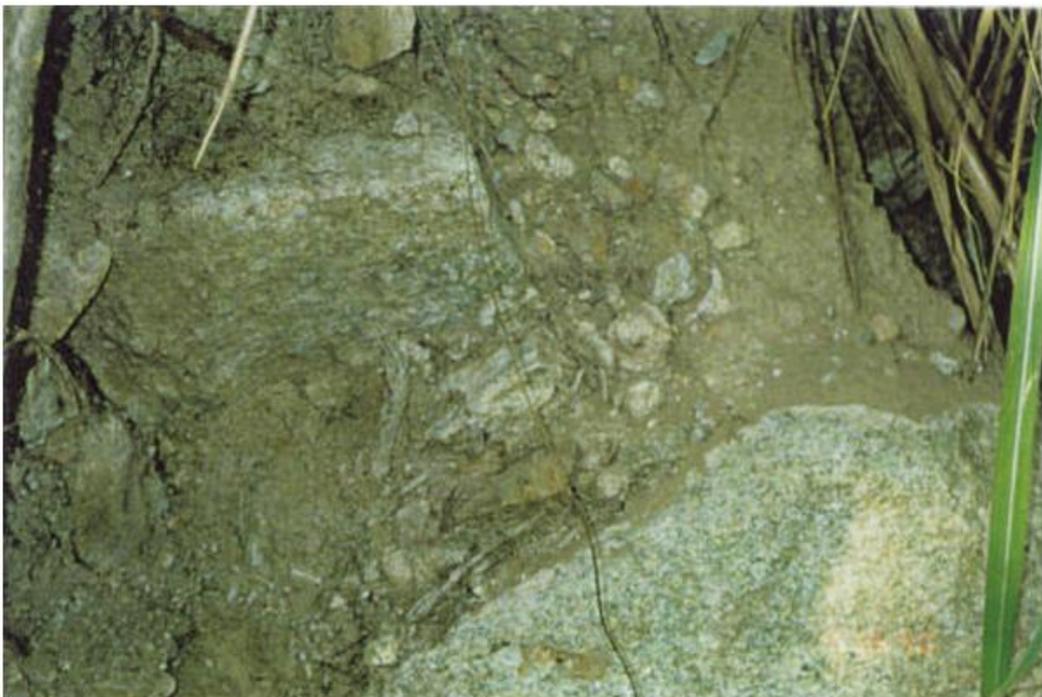
TP 190-4

Plate 92 - Class 3 Debris. Boulders with Subsidiary Matrix at Ch 600.  
Note Flow Aligned Vegetation Fragments

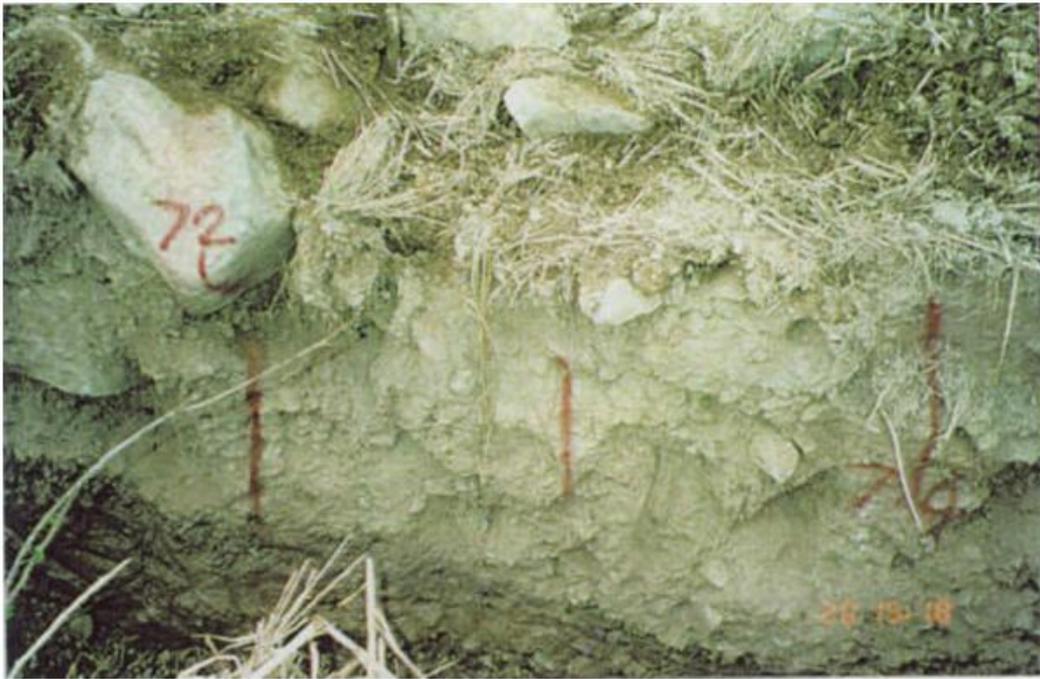
TP 190-5

Plate 93 - Close-up of Matrix at Ch 600

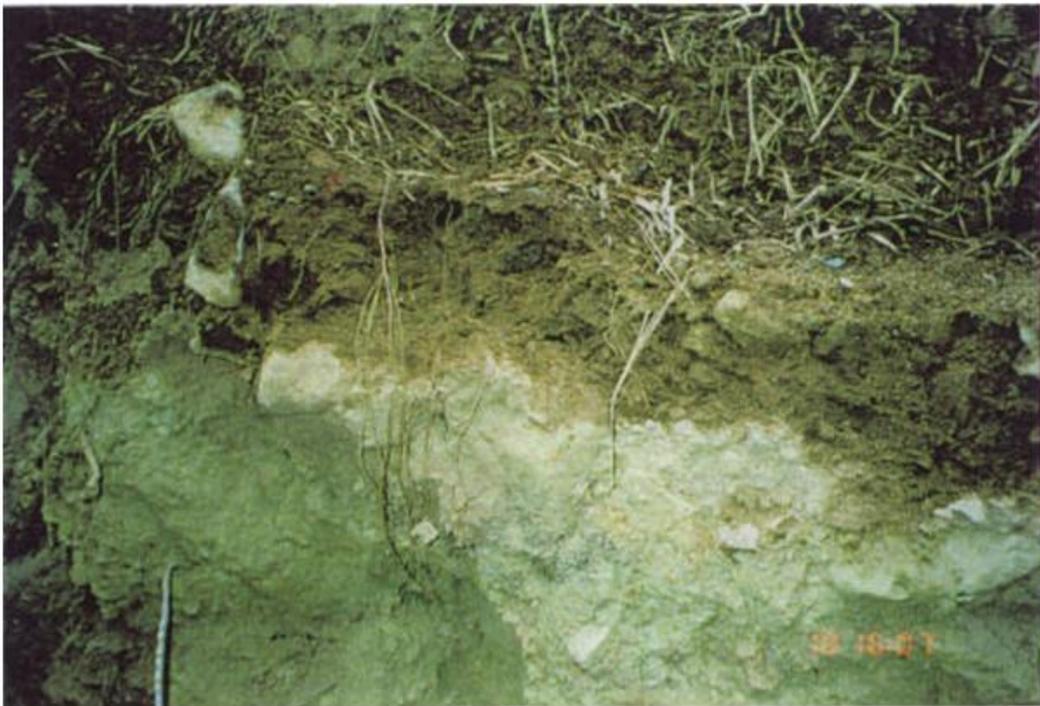
TP 187-23

Plate 94 - Contact Type 3. Grey Class 2 Debris over Brown Insitu Soil at Trench 2 Ch 73

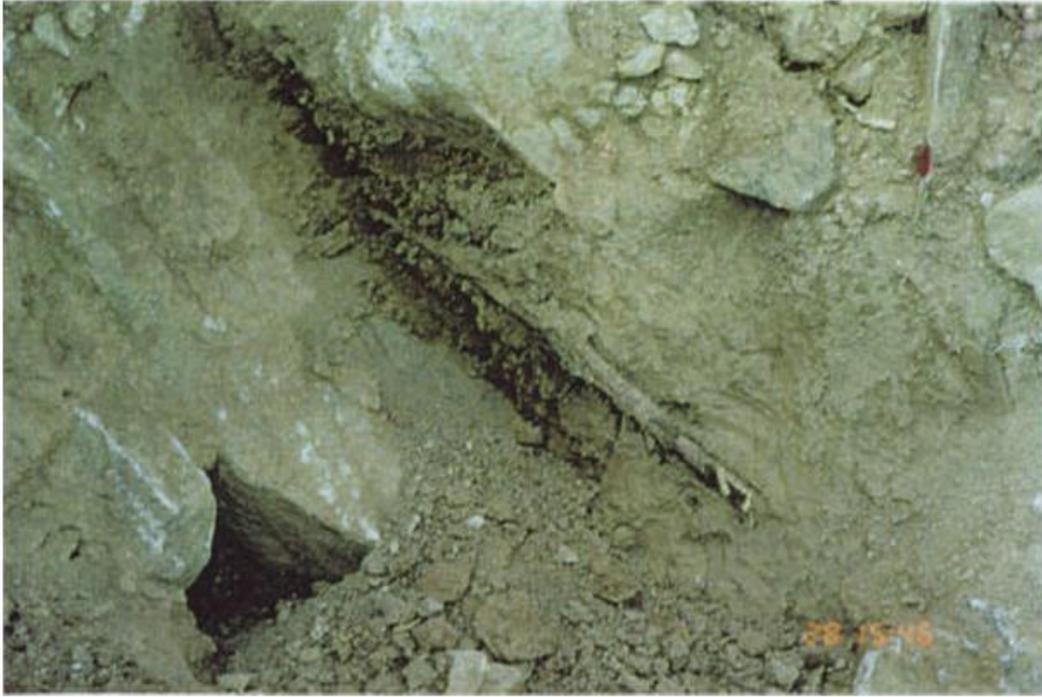
TP 184-3

Plate 95 - White Class 4 Debris Overlain by Brown Sandy Sorted (Alluvial) Debris with Type 3 Contact over Grey Insitu Material at Trench 2 Ch 33

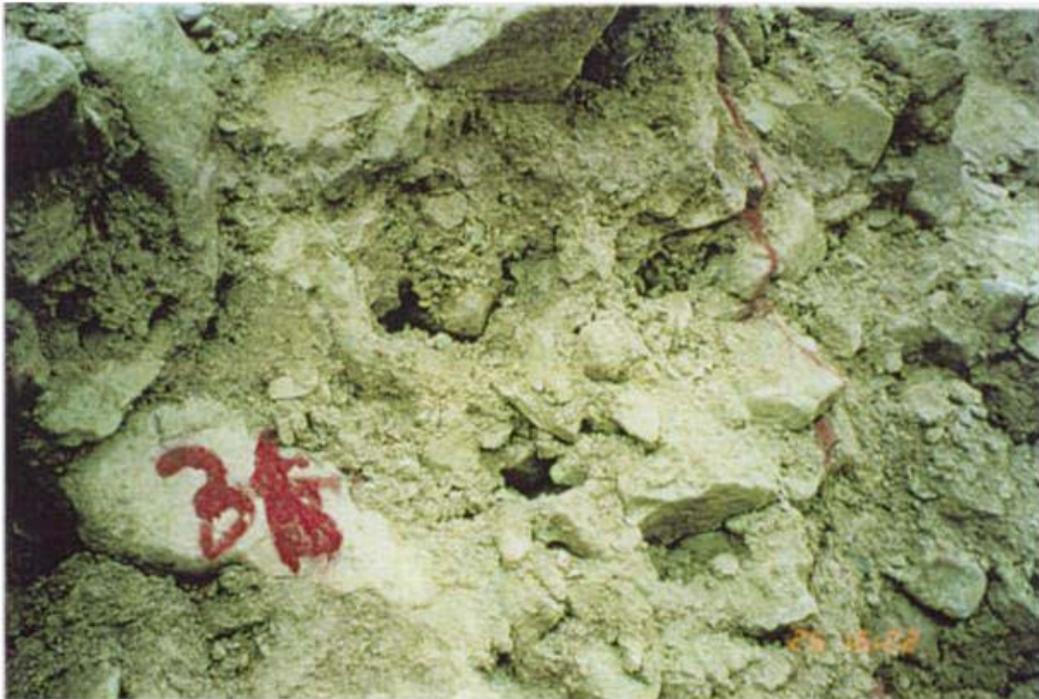
TP 190-22

Plate 96 - Voids and Vegetation in Class 2 Debris. Trench 1 Ch 78

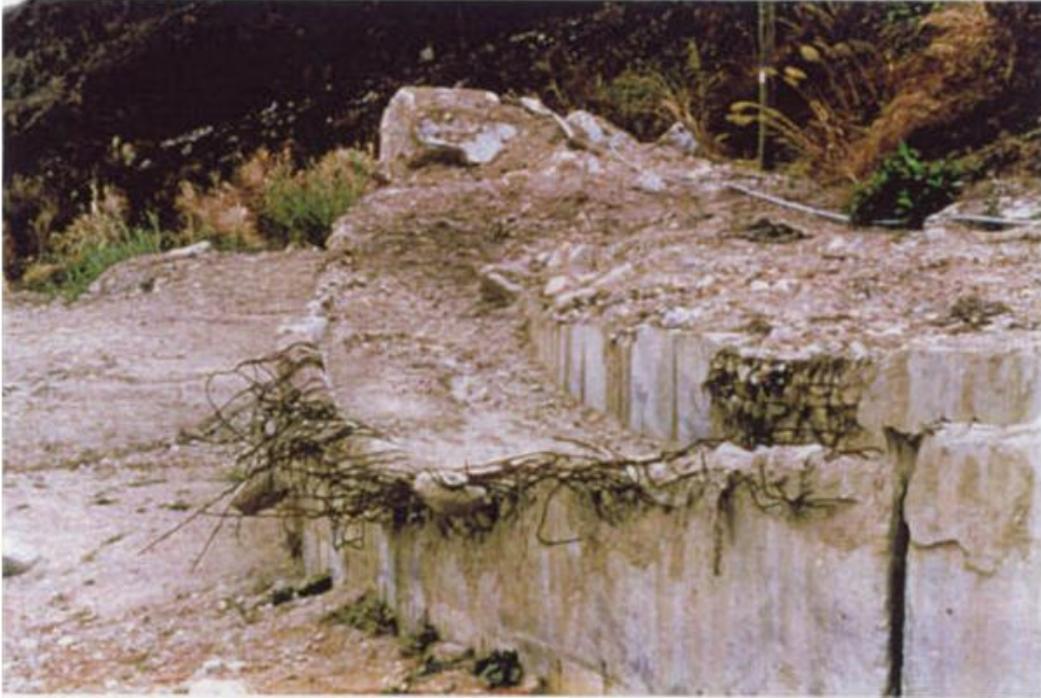
TP 190-9

Plate 97 - Pipes and Loose Texture in Channel Colluvium

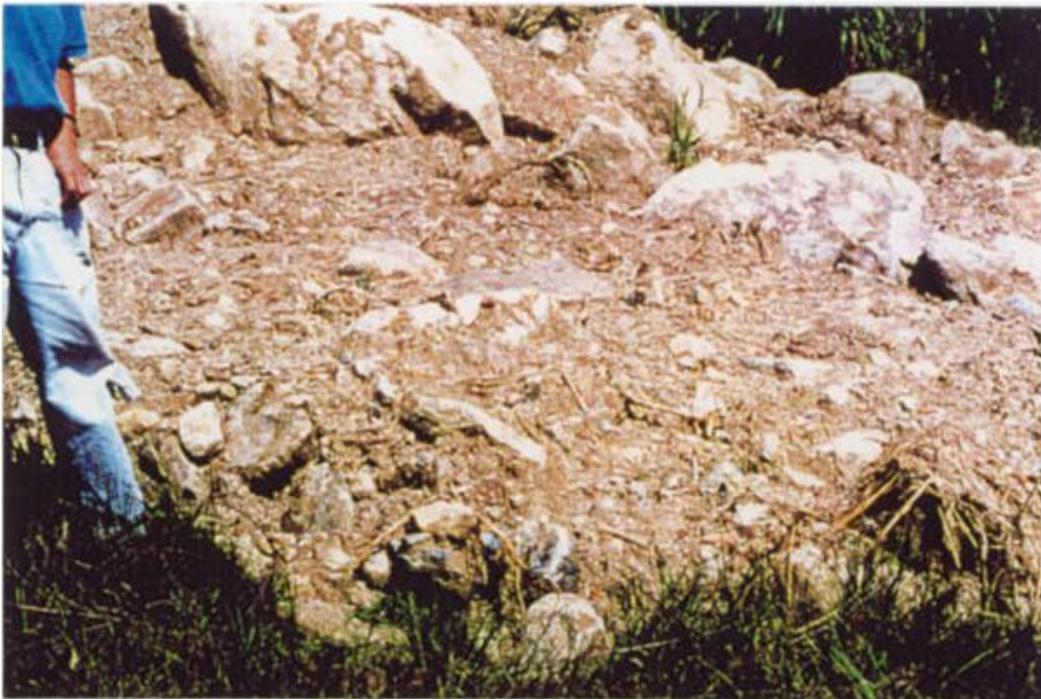
TP 308-24

The following characteristics of the remoulded debris deposits indicate deposition from a flowing material. Sheets of remoulded debris have a relatively smooth surface (Plates 56, 72 & 83) and in the concrete diversion channel this is level with the top of the channel (Plate 98). Remoulded debris deposits are built up on the upslope side of obstructions and form a trail on the downslope side (Plate 43). Thin deposits of remoulded debris occur on and below boulders (Plates 72 & 73) and around the bases of bouldery Class 3 debris (Plate 68). Locally there is flow alignment of vegetation and clasts within the remoulded debris (Plates 92 & 93). The debris deposits commonly have a lobate steep sided outline both in the gross morphology of the scar (Plates 13 to 15 & 70) and of small areas within it (Plates 76 & 99). The relatively uniform thickness of the debris in the primary lobes and on the cut slope (Drawings GEO/P/PTE/2 & GEO/P/PTE/3). The extensive presence of undisturbed vegetation below remoulded debris in the deposition area (Type 1 contact, Section 6.2.3, Plate 65).

Plate 98 - Remoulded Debris Surface Level with Lip of Diversion Channel

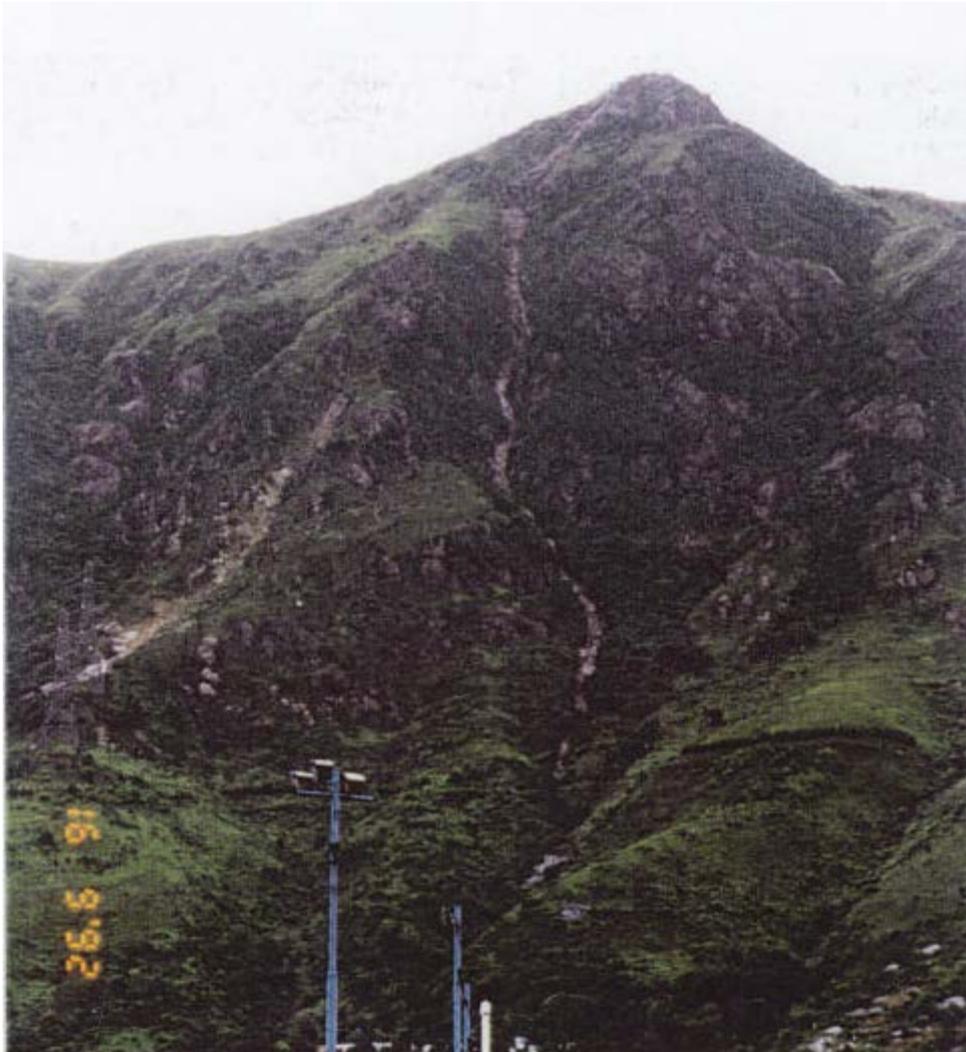
TP 140-2

Frontispiece. The 1992 Debris Flood trail on Tsing Shan.

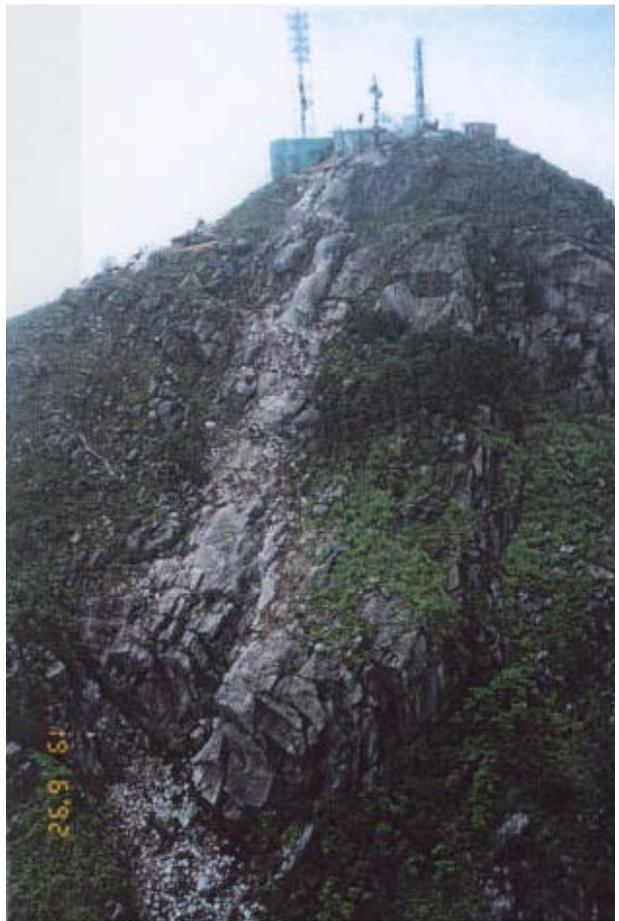
PS 716-11

Plate 1 - Summit and Rubbish Trail  
Ch -80 to Ch -10

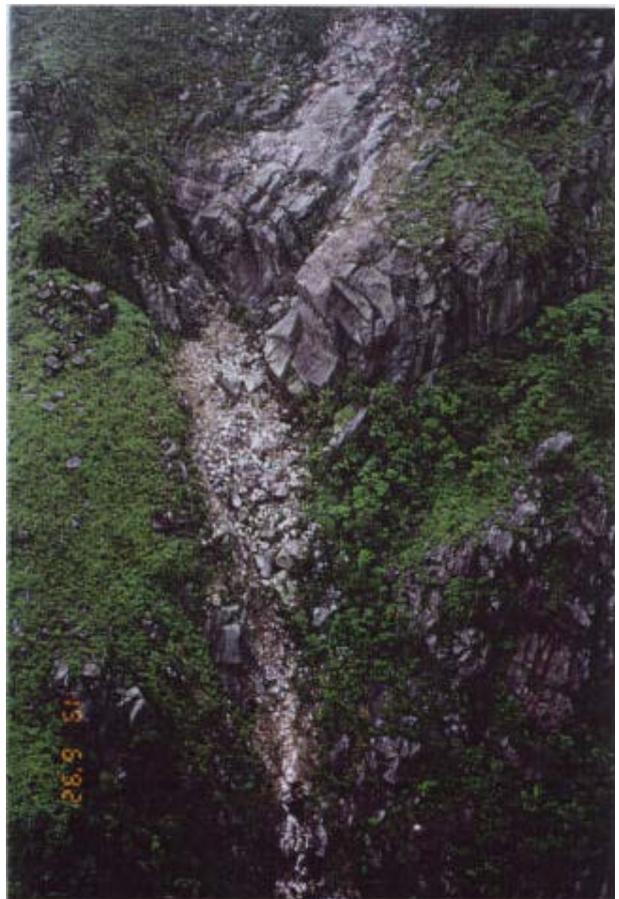
PS 716-12

Plate 2 - Rubbish Filled Depression  
Ch -50 to Ch 10

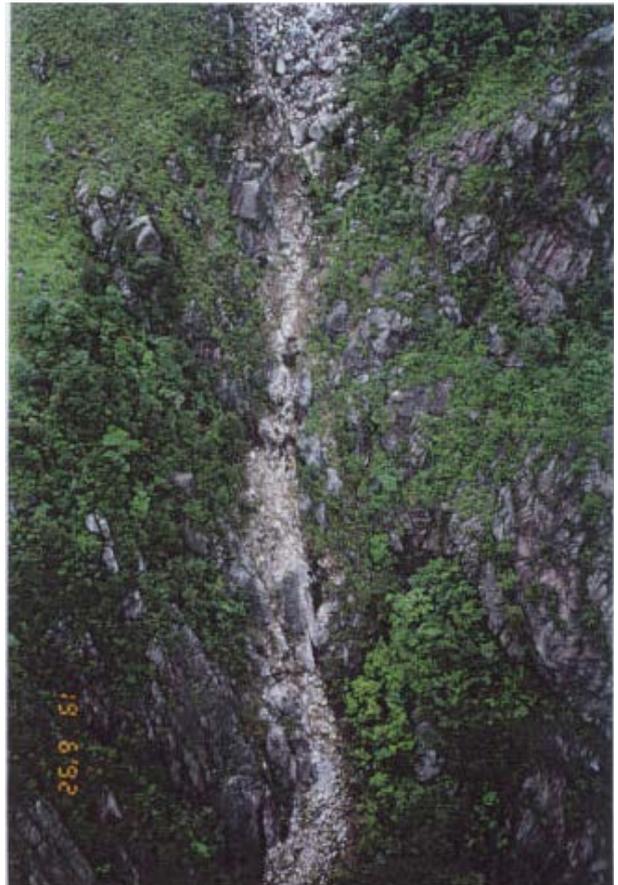
PS 716-13

Plate 3 - Scarp at Head of Trail Ch -20 to  
Ch 50

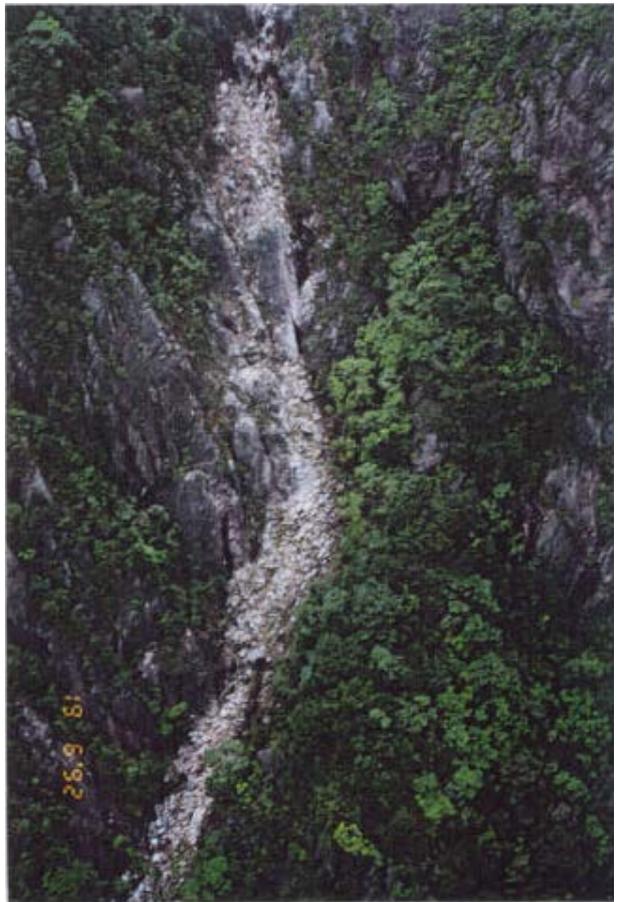
PS 716-14

Plate 4 - Rocky Gully Ch 0 to Ch 70

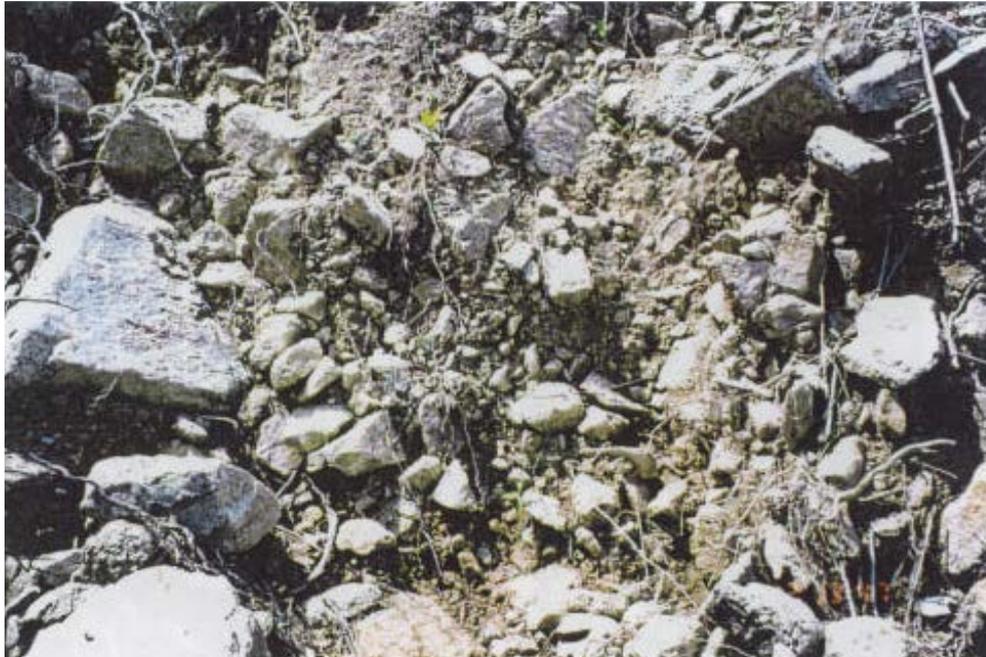
TP 145-10

Plate 14 - Scarp at Start of Debris Flood Trail, Ch 0

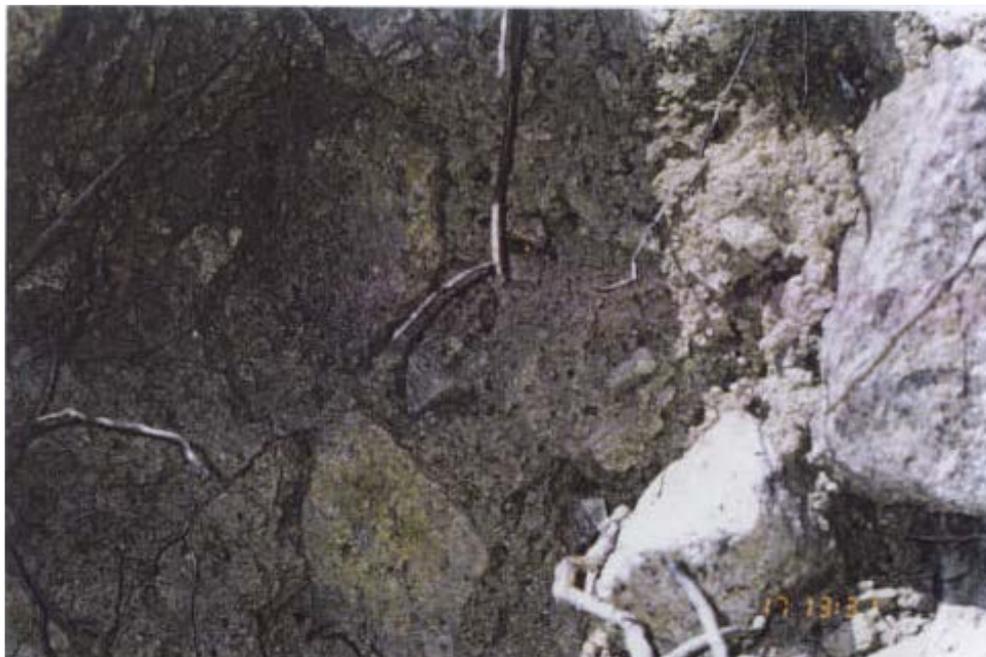
TP 145-5

Plate 15 - Colluvium Exposed in Scarp (Samples M36, M25A), Ch 0

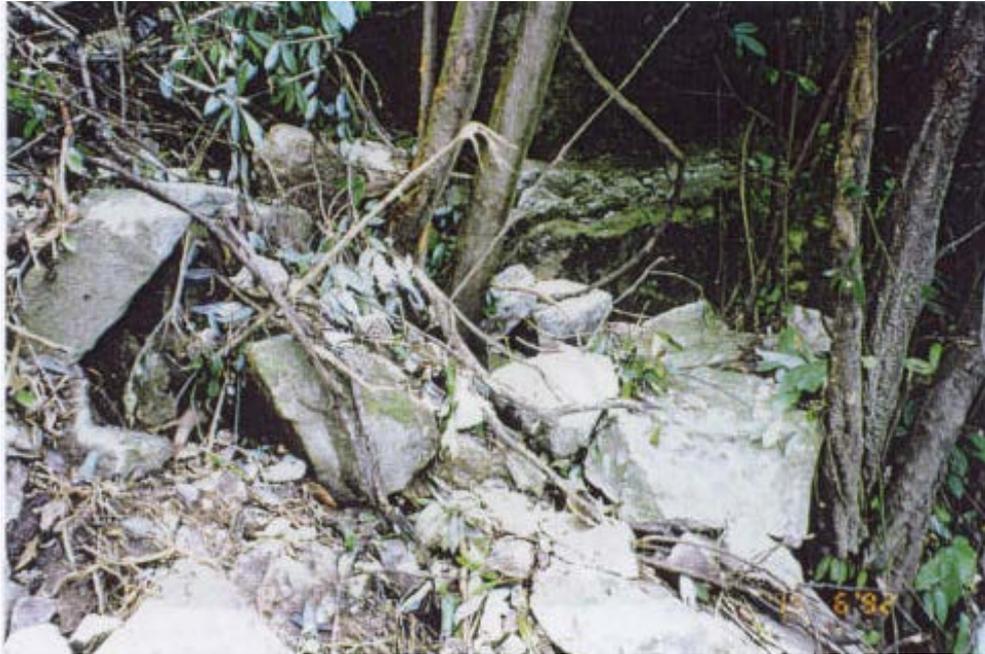
TP 199-34

Plate 16 - Close-up of Colluvium in Scarp Showing Soil Pipes

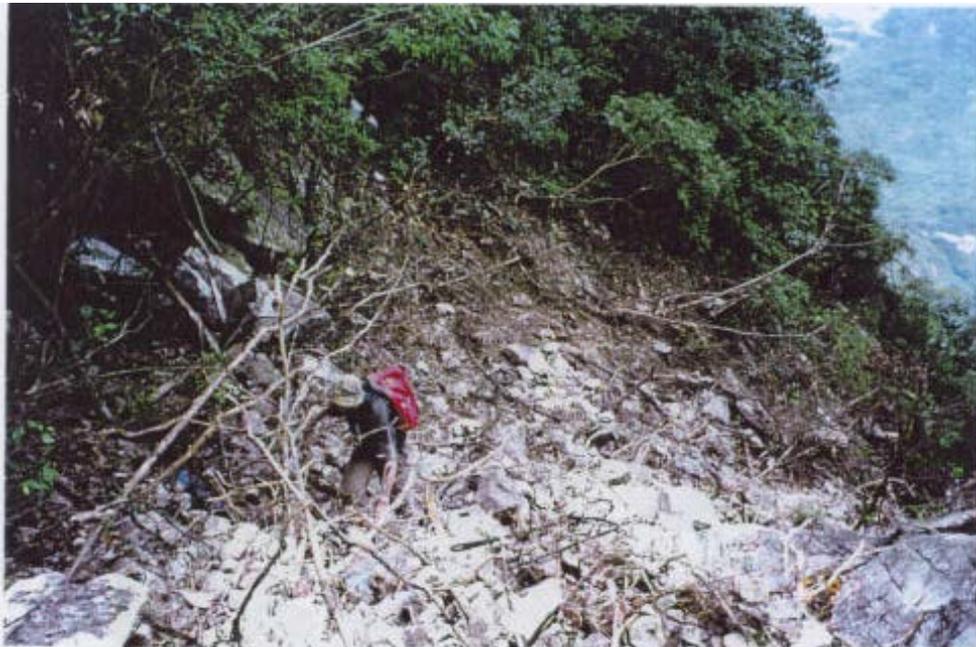
TP 135-22

Plate 17 - Boulders Caught in Vegetation at Side of Trail, Ch 45

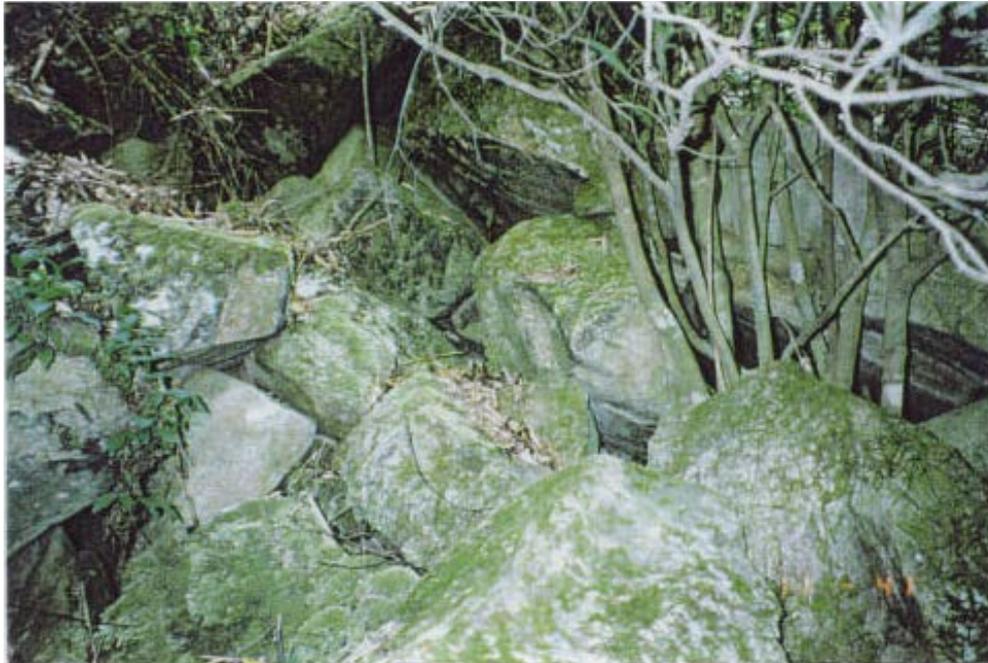
TP 137-6

Plate 20 - Rocky Gully, Ch 70

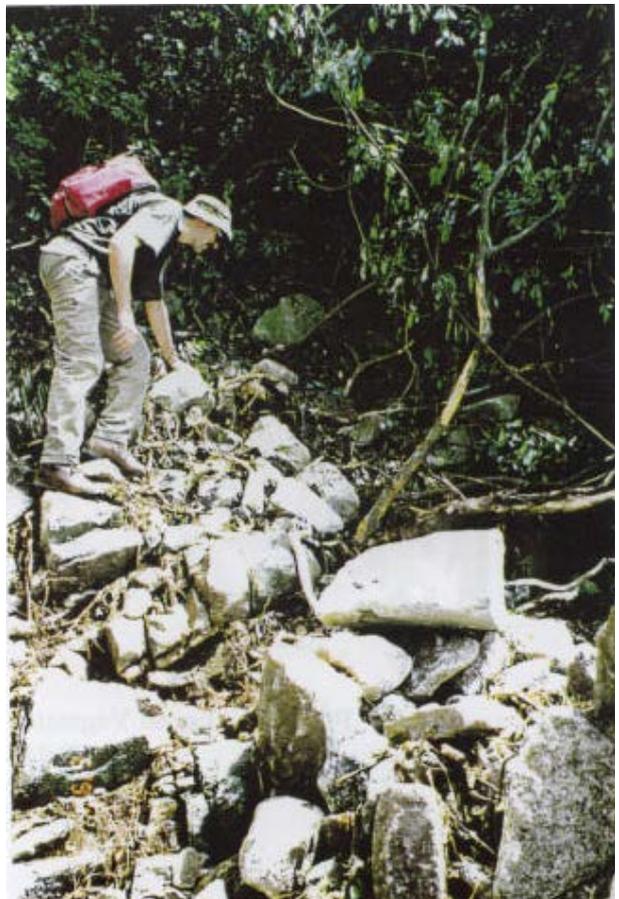
TP 136-8

Plate 30 - Loose Boulders beside the Trail, Ch 260

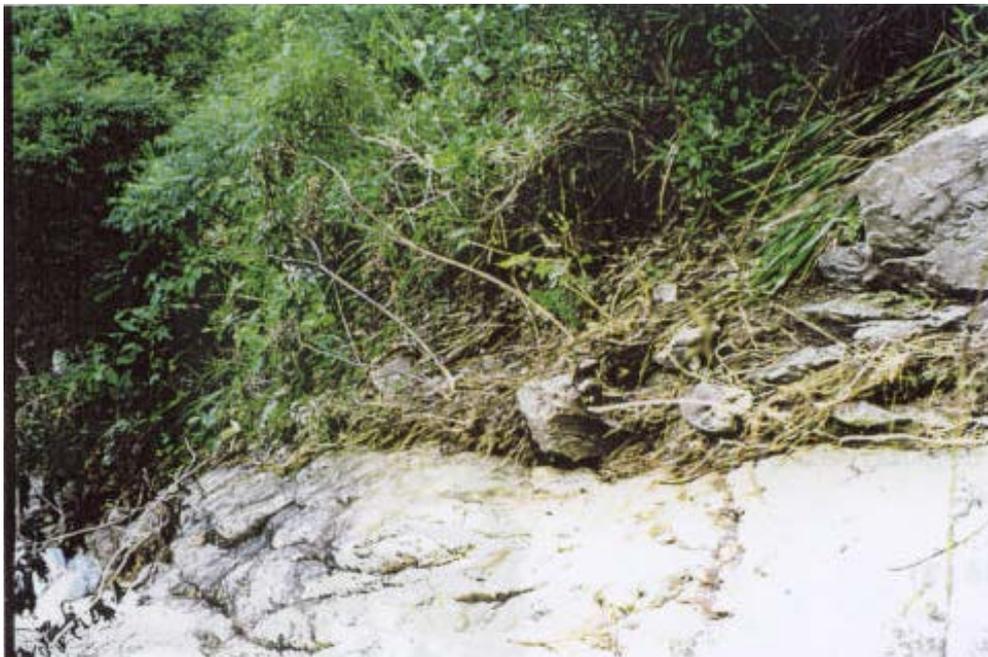
TP 138-22

Plate 31 - Boulder Levee, Ch 270

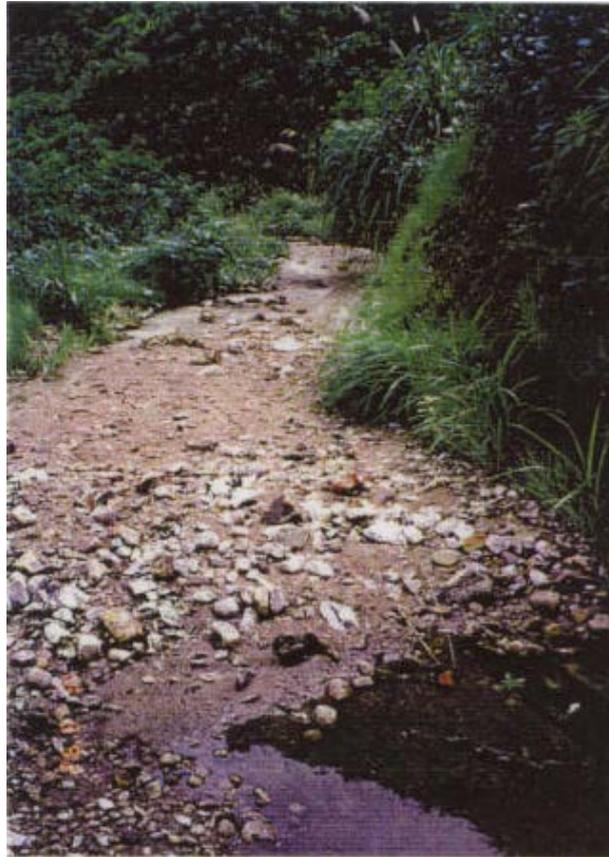
TP 140-10

Plate 33 - Debris Fan on Footpath (Sample DFM4), Ch 360

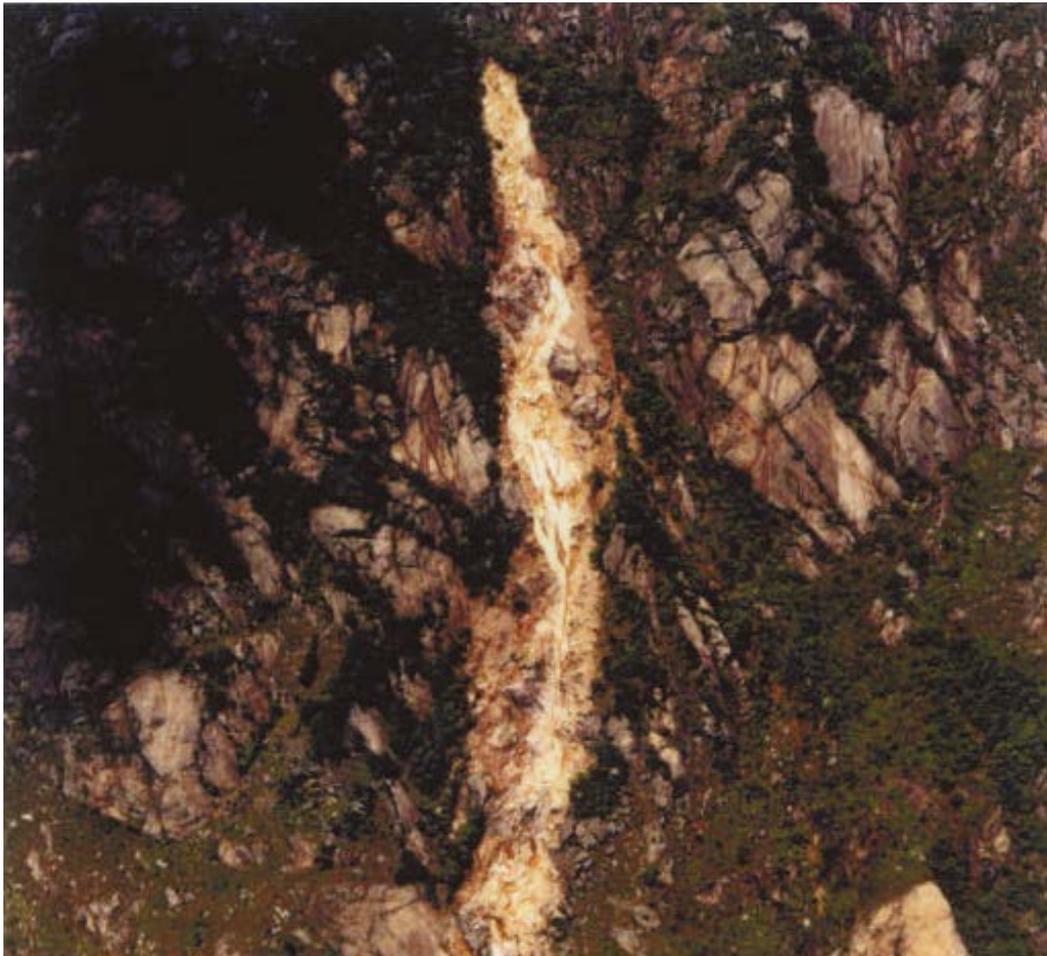
PS 1112/10

The crown of the scar is located at 360 mPD, in a vegetated area of angular colluvial boulders that slopes at about 40° between steeper rock outcrops (Plate 1). The colluvial deposit is clast supported, with about equal proportions boulders and cobbles and up to 15% silty sand with gravel. From Ch 0 to Ch 20, the scar forms the source area of a 150 m<sup>3</sup> debris avalanche (Plates 10 & 11). This area is near the ridgeline where the drainage pattern between the outcrops is indistinct. However, it appears to be located at the narrow outlet of a 6,400 m<sup>2</sup> sub-catchment (Figure 2) where flow of surface water, and groundwater in the superficial deposits, converges. On 4 May 2000, groundwater was discharging from the lower part of the source area at an estimated flow rate of about 0.1 l/s. The source area merges downslope into an indistinct rocky gully where there is evidence of considerable erosion of colluvium and weathered granite but little deposition (Plates 12 to 16). At Ch 125 the remains of a large python (about 150 mm in diameter) were found. The snake appears to have been cut in half by the debris flow.

Plate 1 - The Source Area and Bedrock Gully, Ch 0 to 130

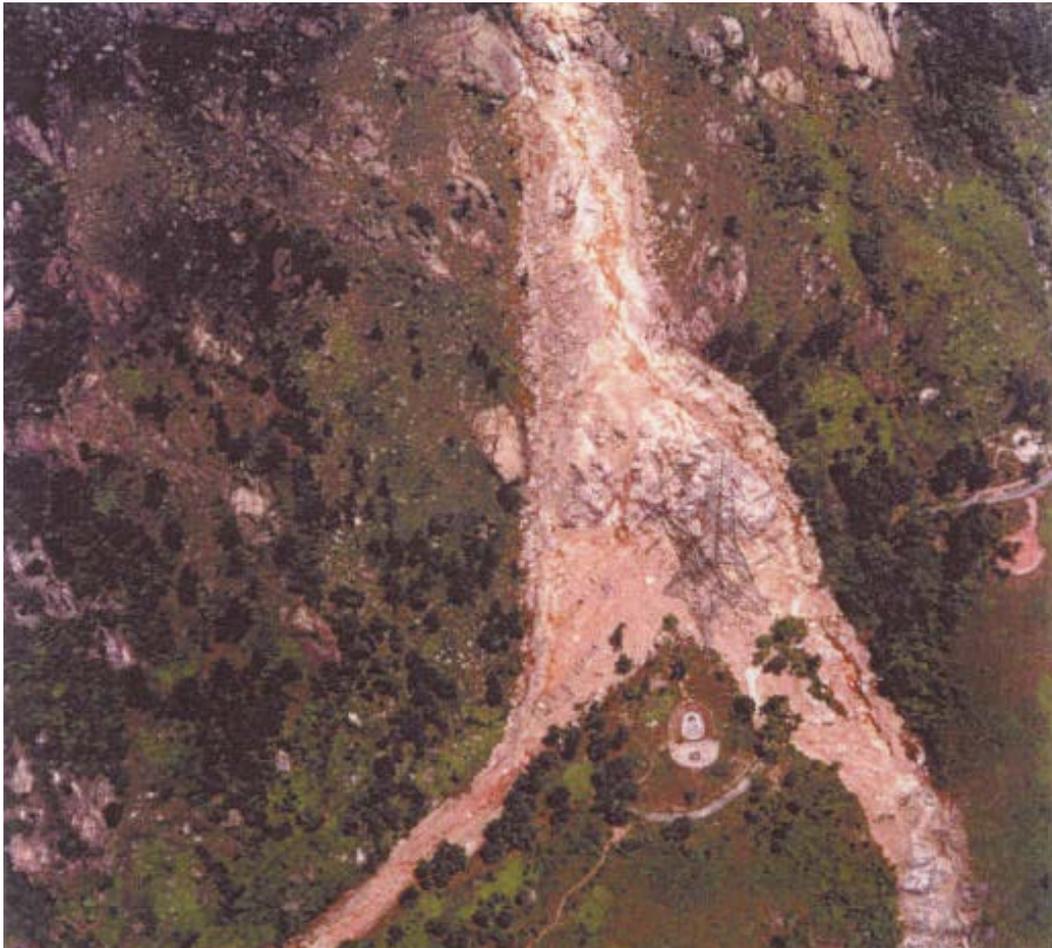
PS 1115/8

At Ch 135 (250 mPD), the gully ends at a planar to convex 30° slope of bouldery colluvial deposits that forms the upper part of a spur line descending to the China Light and Power (CLP) pylon at 180 mPD (Plate 2). The debris trail fanned out at this point with bouldery levees deposited along both sides of the scar (Plates 16 & 17) and erosion of colluvium and weathered granite in the area between them. Just upslope from the CLP pylon is a large rock outcrop. This outcrop deflected some of the debris down into the southern drainage line, but formed an obstruction above the northern drainage line and more than

Plate 2 - The Colluvial Slope, the Spur and Pylon, Ch 130 to 320
