# **TSING SHAN DEBRIS FLOW AND DEBRIS FLOOD**

**GEO REPORT No. 281**

This GEO Report consists of two Landslide Study Reports on the “Tsing Shan Debris Flow and Debris Flood” (LSR 2/2001) and “The 2000 Tsing Shan Debris Flow” (LSR 3/2001).

# **SECTION 1: THE 1990 TSING SHAN DEBRIS FLOW**

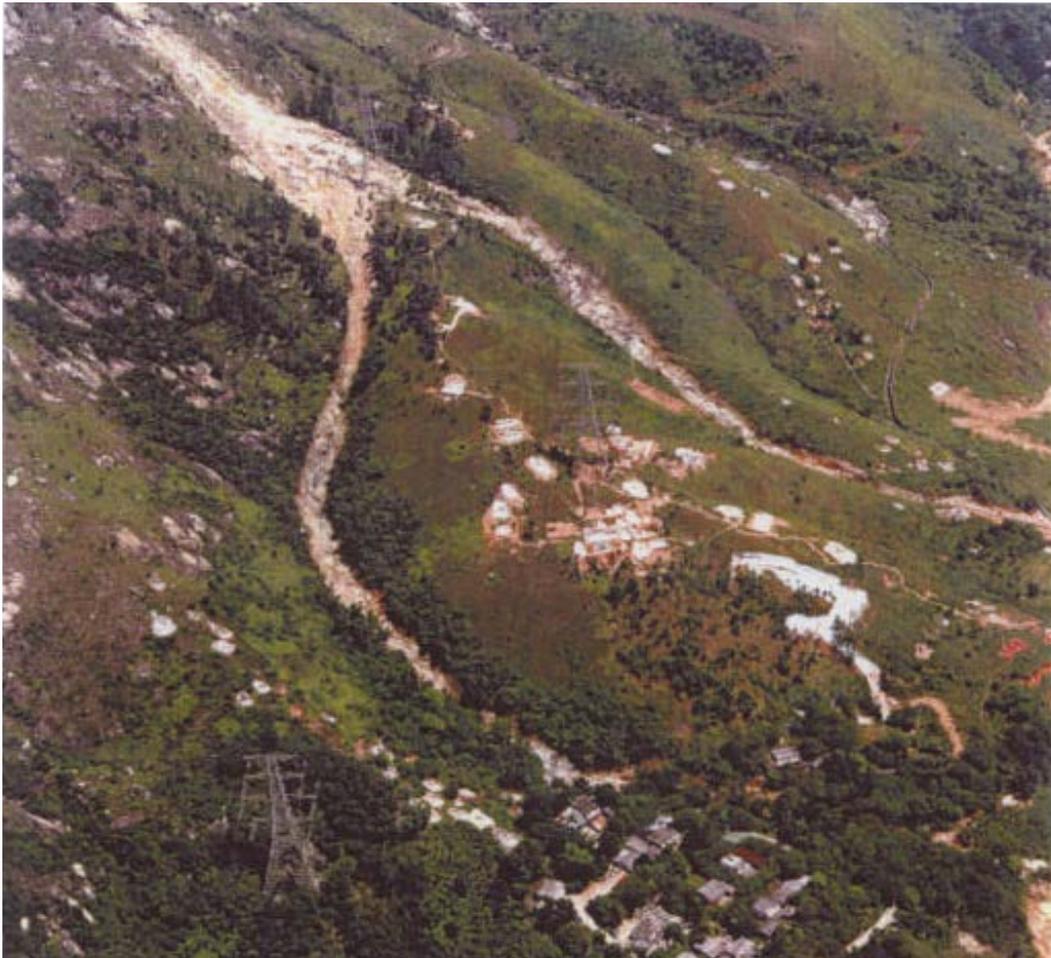
PS 1118/12

Plate 3 - Debris Avalanche Divided into Two Channelized Debris Flows at the Spur

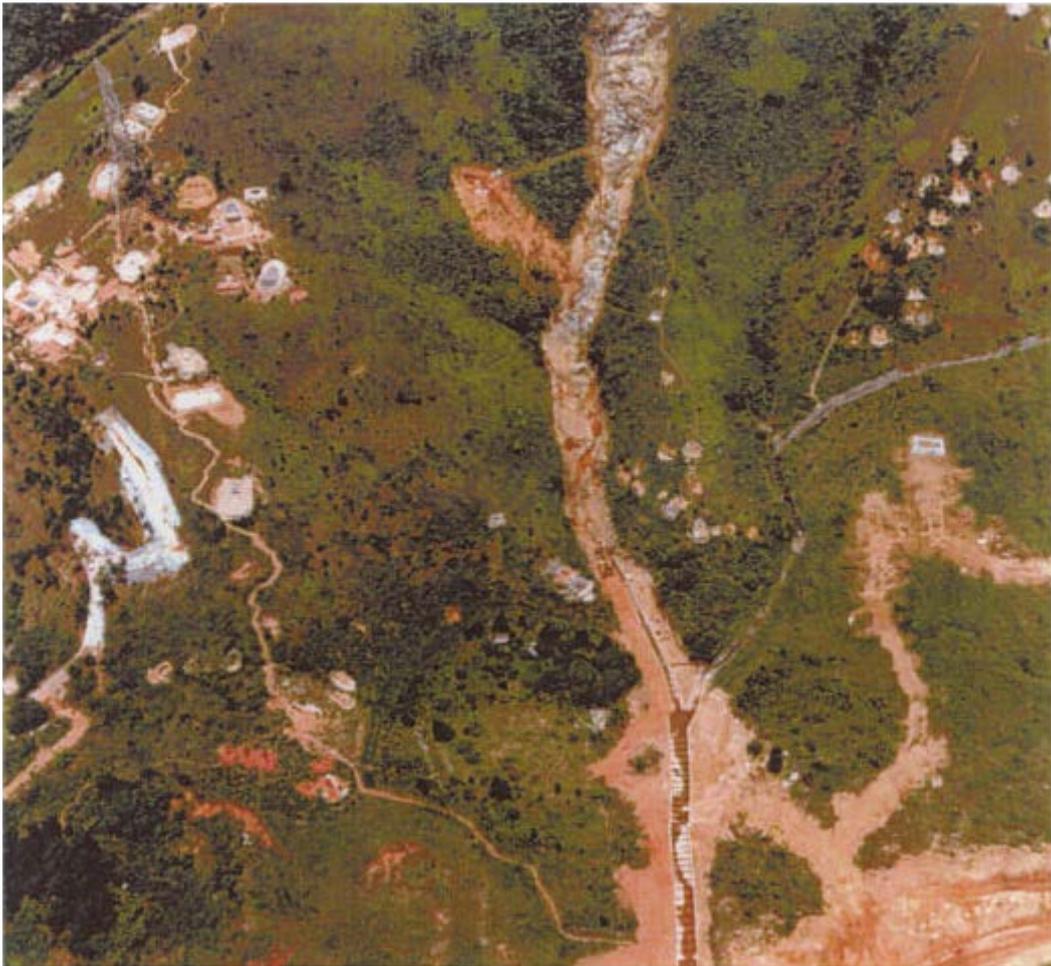
PS 1114/5

The northern drainage line is relatively straight and its upper parts slope at 50° (Figure 5) with bedrock exposed at Ch N315 and along the stream channel below it (Plate 4). Colluvial deposits are restricted to a thin ribbon in the lower parts from Ch N430 to Ch N480. The debris flow was mainly transportation in this part of the scar. Minor erosion of the weathered profile averaged 0.62 m<sup>3</sup> per linear metre. Super-elevations recorded at Ch N420 and Ch N460 both indicate a velocity of about 14 m/s (50 kph). Along the centreline of the trail at Ch N440 there is a 1 m deep eroded gully in the pre-existing colluvium and residual soil. This was probably eroded by floodwater after the main debris flow. From Ch N480 the natural drainage channel had been trained into a concrete cascade channel (1.5 m wide by 2 m high). Debris followed the cascade and overflowed both sides but was still channelized by the valley sides as far as the crest of the old Area 19 cut slope (Ch N525) where the cascade joins with another one and becomes larger (5 m wide by 2 m deep). Here about 100 m<sup>3</sup> of boulders (up to 2 m in diameter) with some finer materials were deposited on a 12° slope beside the cascade (Plate 20). Debris followed the wider cascade onto the Foothills Bypass construction site spilling onto the slope on both sides and overrode a small concrete bridge at Ch N600 (Plates 23 & 24). Some 10 m beyond the bridge, the concrete channel had been diverted 90° into a temporary trapezoidal channel (Plate 6) where the main deposition occurred (Plate 23). The diversion channel was blocked, the bridge deck was damaged (Plate 24), and about 200 m<sup>3</sup> of bouldery debris was deposited (Plate 25). Boulders at this location range from 2 m<sup>3</sup> to 15 m<sup>3</sup> in size. The travel angle from the crown of the scar to this point is about 27°.

Plate 4 - The Northern Channelized Debris Flow and Old Cut Slope, Ch N320 to N580

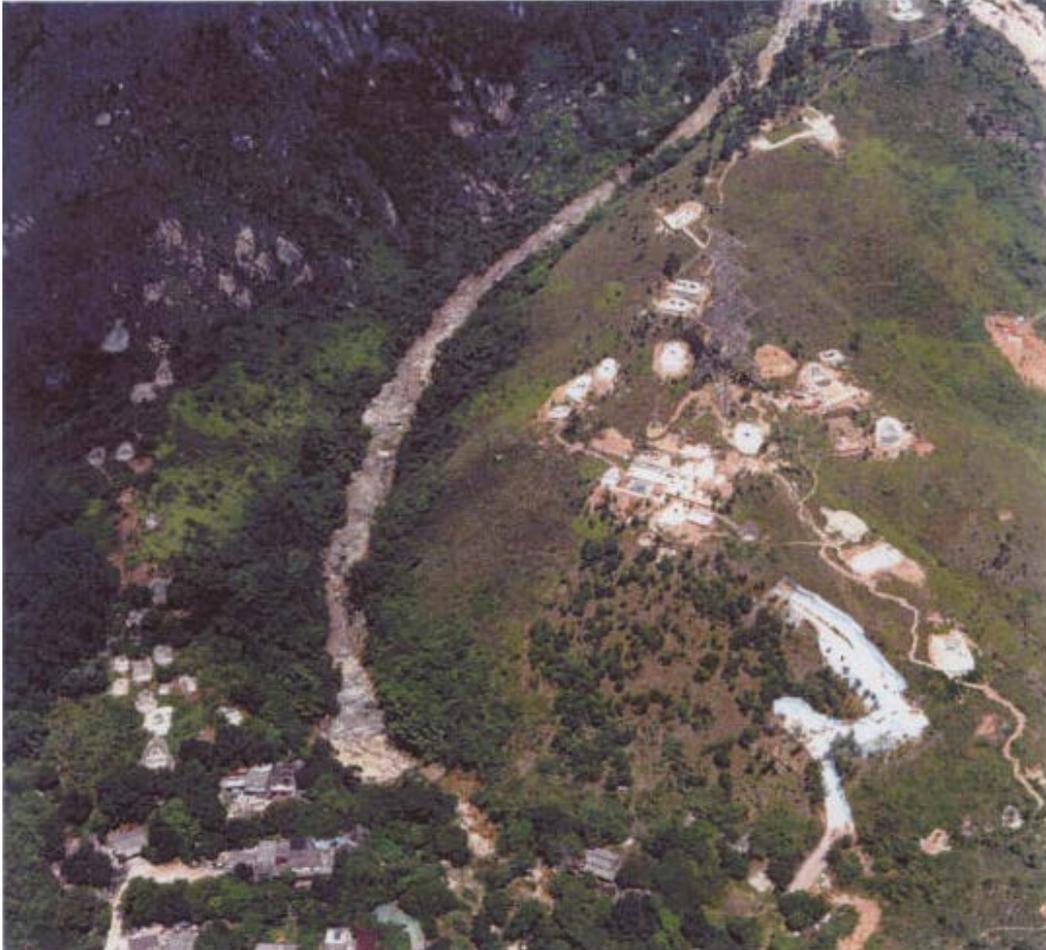
PS 1113/4

Plate 5 - The Southern Channelized Debris Flow and San Shek Wan San Tsuen,  
Ch S300 to S600

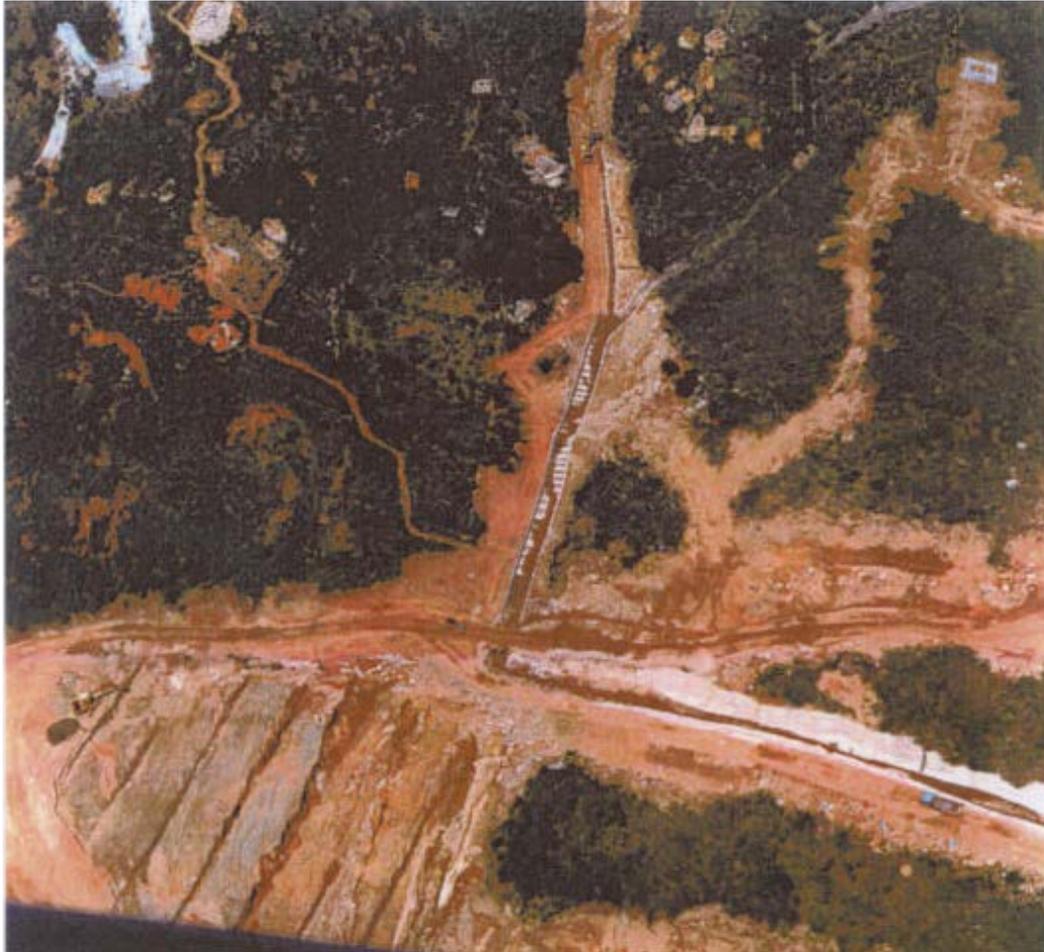
PS 1110/6

Plate 6 - The Main Deposition Area of the Northern Branch and Gully Erosion of the New Cut Slope at the Foothills Bypass Site, Ch N450 to N650 (20 April 2000 after Cleanup, Plate 8 Shows Area on 17 April)

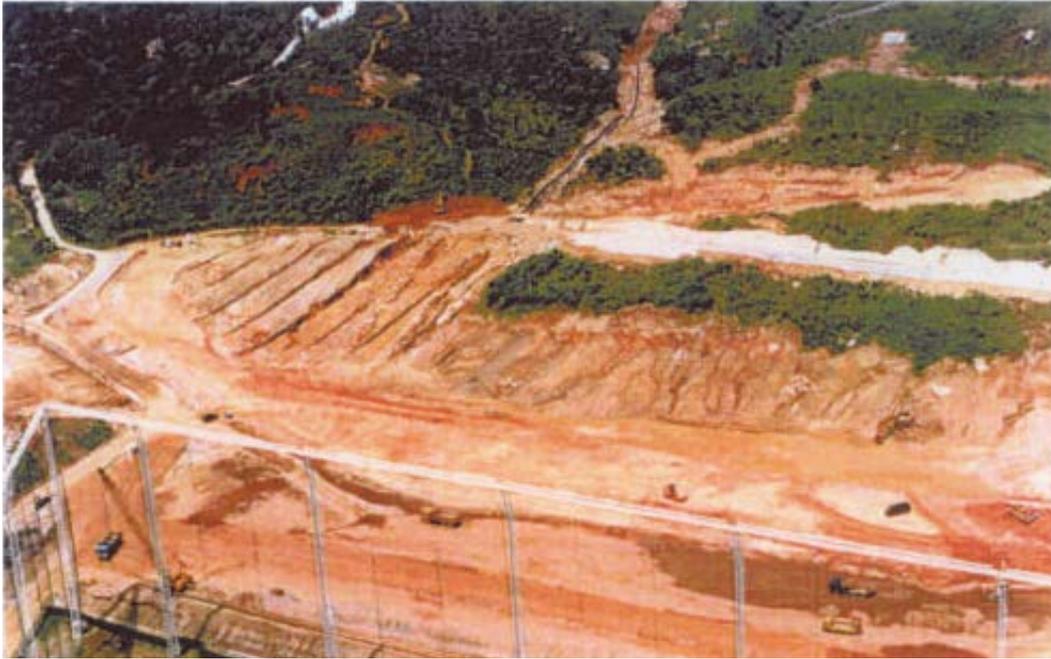
TE 2000/016/11

Due to the blocked channel, floodwater and a small amount of debris overflowed onto a newly formed cut slope and eroded sand from a 1 m thick drainage blanket and recently backfilled deep trench drains (Plate 26). The floodwater flowed through the site, eroding deep gullies in exposed completely decomposed andesite and recently placed fill. Part of the flood joined water from the southern drainage line, part washed onto the golf driving range depositing sand, silt and gravel, and part flowed northeast, off the site (Plates 8, 9, 34 & 35).

Plate 8 - The Foothills Bypass Site, Ch N500 to N850, 17 April 2000

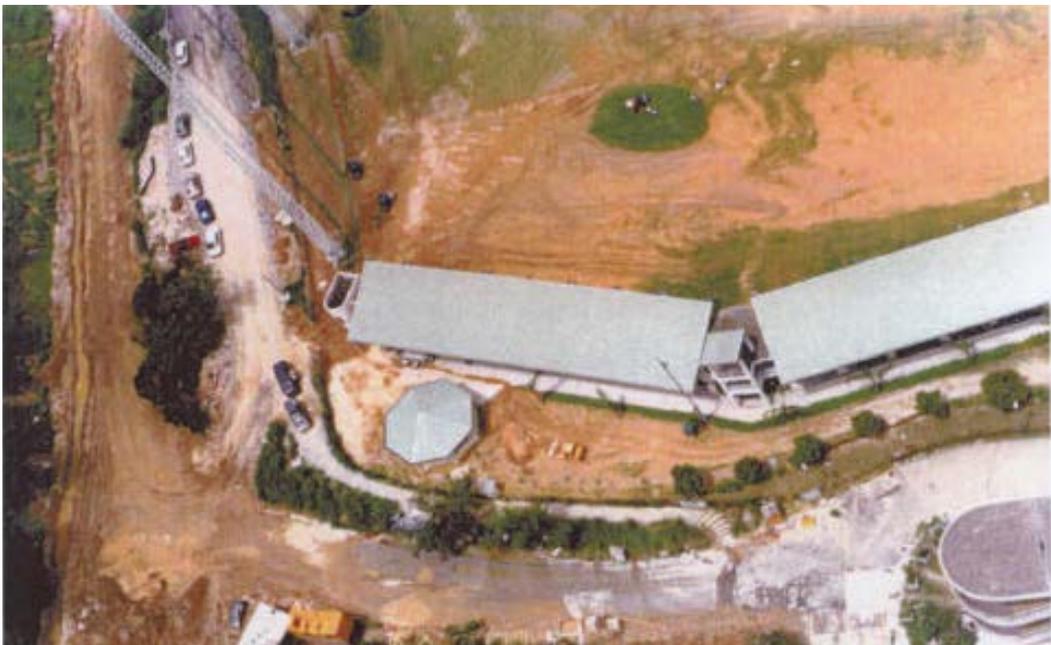
TE 2000/018/6

Plate 9 - Deposits on the Golf Centre and Site Access Road, Ch N850 to N990 and Ch S1100 to S1220, 17 April 2000

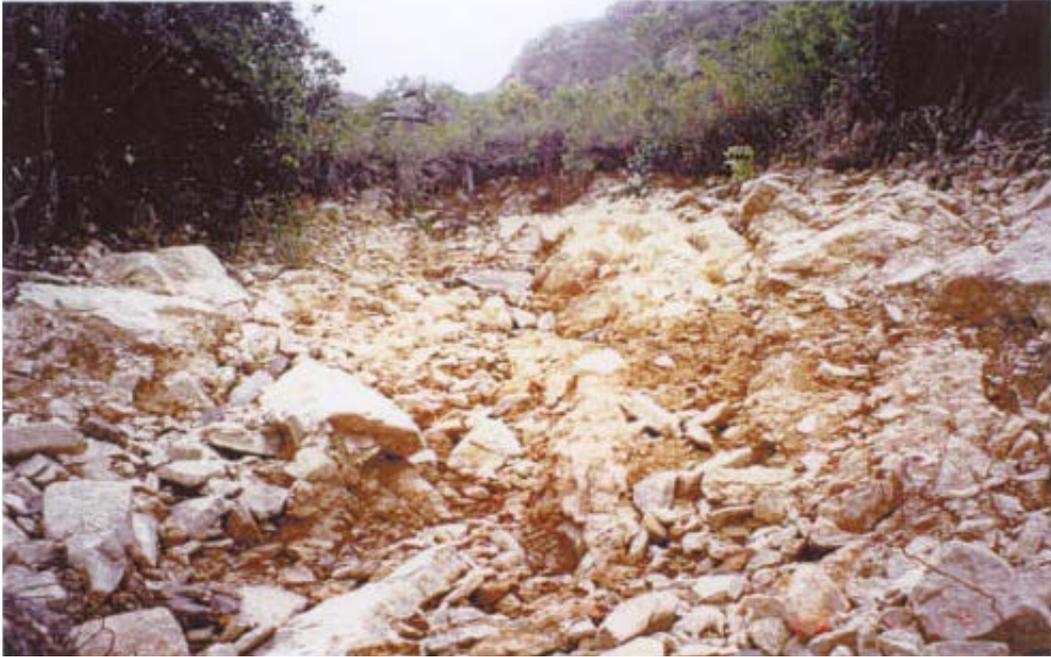
TE 2000/015/0

Plate 10 - The Source Area, Ch 0 to 20, 17 April 2000

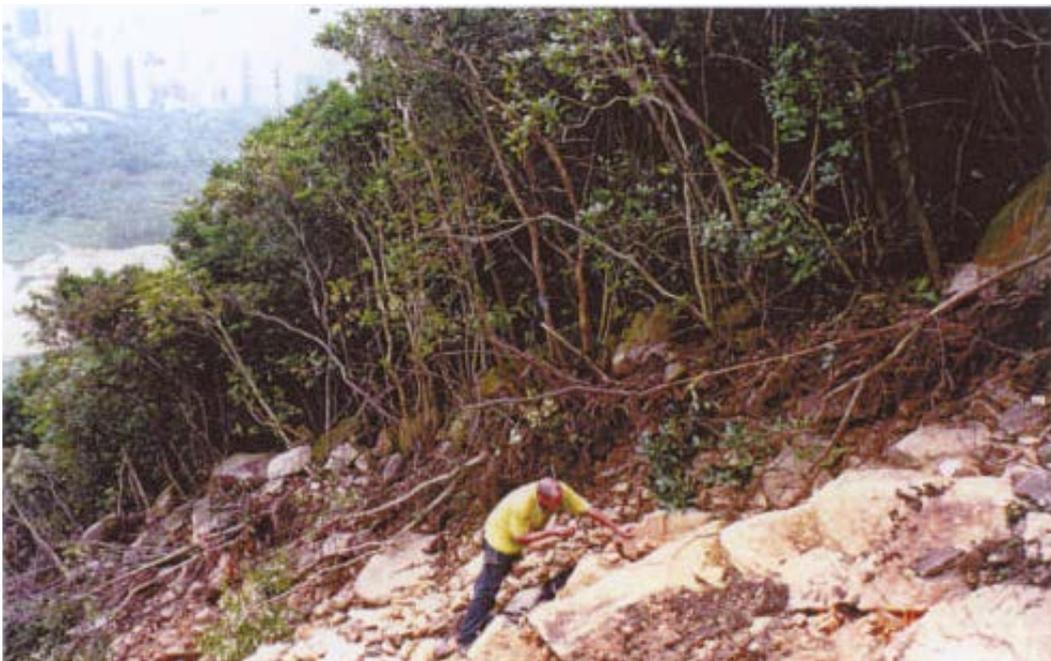
TE 2000/033/15

Plate 11 - Boulders and Vegetation Adjacent to the Source Area, Ch 10 to 30

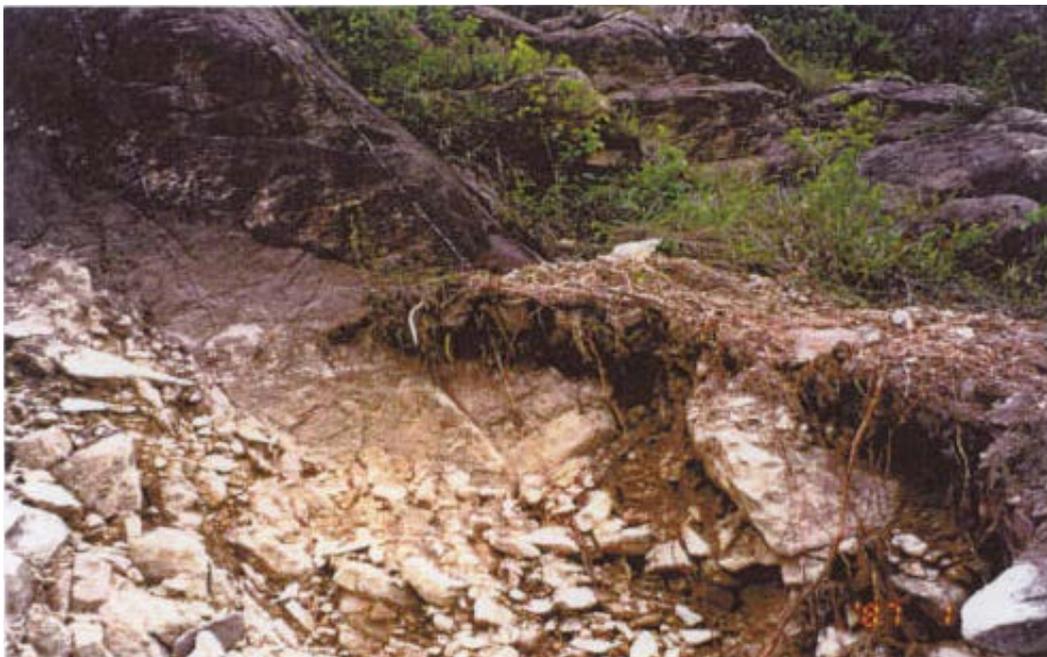
Plate 12 - Debris on the Undisturbed Ground Surface at the Edge of the Scar at Ch 30

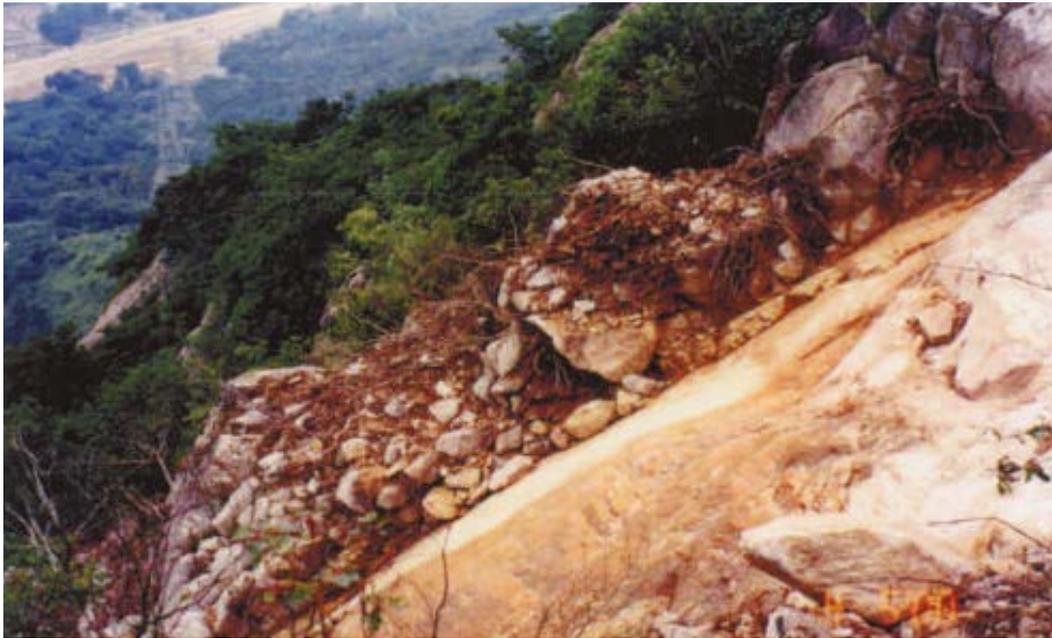
Plate 13 - Erosion along the Bedrock Gully at Ch 70

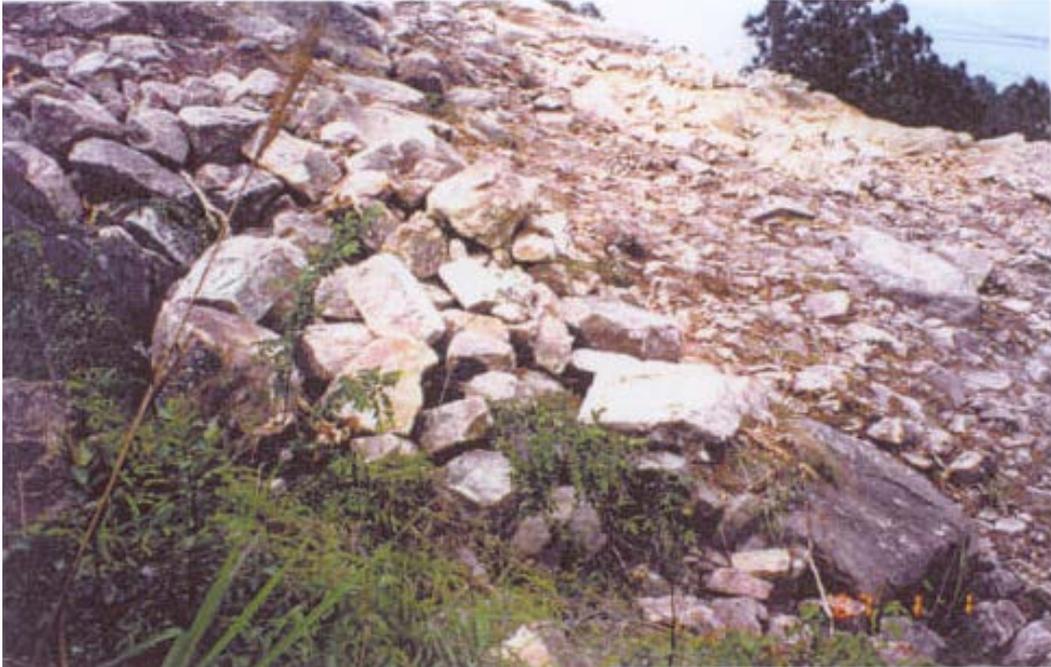
Plate 15 - Erosion to Fresh Rock along the Bedrock Gully at Ch 110

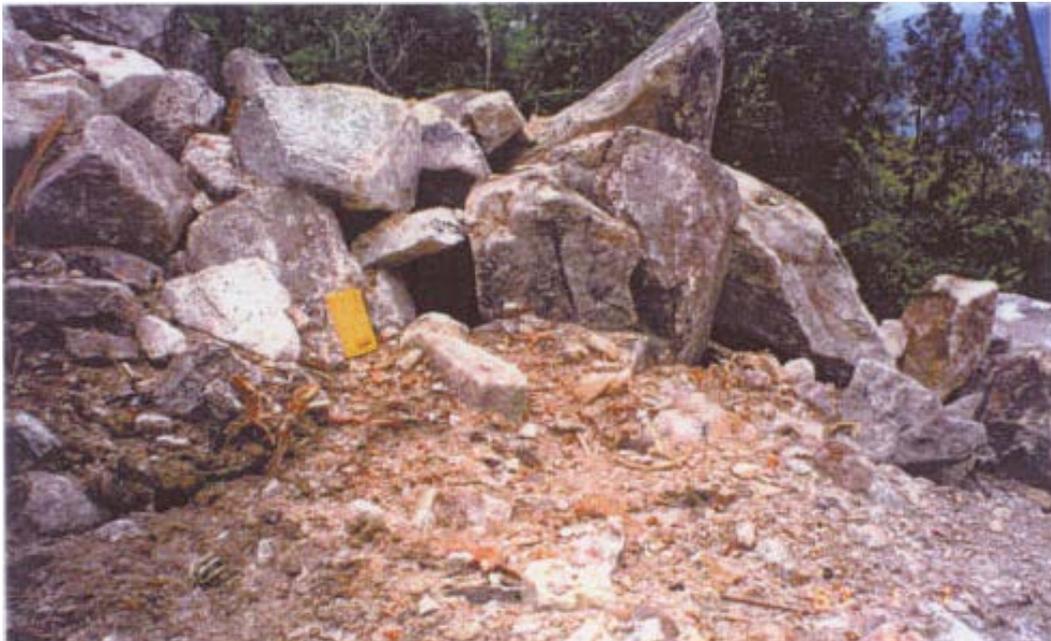
Plate 16 - Southern Boulder Levee at Ch 180

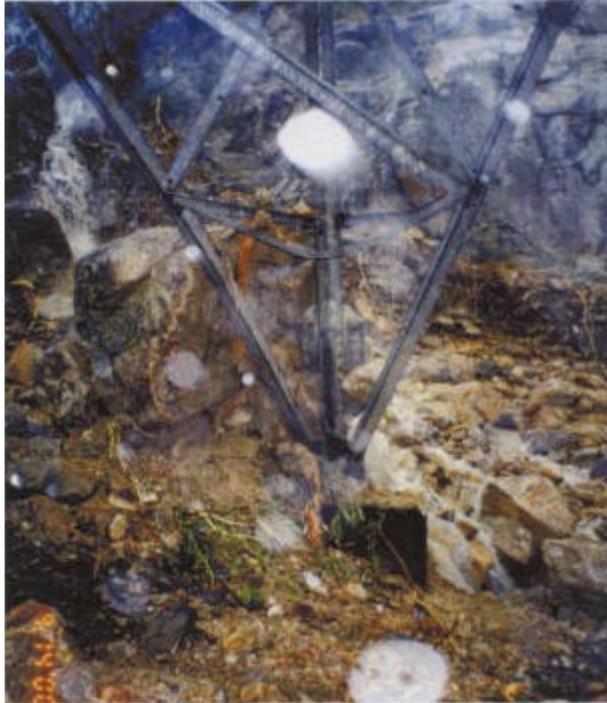
On the northern side of the scar, near the CLP pylon, there are larger deposits of boulders protruding from a finer matrix (Plates 17 & 19) and evidence of debris up to 3 m high at the pylon legs. About 6 hours after the event the matrix was very soft and wet but later when dry it became stiff. The bouldery deposits are up to 2.5 m thick and their tops are at a similar level although separated by irregular gullies. The base of the gullies has been eroded into the underlying existing colluvium by flowing water. At this location debris may have accumulated in a thick lobe from the flow down the southern drainage line. As the lobe built up it either overflowed into the northern drainage line leaving the irregular gullies or was subsequently eroded by water, or more fluid debris, that carried it down the northern drainage line.

Plate 17 - Northern Boulder Levee and Matrix at Ch N250

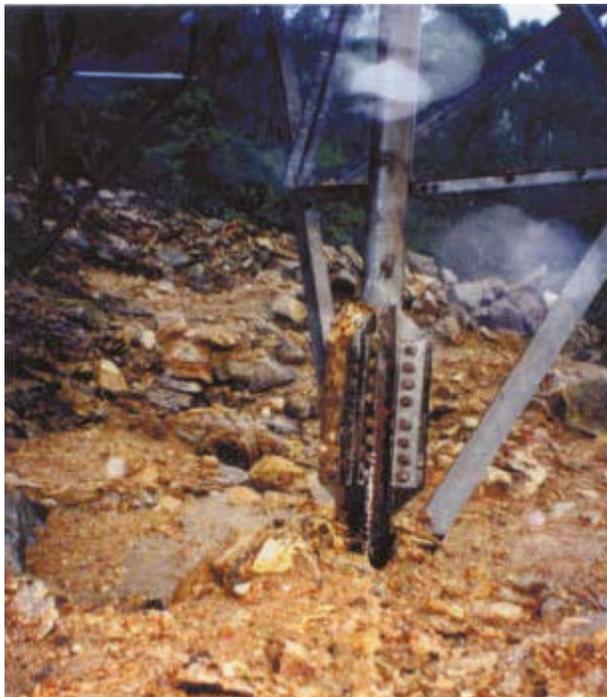
The China Light and Power (CLP) pylon located on a spur at about Ch 240 received almost a direct hit from the debris (Plates 18 to 21) and the debris impact bent several bracing struts. Debris piled up to 1 m thick against the uphill legs and there is evidence of active debris up to 3 m above ground level. The debris flow also caused some erosion around the pad footings. CLP have since constructed some deflection barriers to protect the pylon.

Plate 18 - Boulders Piled against Pylon Leg, 14 April 2000

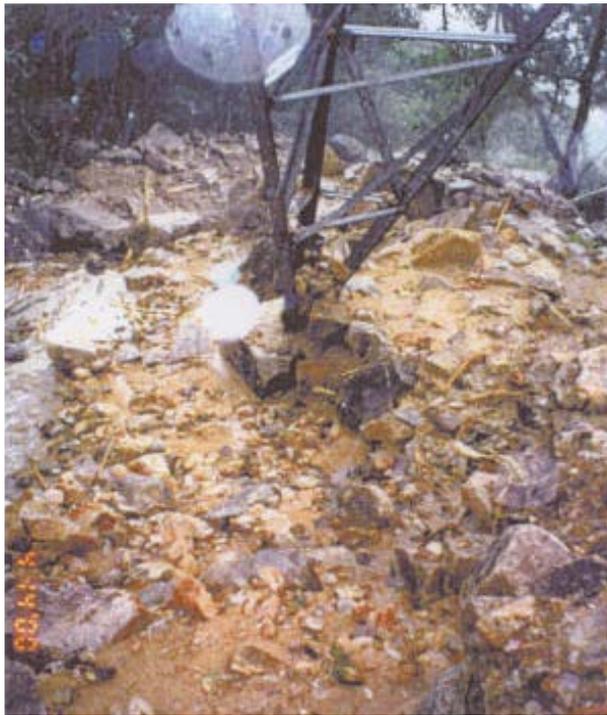
Plate 19 - Pylon Leg Embedded in Debris, 14 April 2000

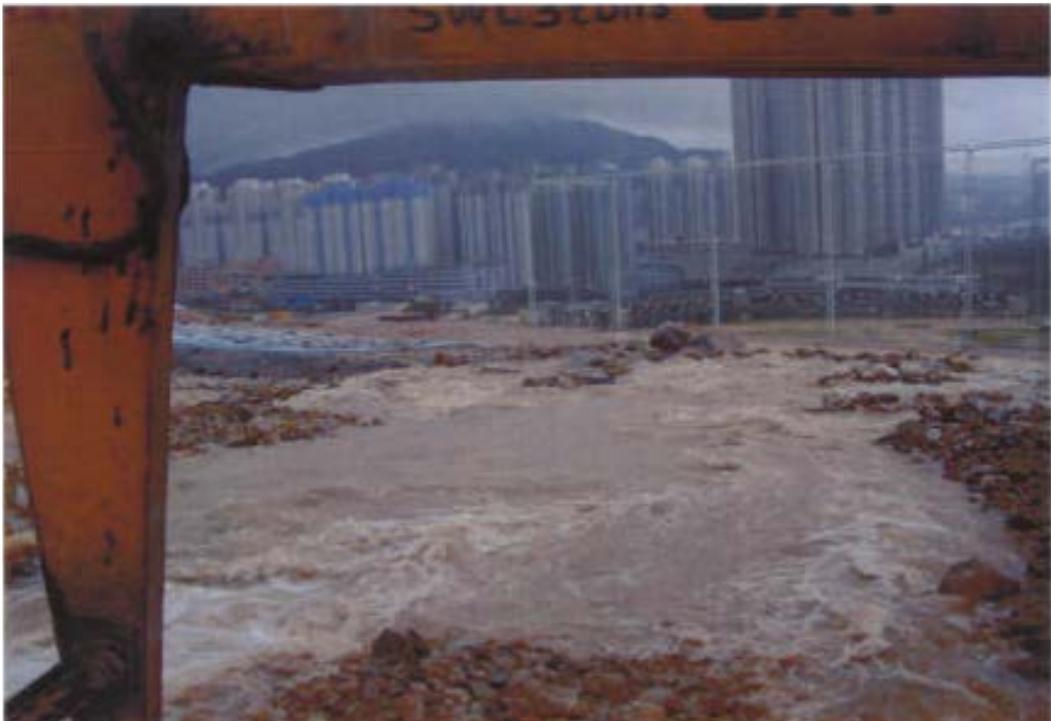
The debris flow resulted in deposition of about 700 m<sup>3</sup> of bouldery debris on the Tuen Mun Foothills Bypass site which blocked a drainage diversion channel (Plates 22 to 25 & 33). The floodwater overflowed and eroded the sand from deep trench drains on a newly formed cut slope and a 1.5 m thick drainage blanket (Plate 26). It also cut gullies several meters deep into the exposed completely decomposed andesite at several locations. The total material eroded and washed from the site is estimated at about 3,000 m<sup>3</sup>. Vehicles parked along the site access road were embedded in debris (Plate 34).

Plate 22 - Deposition at Ch S530

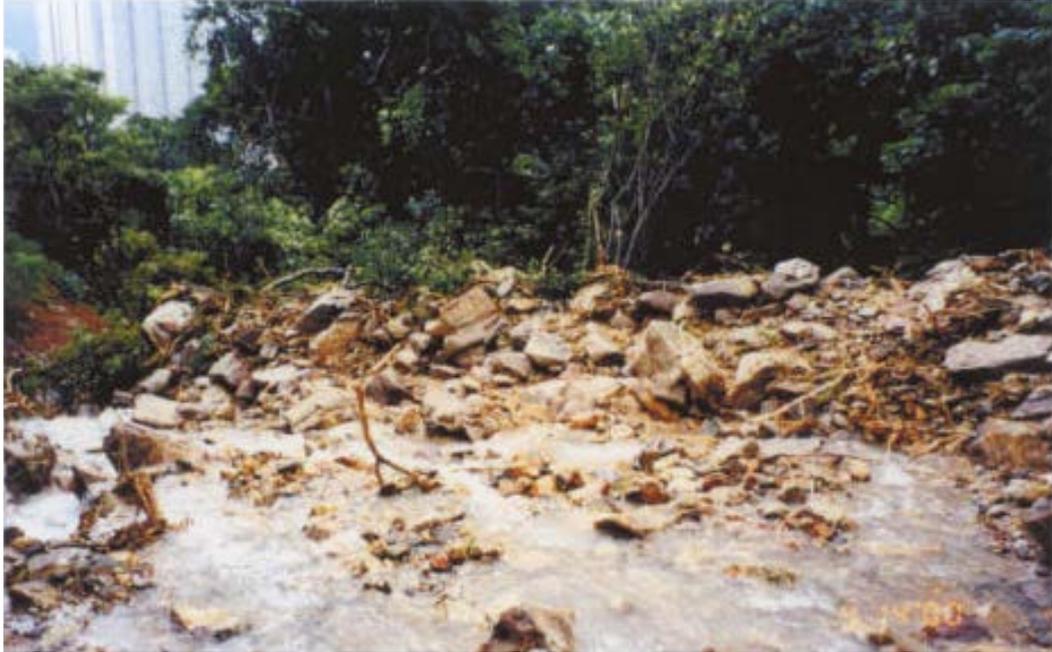
Plate 27 - Large Pre-existing Colluvial Boulders at Ch S430

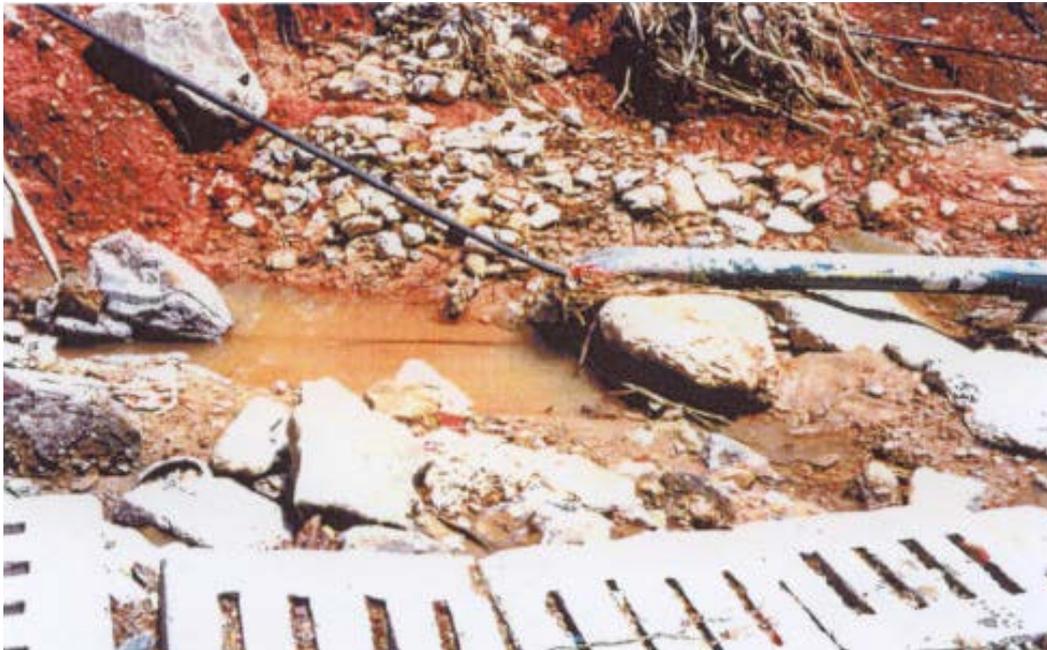
Plate 29 - Bank Erosion at Ch S580

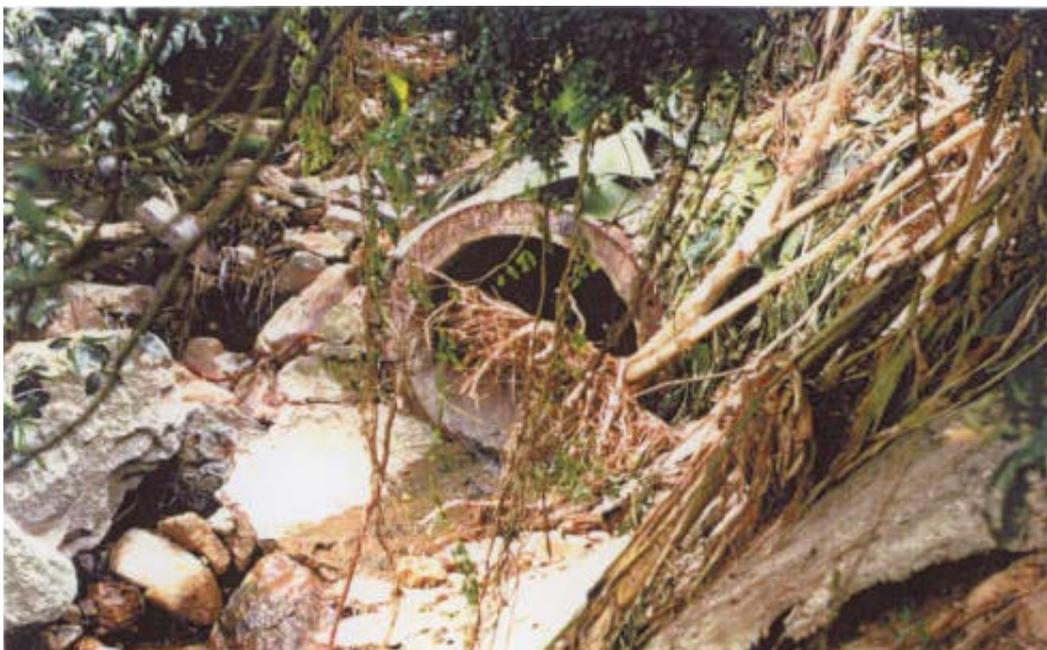
San Shek Wan San Tsuen Phase II was not directly affected by the debris flow although stream bank erosion came within 10 m of a house (see Section 4.4 above). On 14 April 2000, following the debris flow event, the GEO advised the residents of this house to seek shelter elsewhere in periods of heavy rain. Further downstream the debris flow blocked and overrode the culvert at the access road to the village and floodwater eroded along the sides of the concrete roadway. Adjacent to the culvert a 110 mm diameter steel pipe power pole was pushed down by the debris (Plate 30).

Plate 30 - Flattened 110 mm Diameter Power Pole at Ch S650

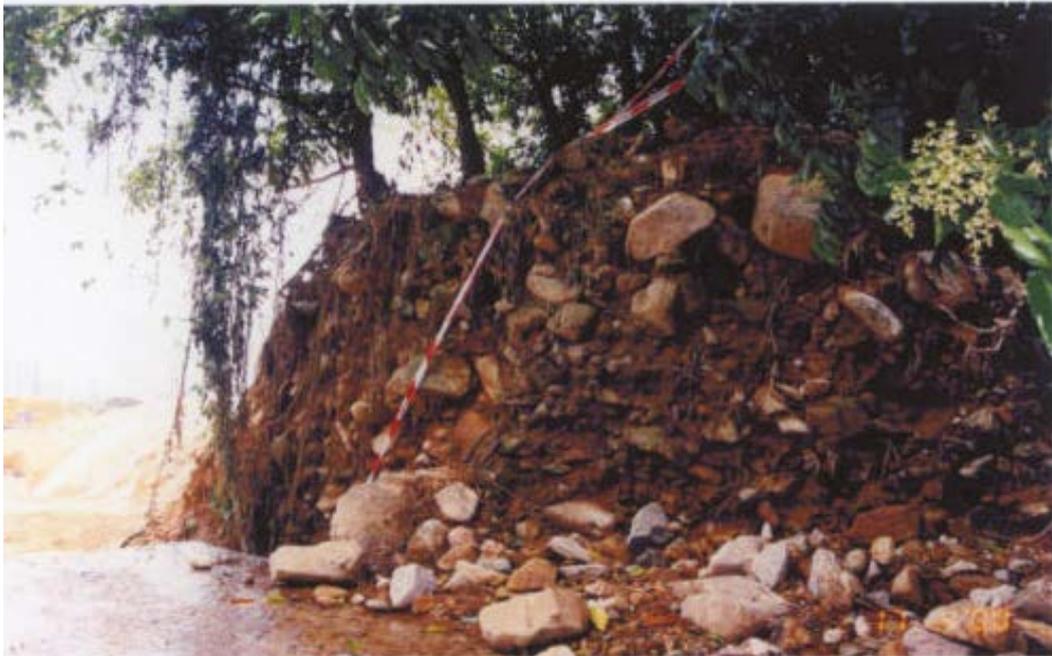
Plate 31 - Blocked 900 mm Diameter Culvert at Ch S650
